# Dam Decisions! Understanding Dam Maintenance and Repair

*NH Lakes Webinar – July 29, 2026*

Corey Clark, P.E.

Chief Engineer – Dam Bureau

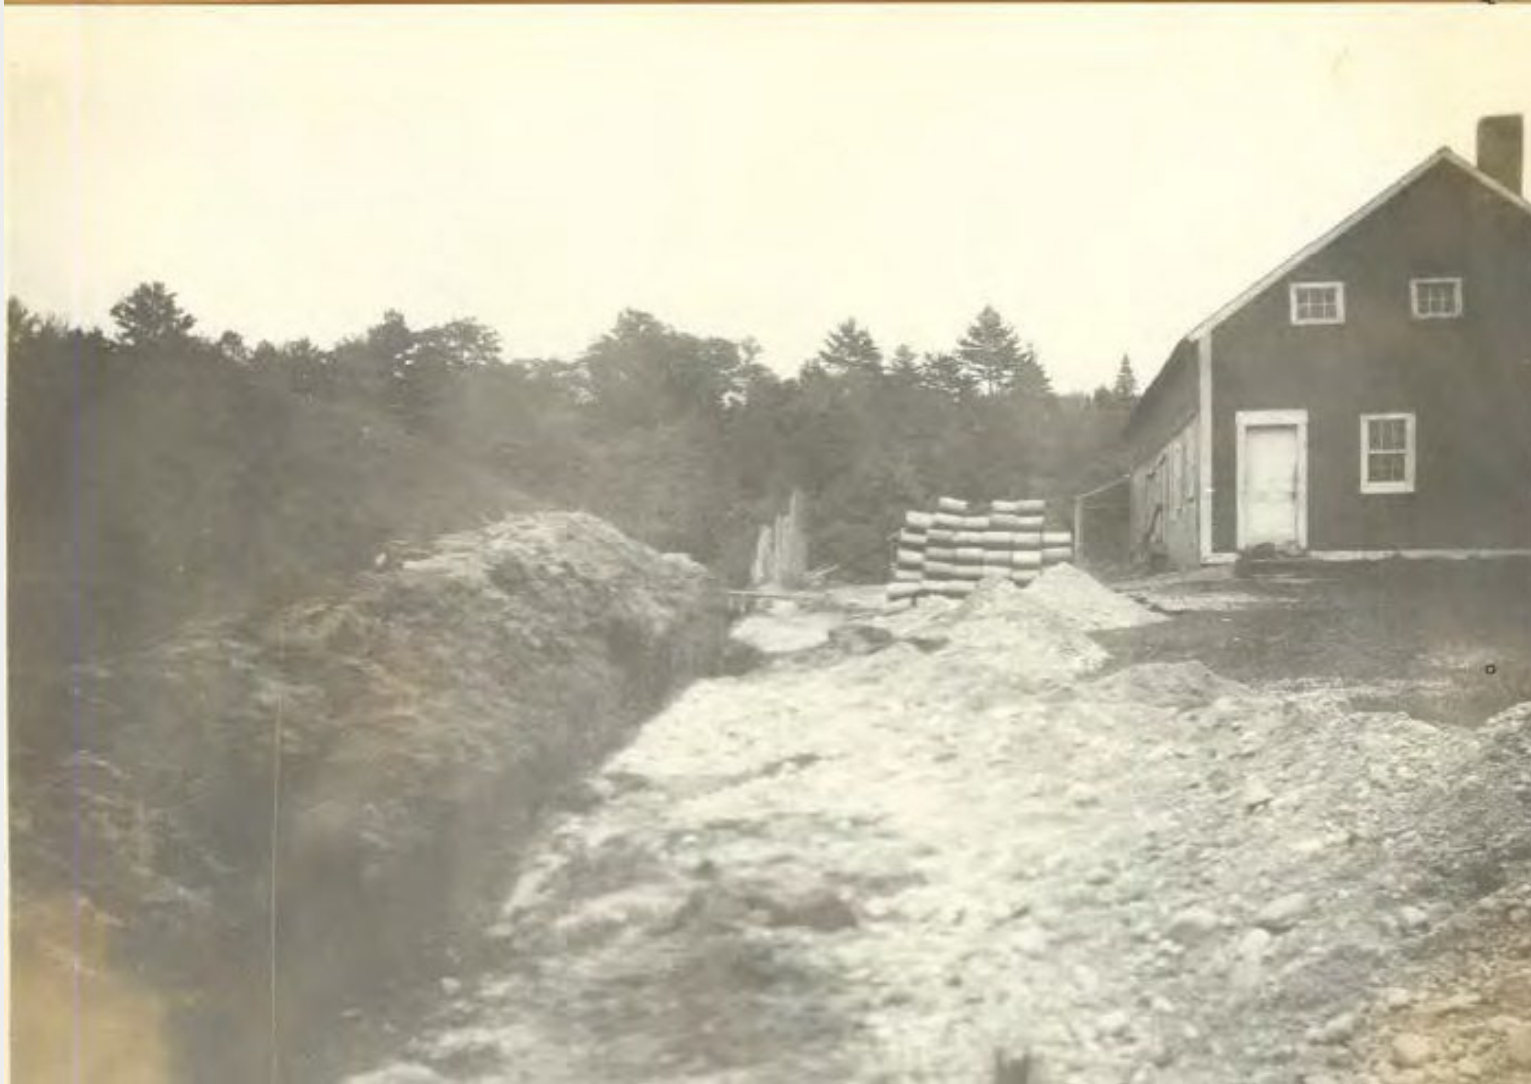
- 1928 toe drain was installed along downstream left side of the dam to mitigate seepage issues

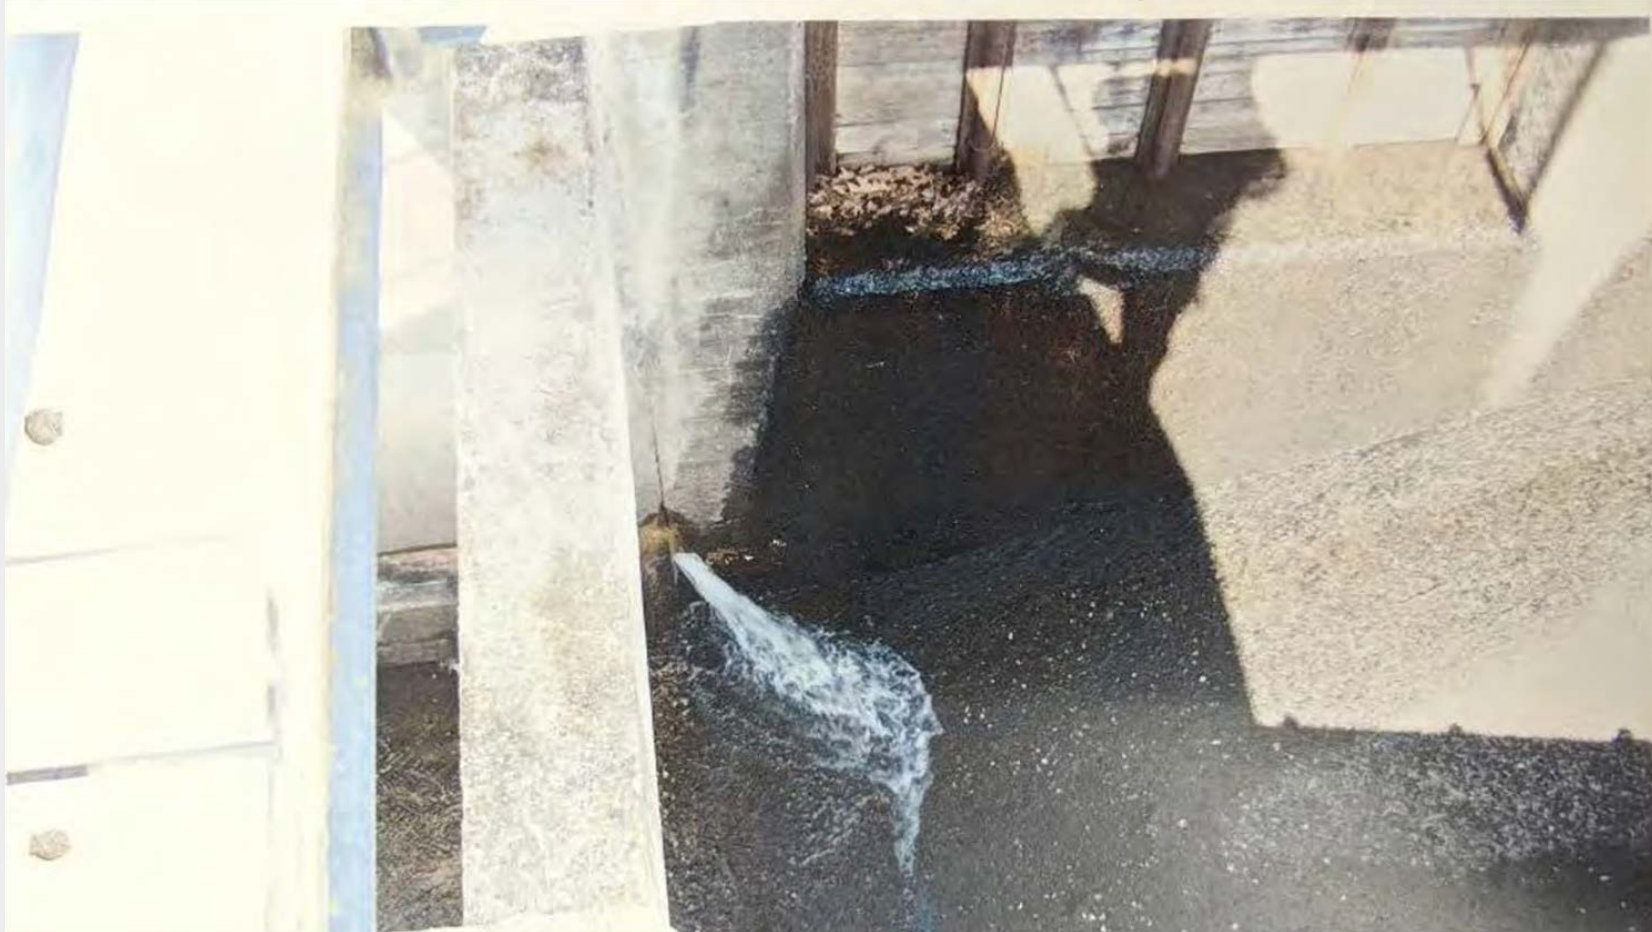
- 2013 drilling completed due to leakage concerns
- Wells installed indicated high water levels along the downstream side of the dam
- Soft soils were observed in borings completed for well installation

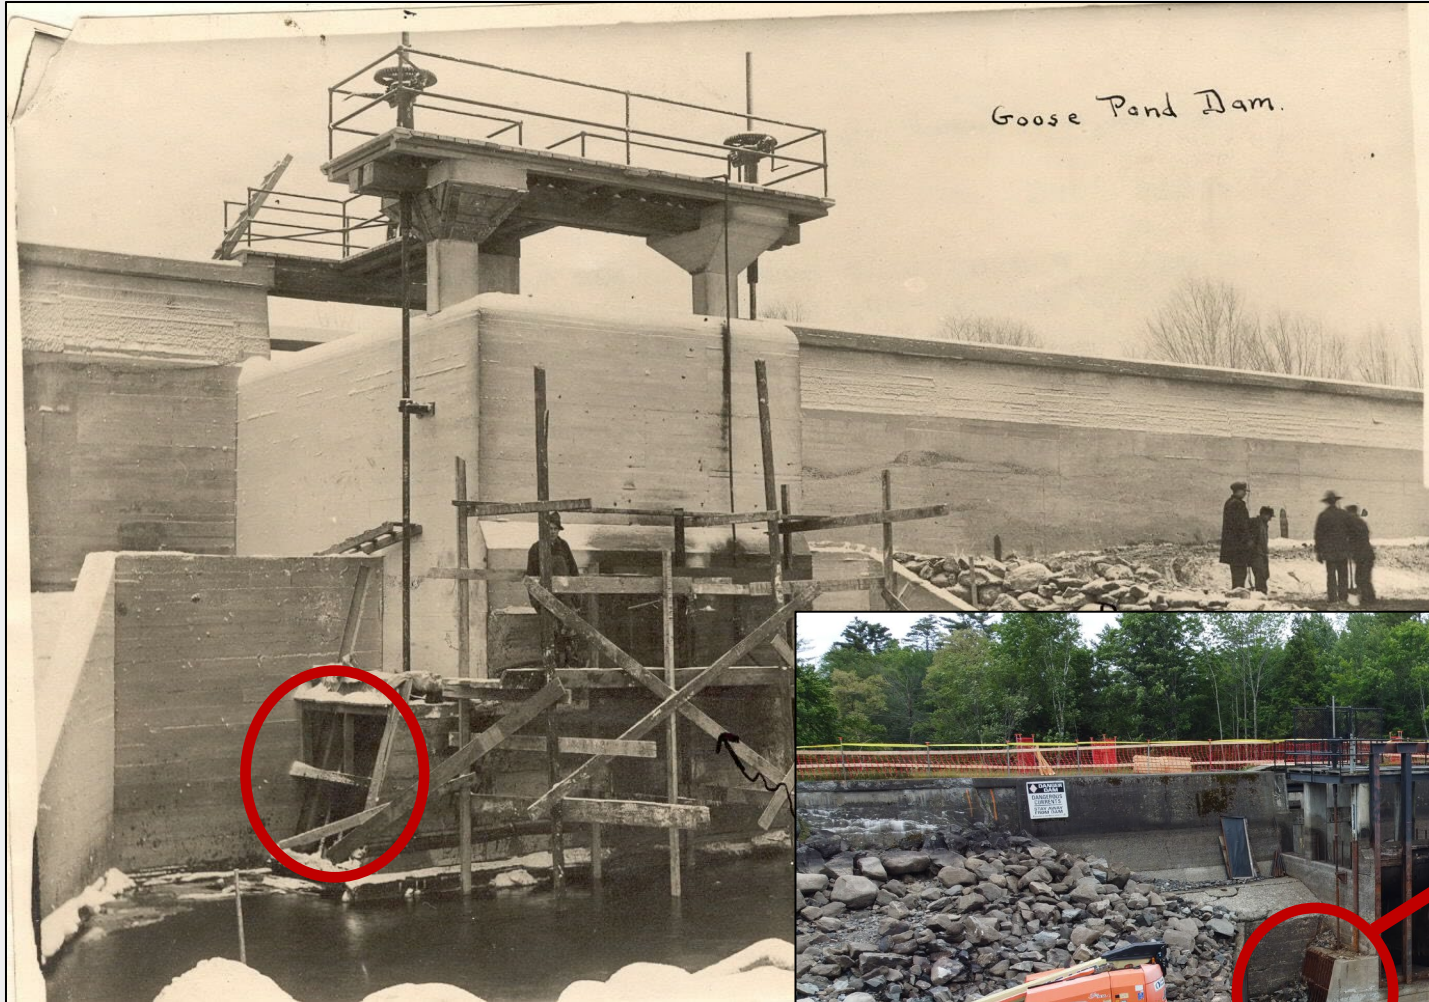
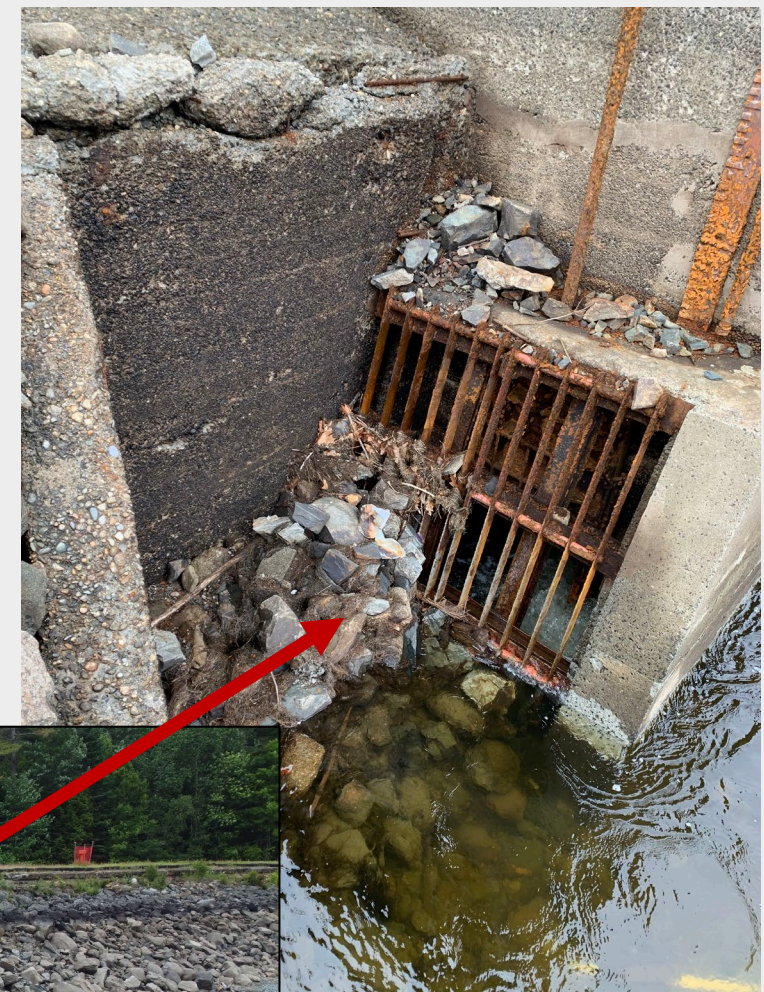
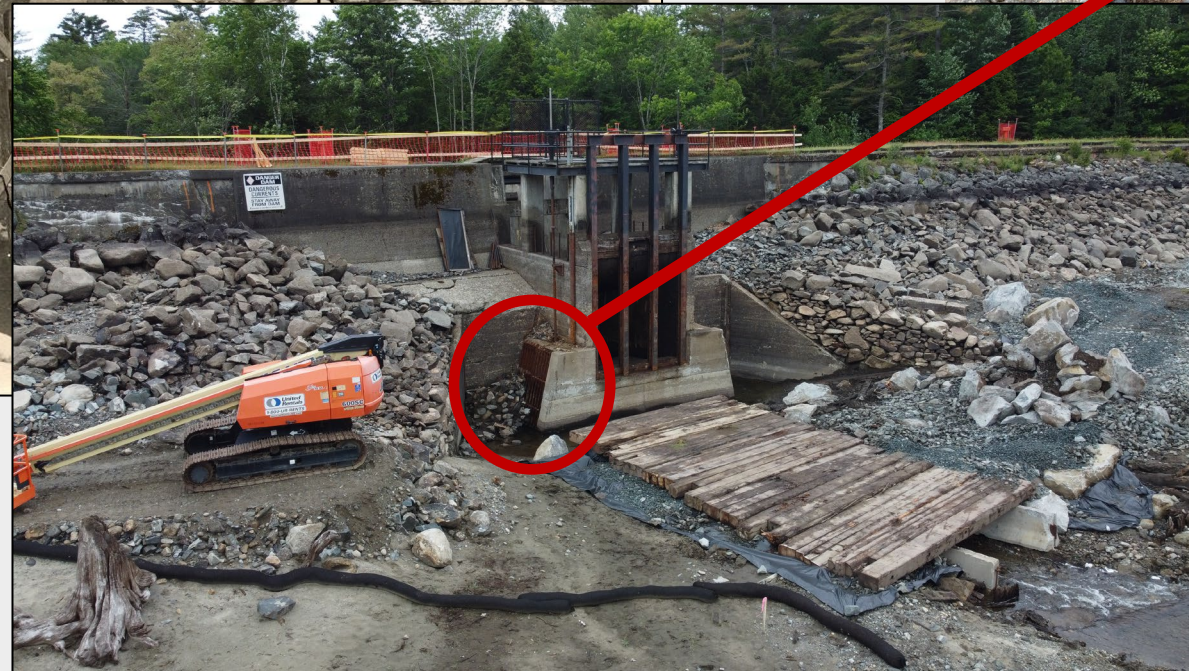
- Determined that existing gates needed replacement

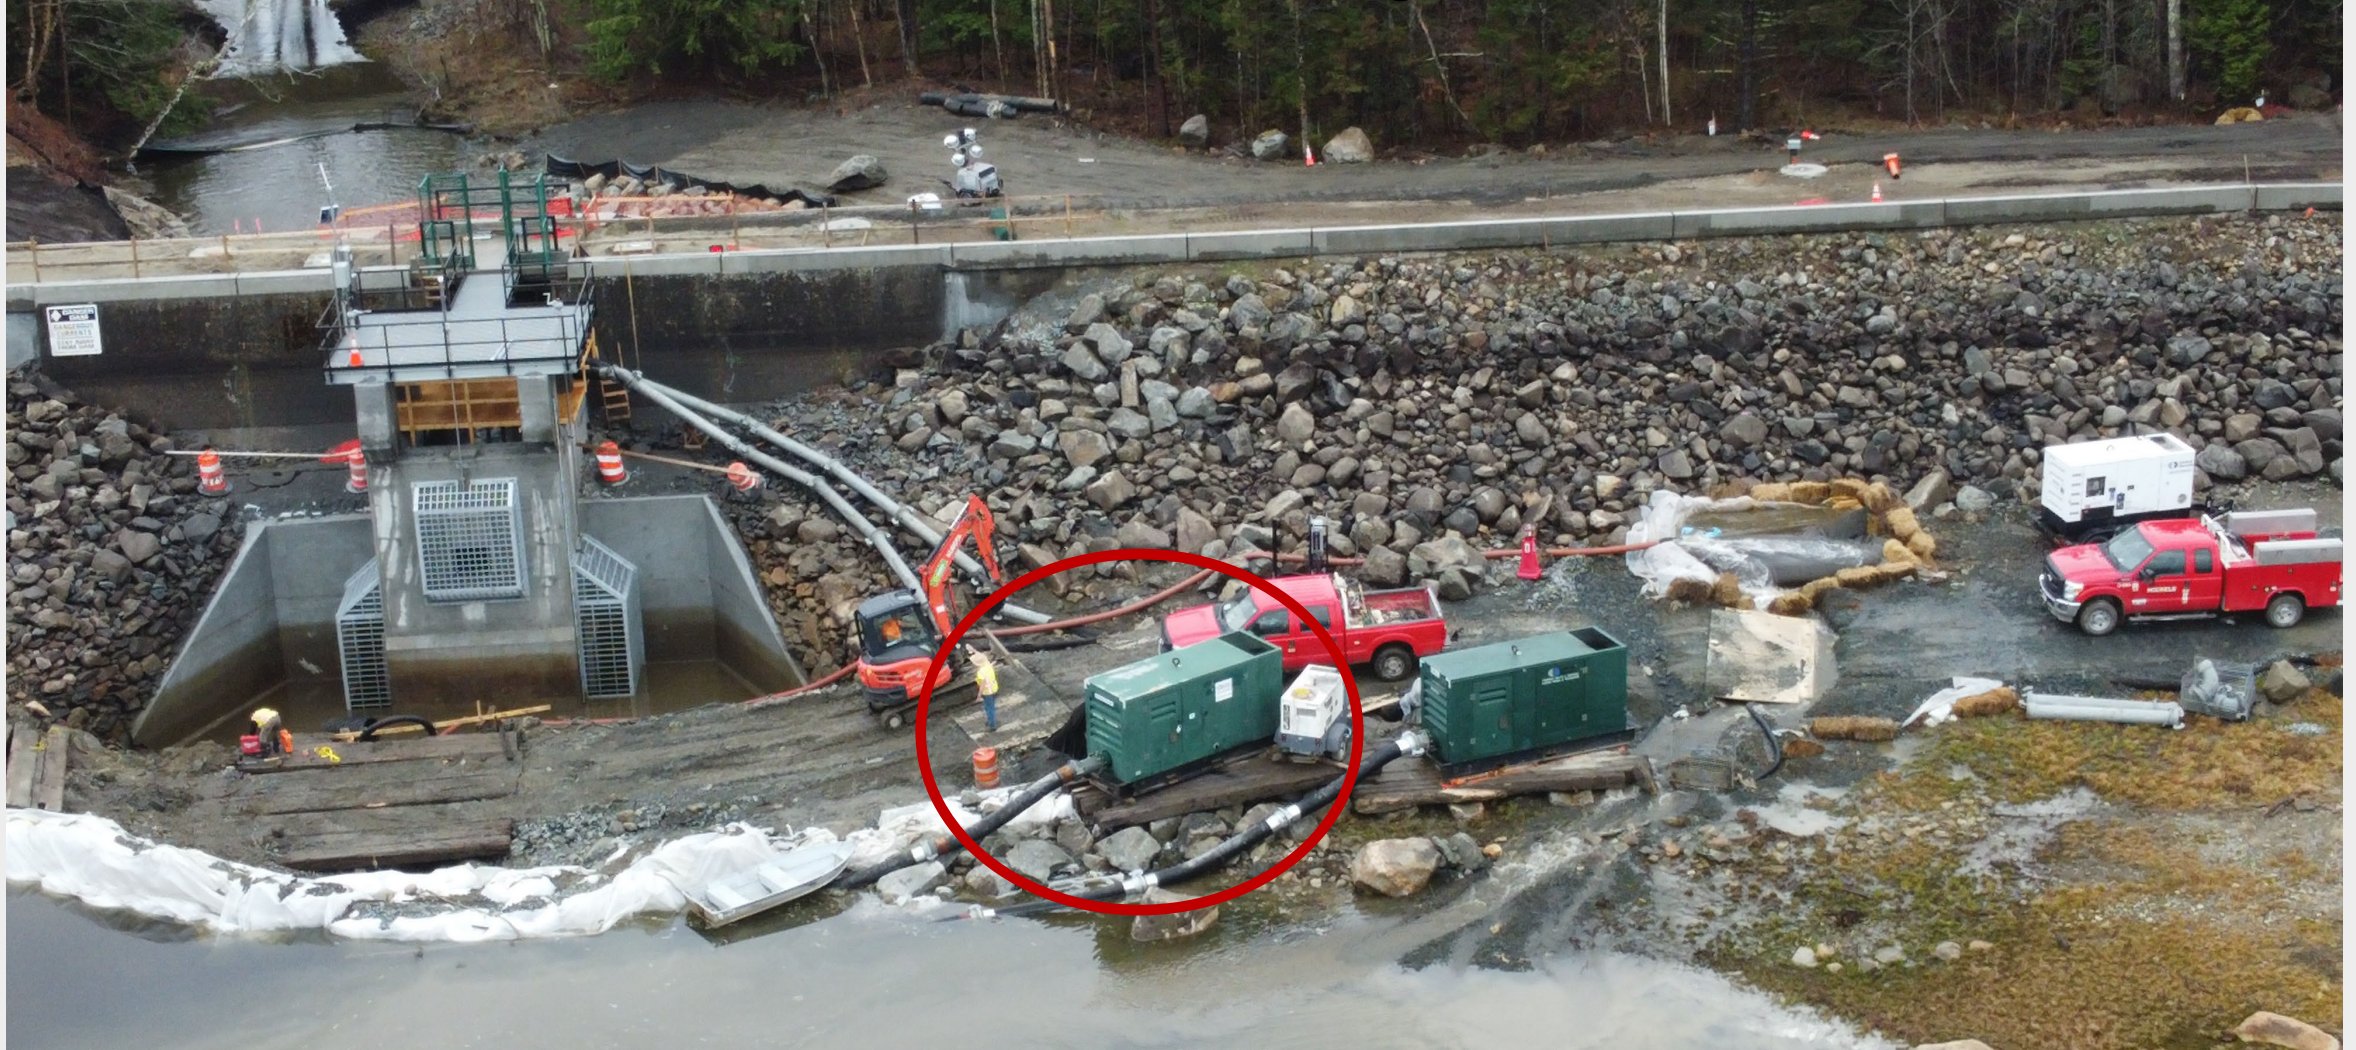
- As project was being completed and new gates were installed the existing cofferdam was overtopped during the spring of 2025

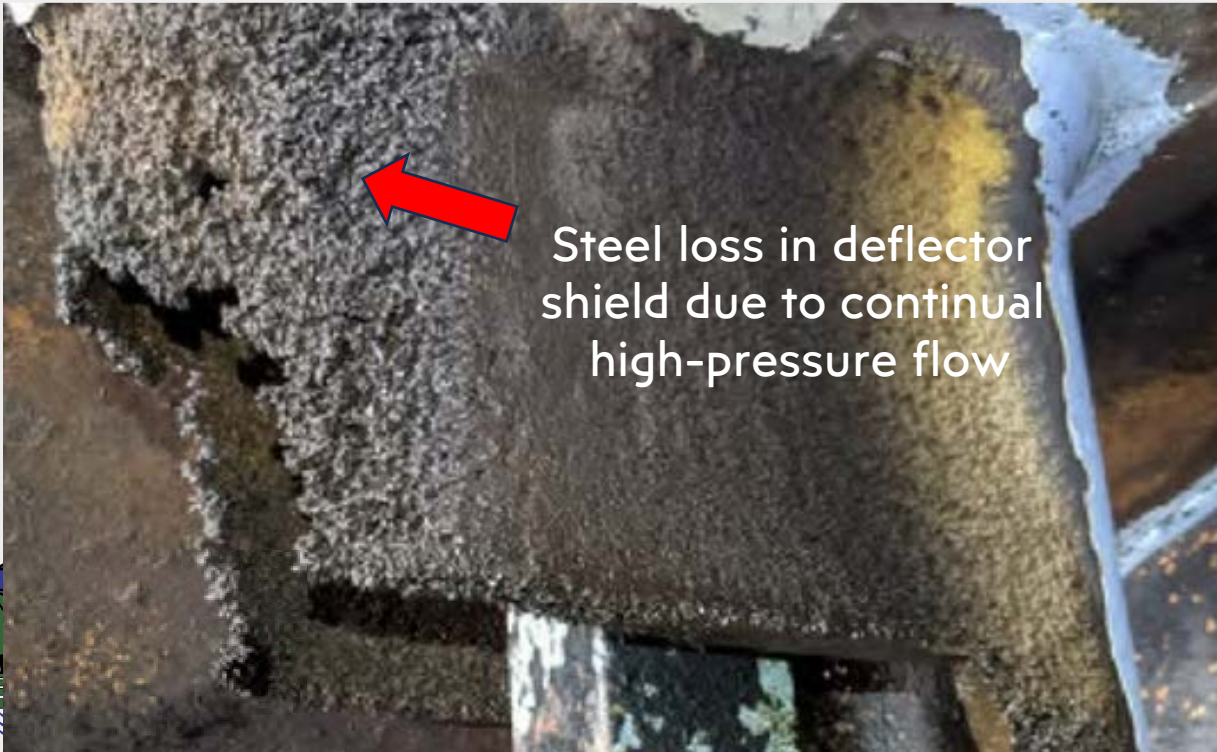
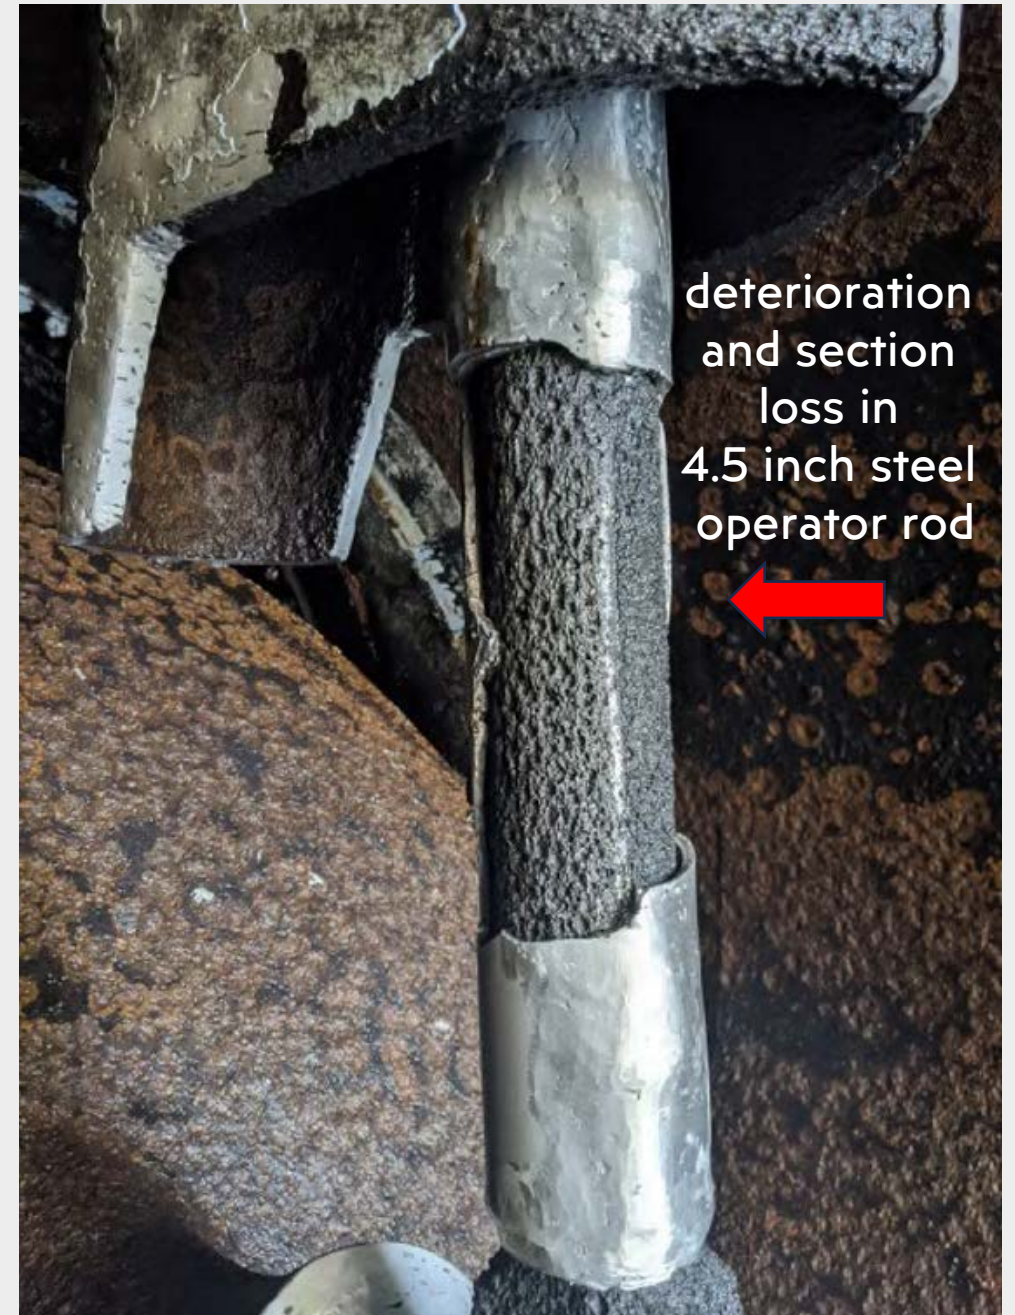
- Valves must run at very small openings they weren't designed for
- Small openings cause cavitation and steel loss
- Valves knock at flows over 400 cfs

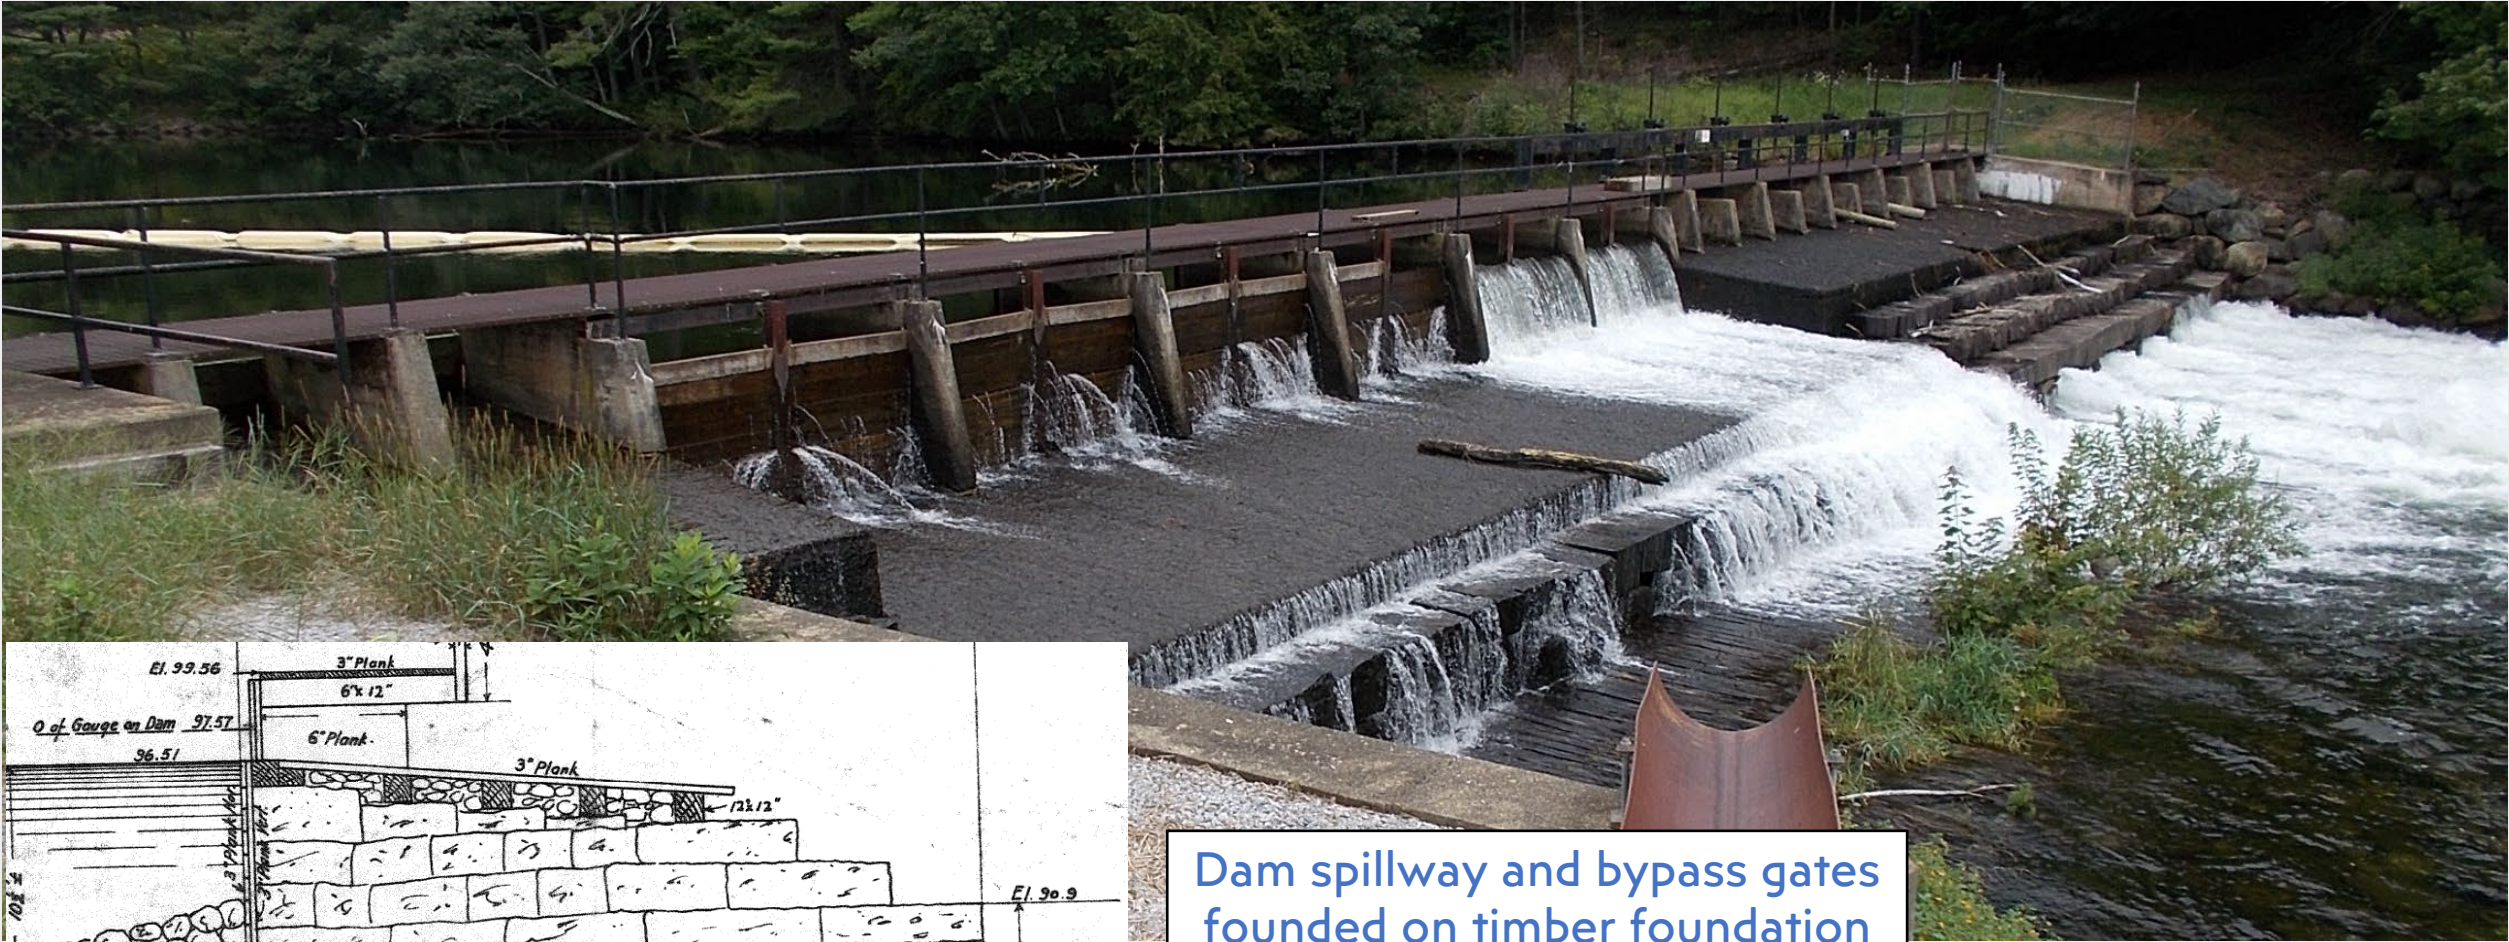
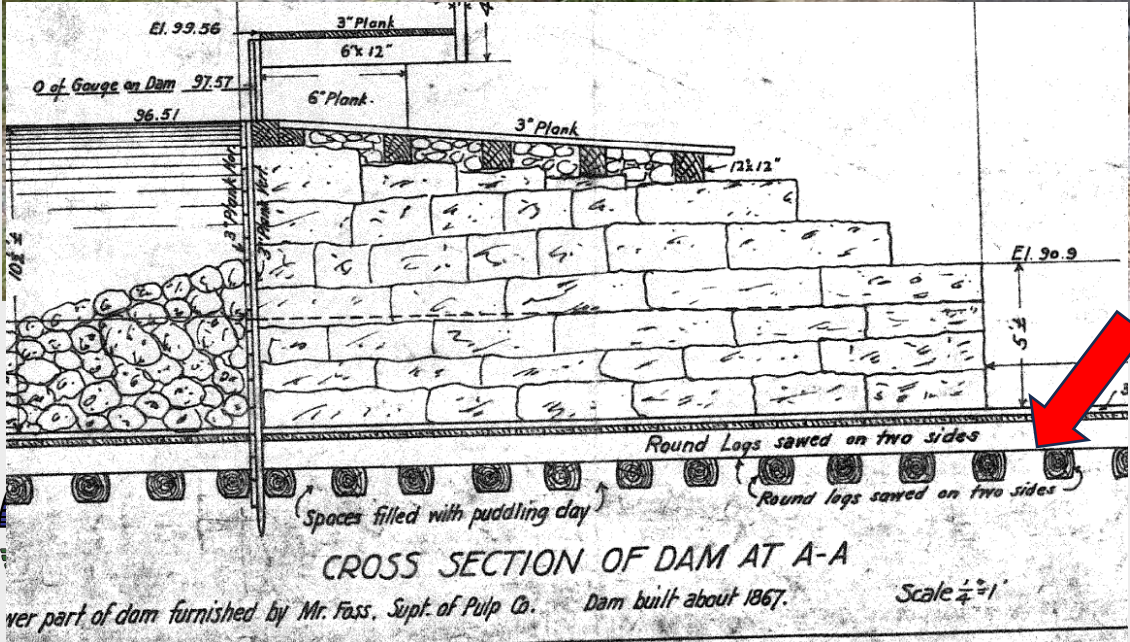
# Lochmere Dam – Lake Winnisquam – Poor Foundation

Dam spillway and bypass gates founded on timber foundation from 1867

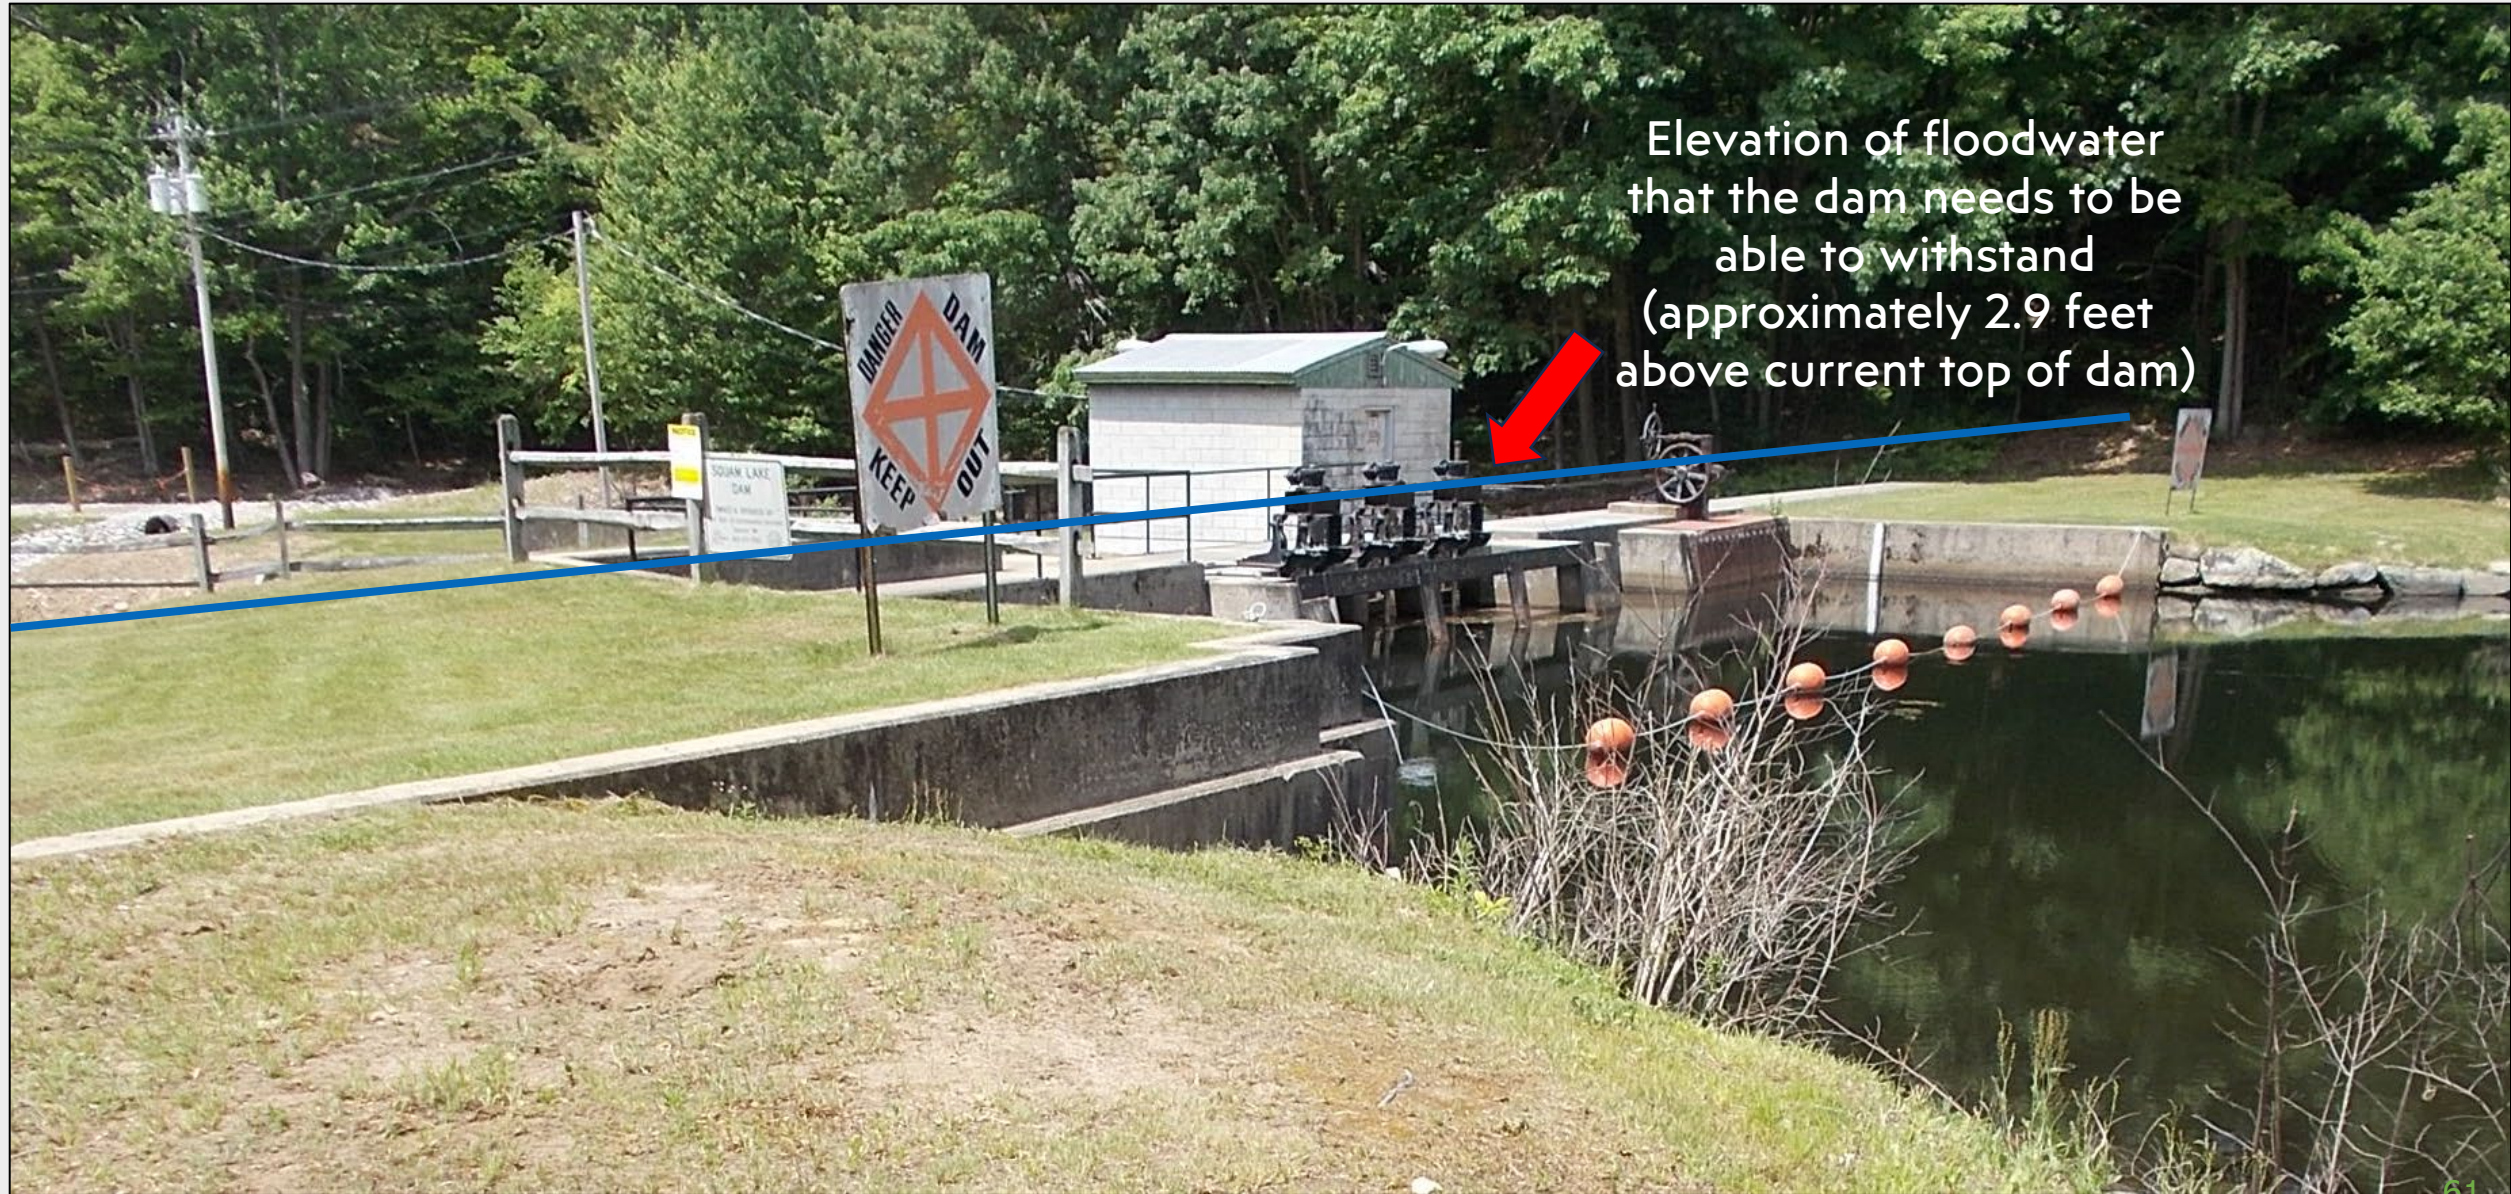
# Squam Lake Dam – Potential Overtopping During Flood

Elevation of floodwater  
that the dam needs to be  
able to withstand  
(approximately 2.9 feet  
above current top of dam)

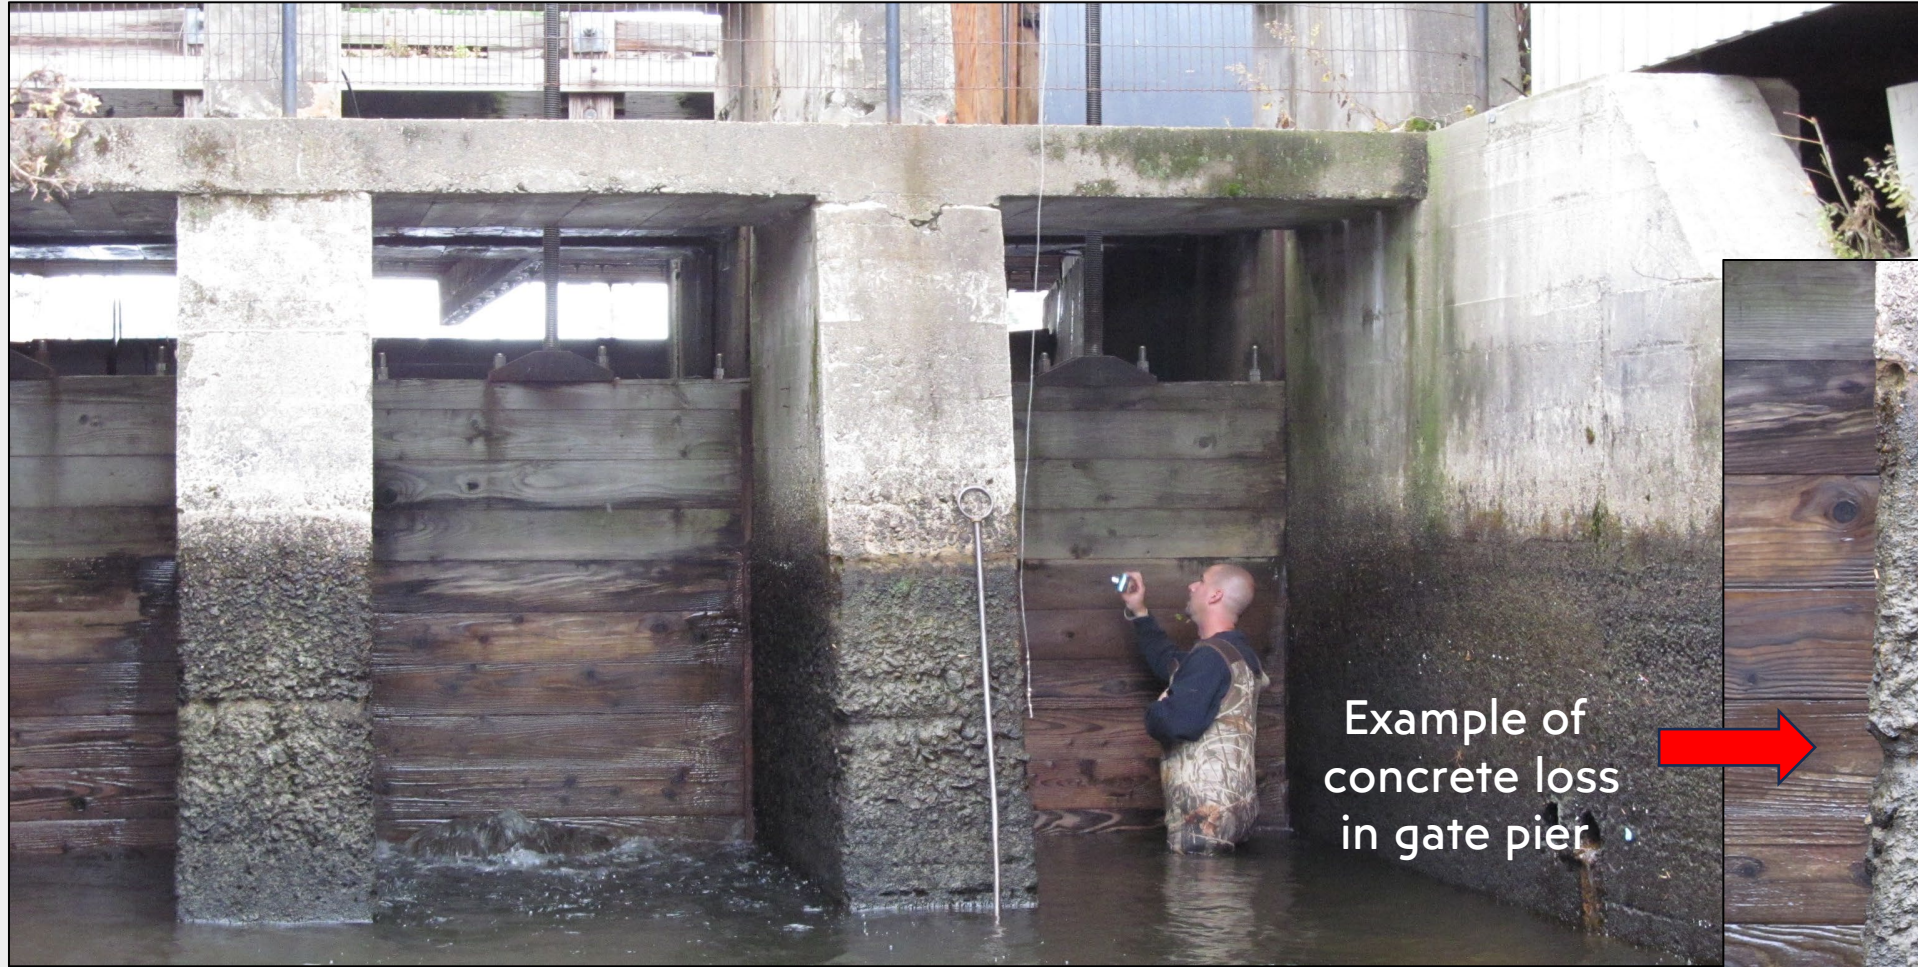
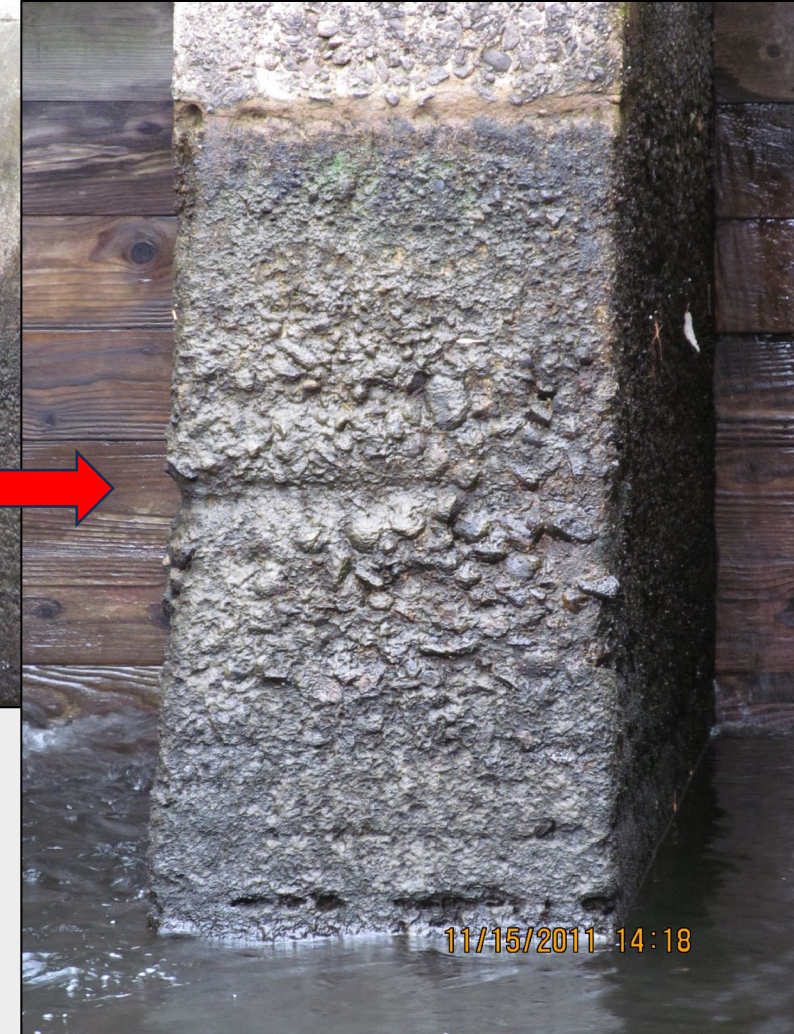
# Lake Sunapee Dam – Concrete Deterioration

Example of  
concrete loss  
in gate pier

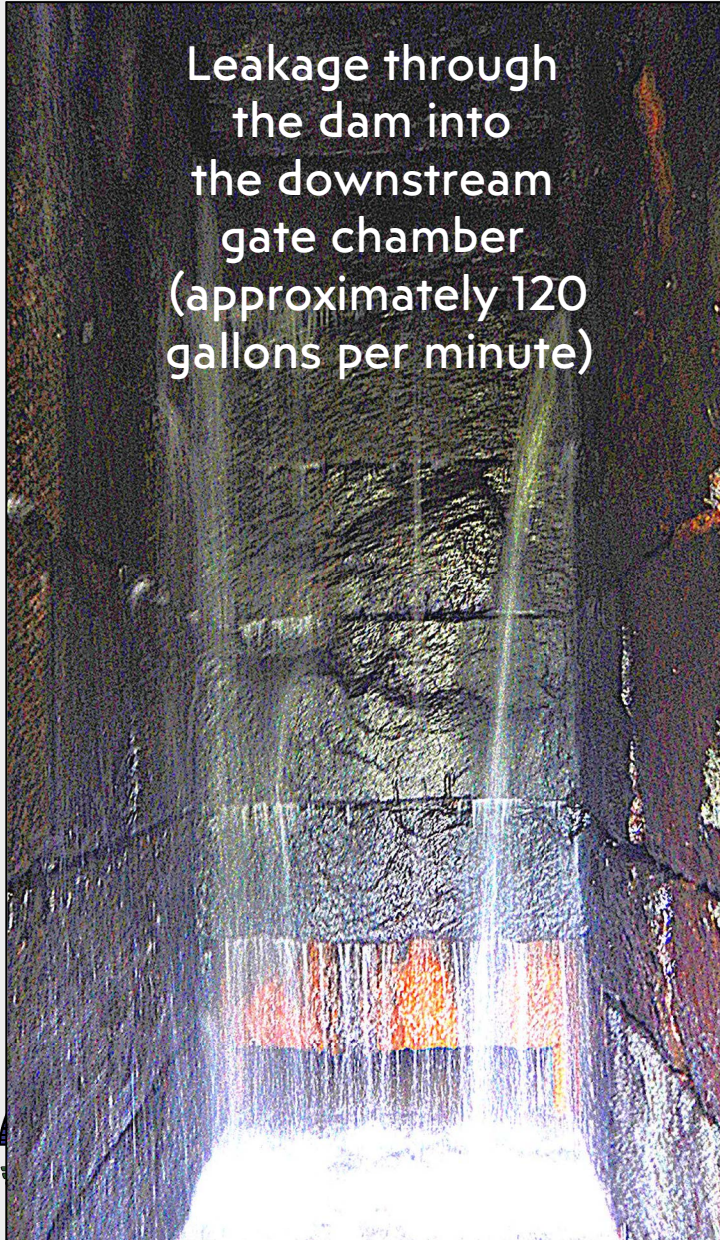
Leakage through  
the dam into  
the downstream  
gate chamber  
(approximately 120  
gallons per minute)

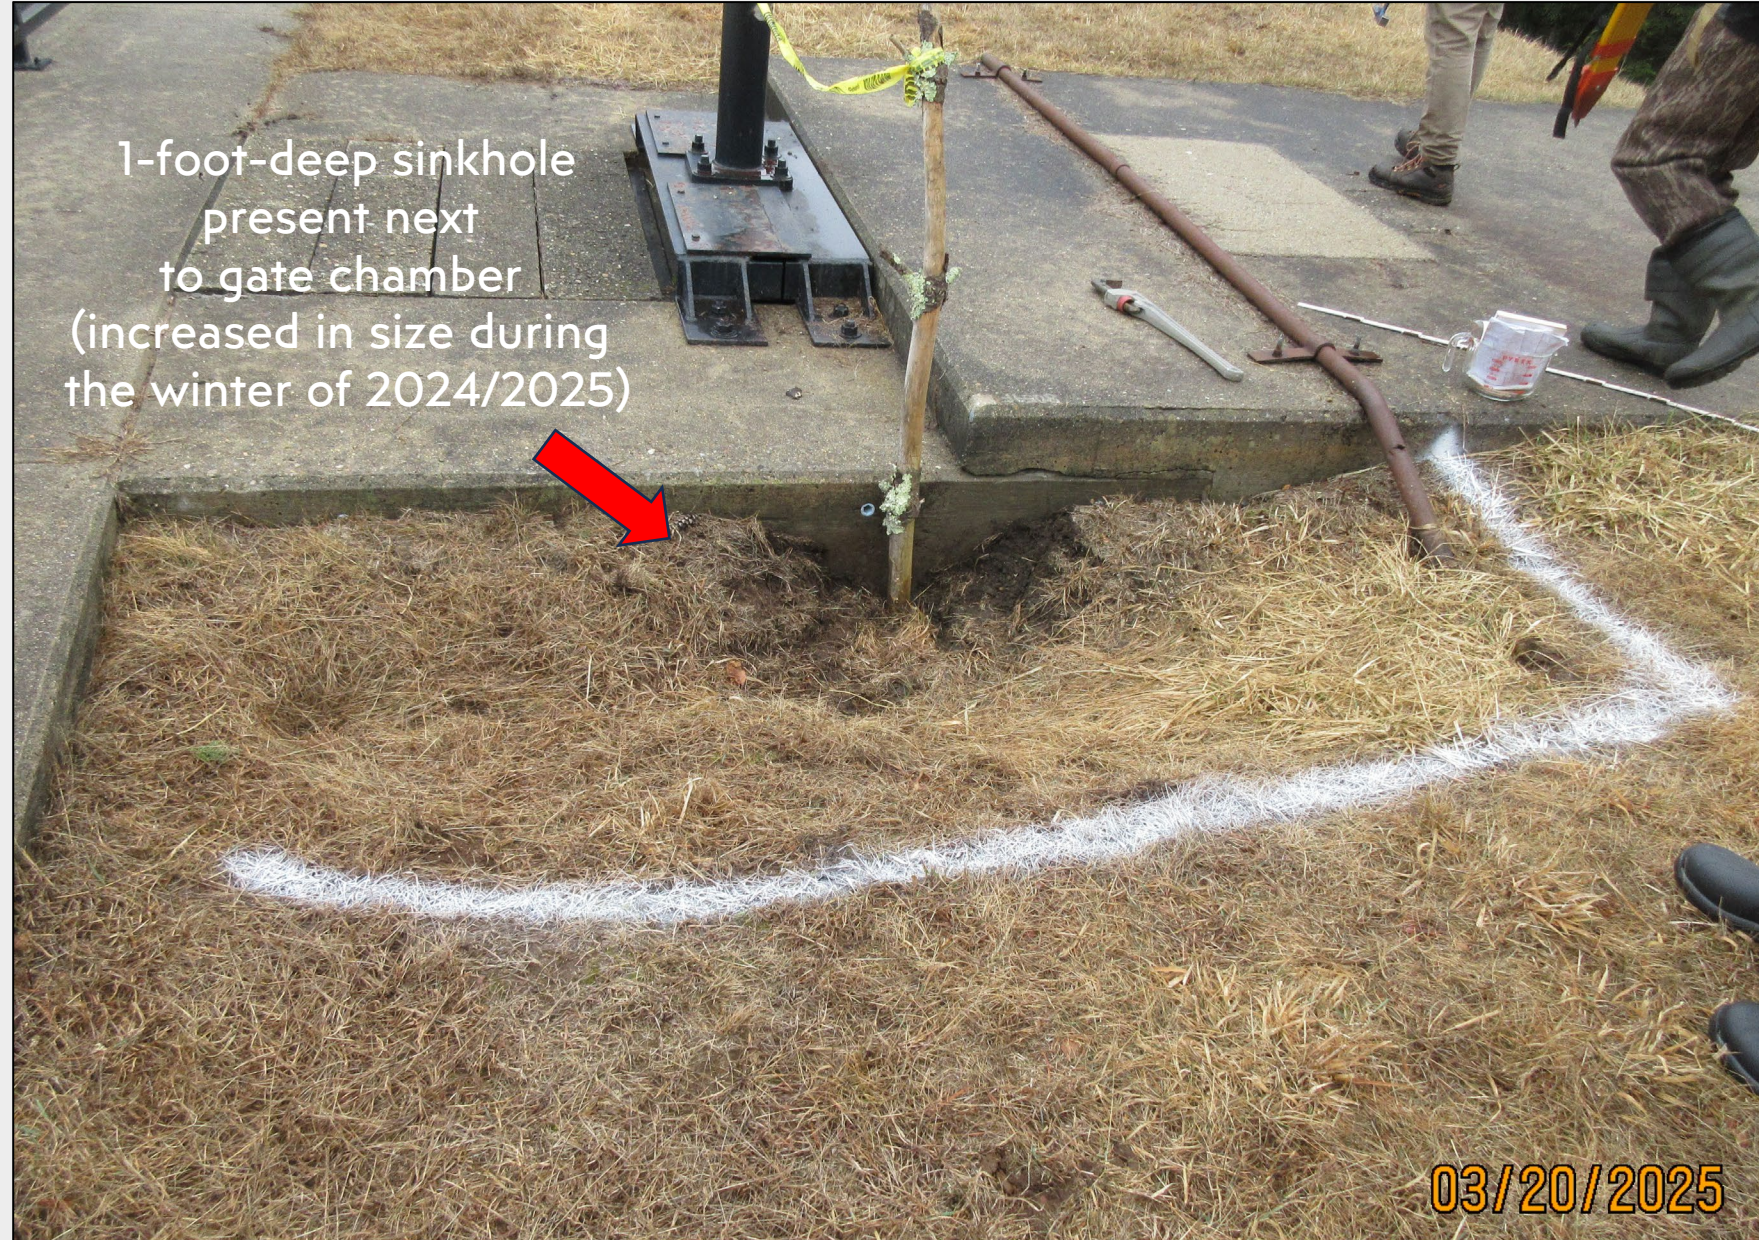
1-foot-deep sinkhole  
present next  
to gate chamber  
(increased in size during  
the winter of 2024/2025)
