States Landing Case Study: A Watershed Management Plan Success Story

Lakes Congress

LAKE WINNIPESAUKEE
ASSOCIATION

States Landing Beach

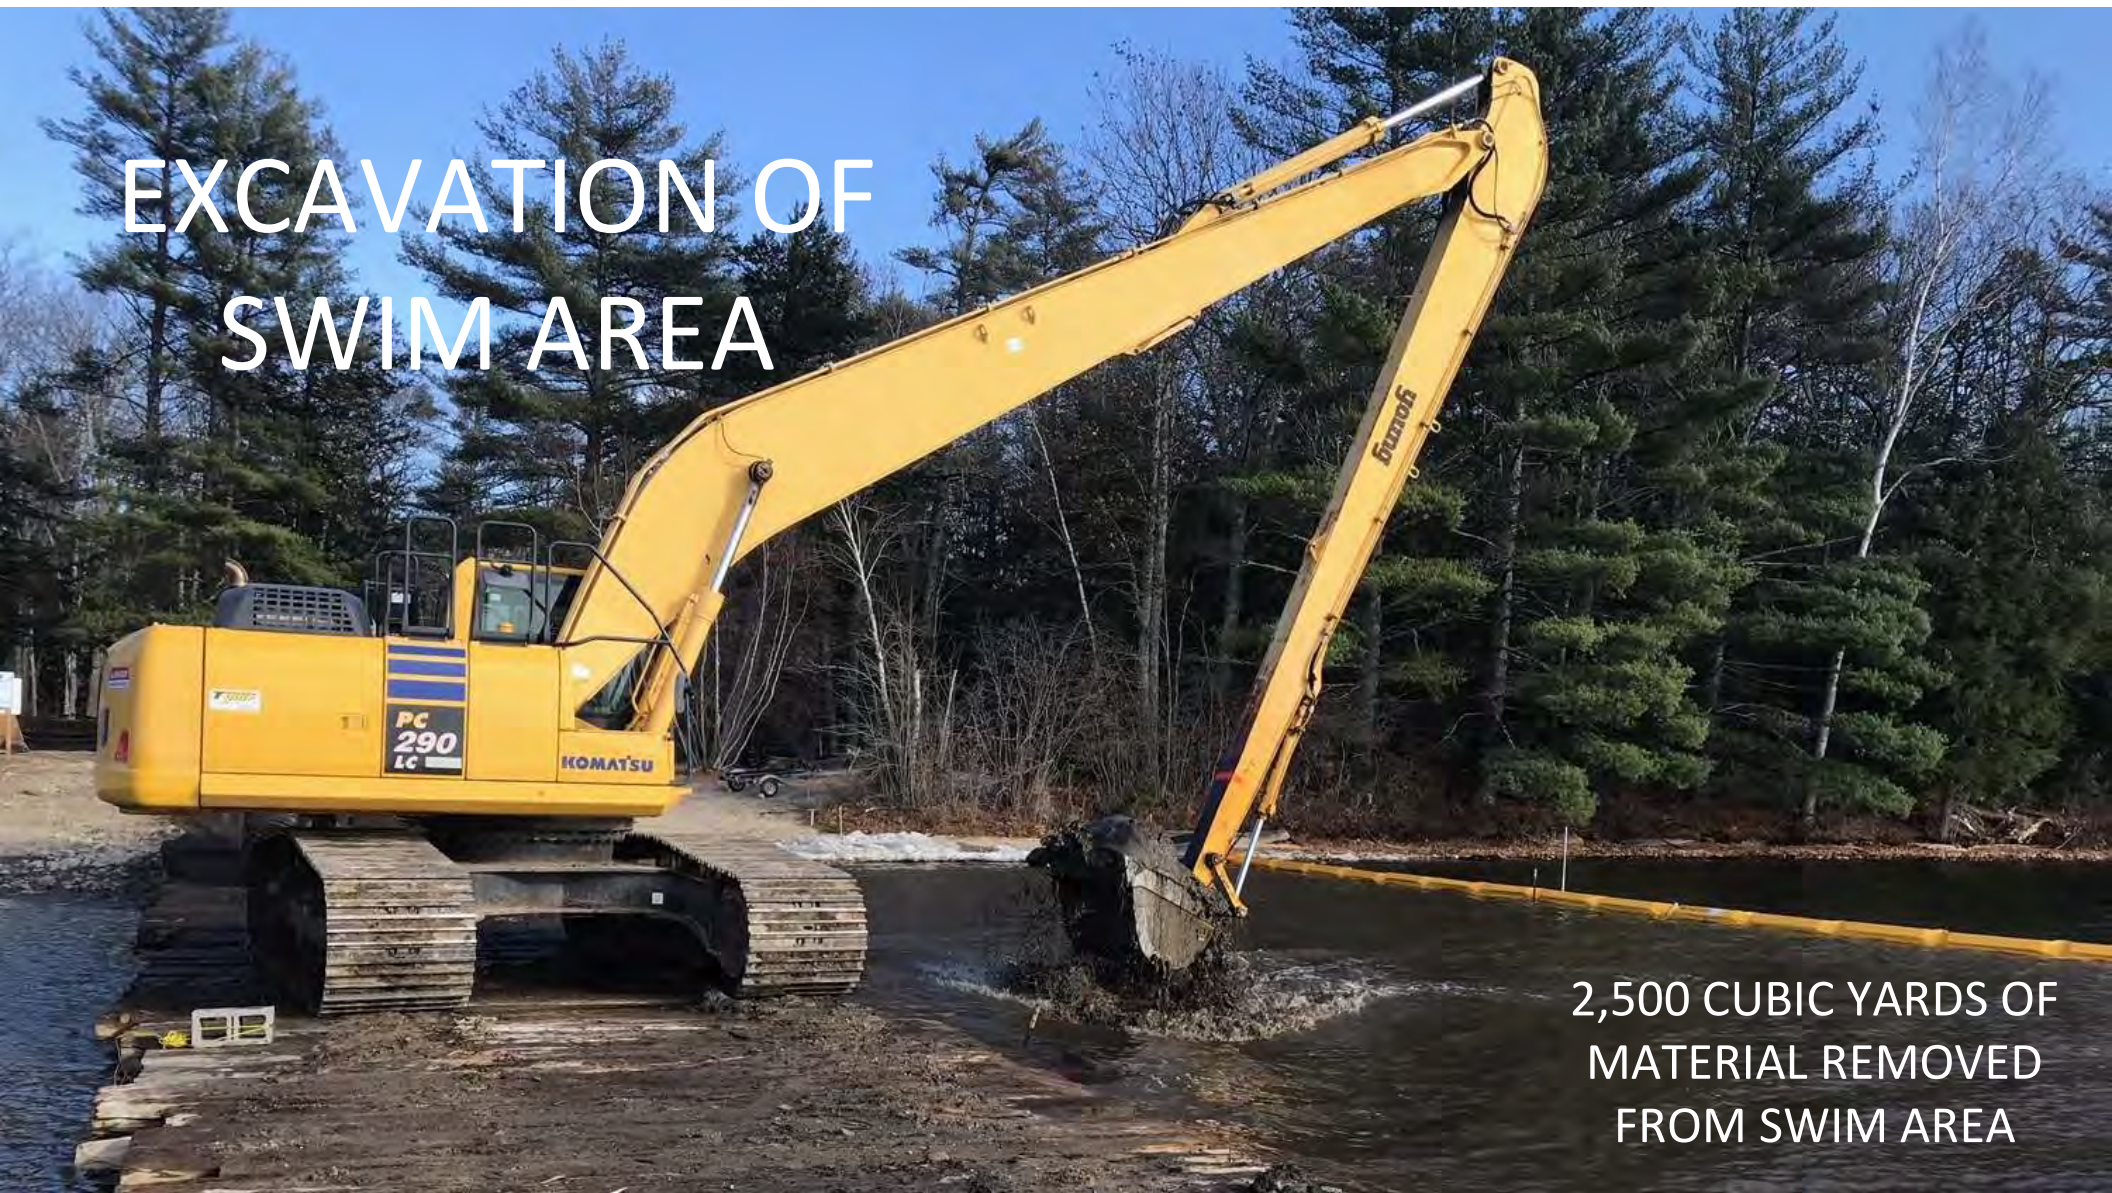
A yellow Komatsu PC 290 LC-10 excavator is positioned on a muddy bank, its arm extended towards a large pile of rip-rap stones. The stones are being used to create a base for an access road. In the background, a body of water stretches towards a distant shoreline with trees and buildings. A yellow safety line is visible in the water. The sky is overcast with grey clouds. A large, dark, irregular shape, possibly a shadow or a graphic element, is superimposed over the right side of the image.

INSTALLING
ACCESS ROAD
3"-6" RIP-RAP BASE

EXCAVATION OF SWIM AREA

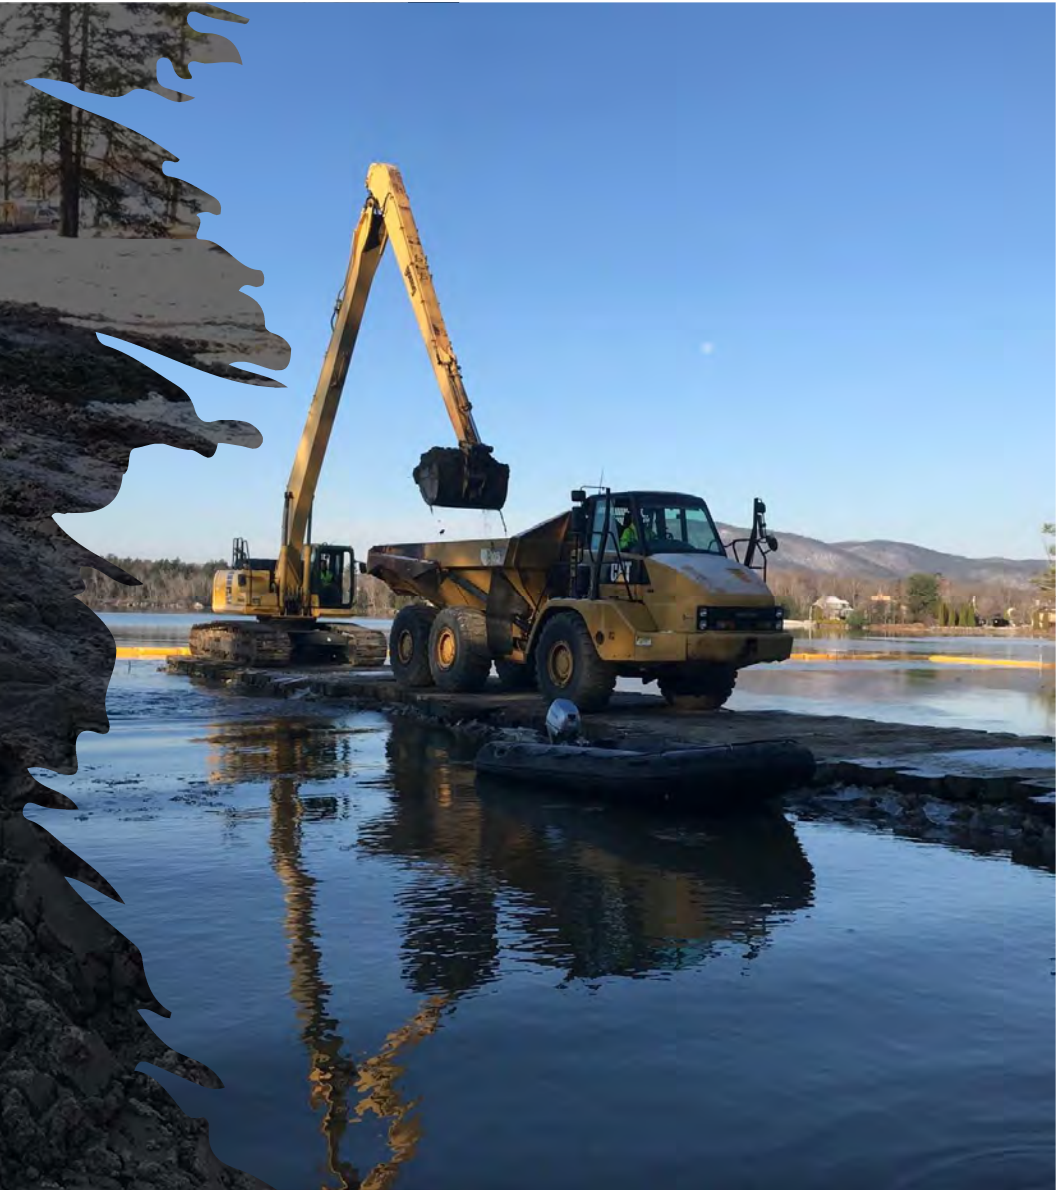
2,500 CUBIC YARDS OF
MATERIAL REMOVED
FROM SWIM AREA

HAULING AND STOCKPILING OF DREDGE MATERIAL

- TRUCKS LOADED AND HAULED MATERIAL TO DEWATERING AREA.
- MATERIAL LEFT IN PLACE TO DEWATER OVER WINTER (SIX MONTHS)
- MATERIAL TESTED FOR CONTAMINANTS
- CONSIDERED “LIMITED REUSE SOILS”
- ULTIMATELY DISPOSED AS FILL ON TOWN PROPERTY

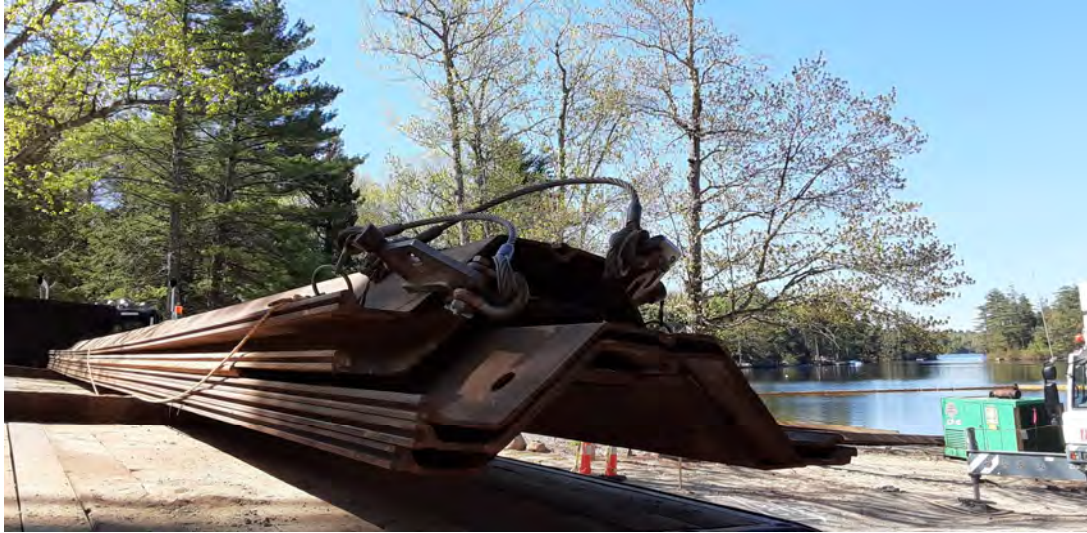
SHEET PILES AND DRIVE HAMMER

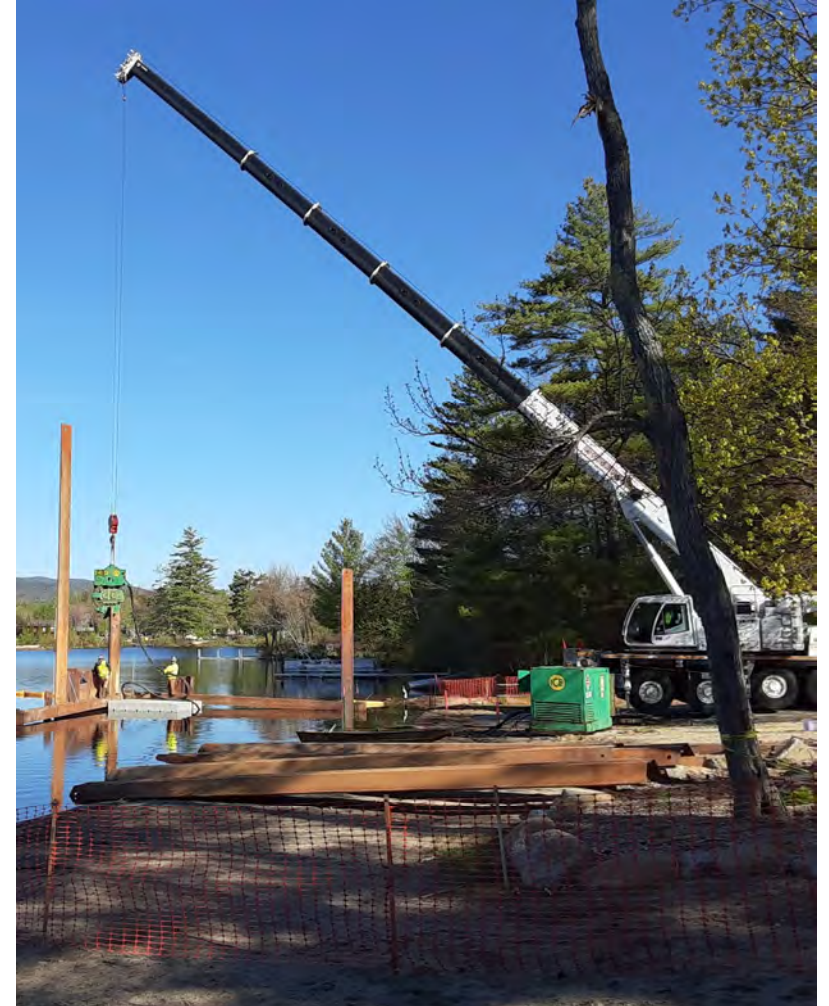
SHEET PILE INSTALLATION COMPLETE

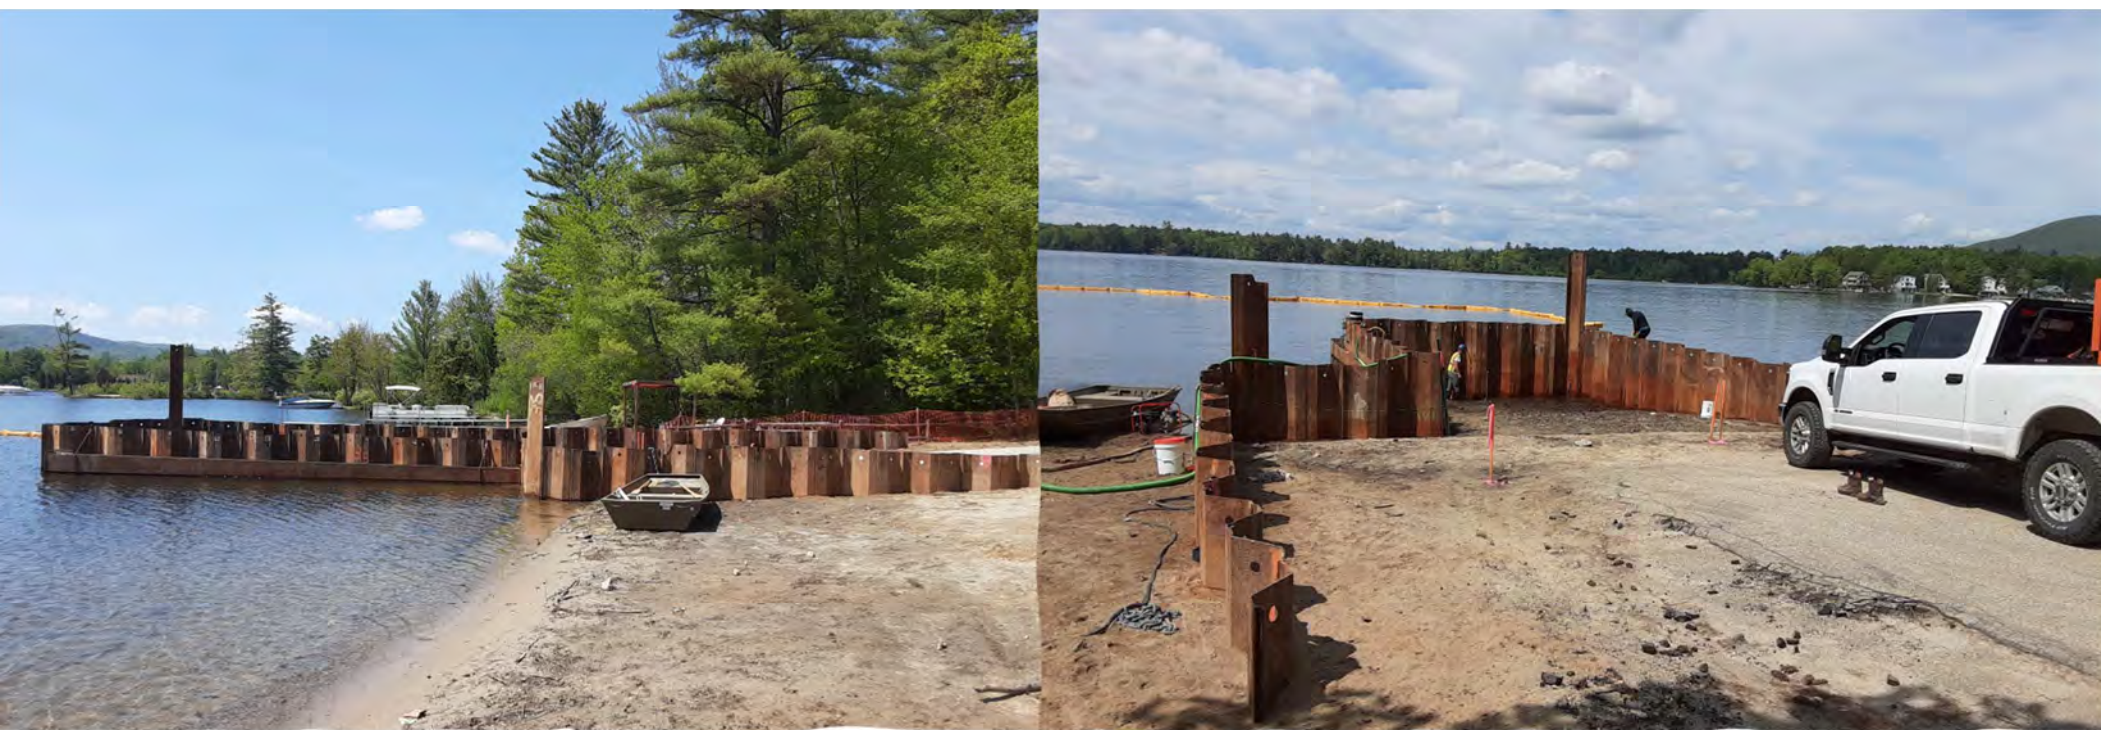
DEWATERING OF WORK AREA

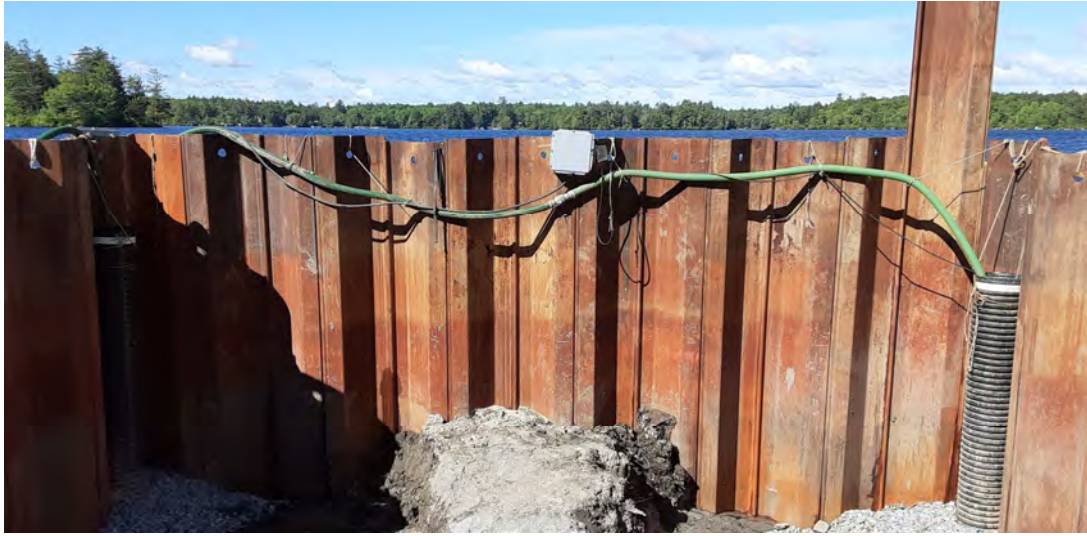
DEWATERING SUMPS

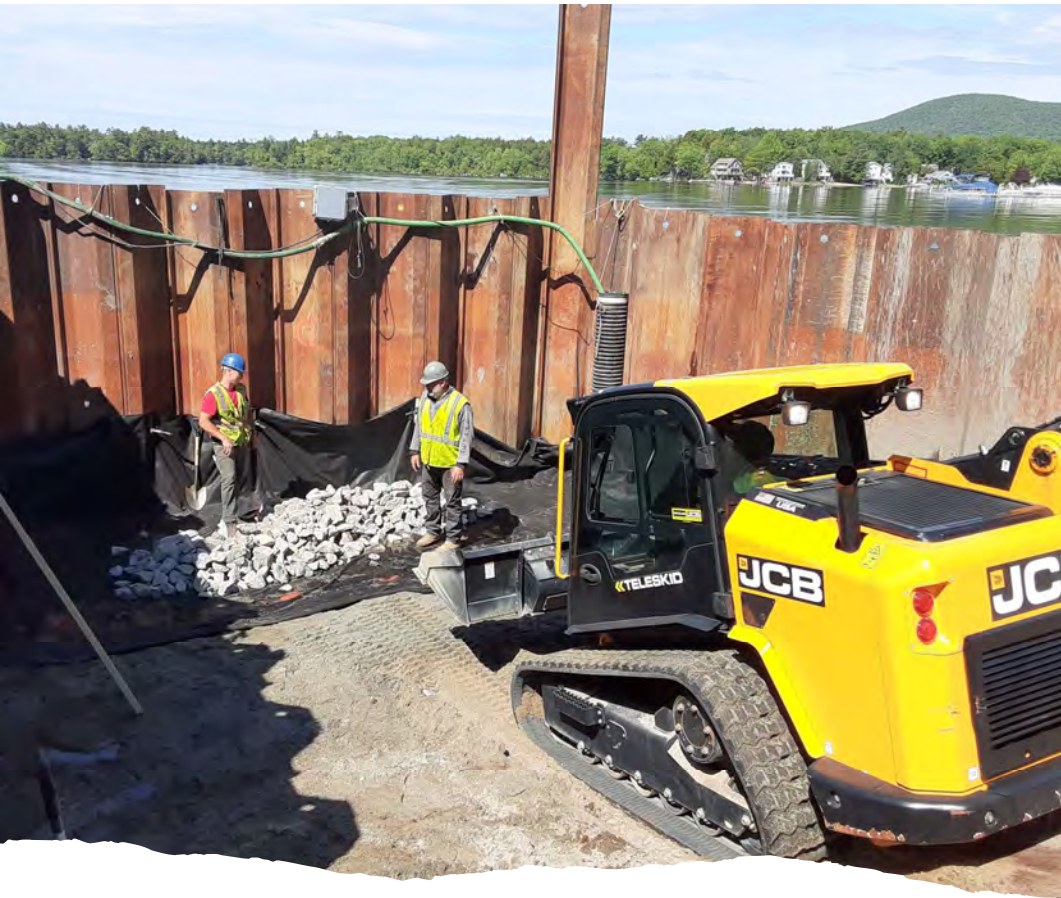
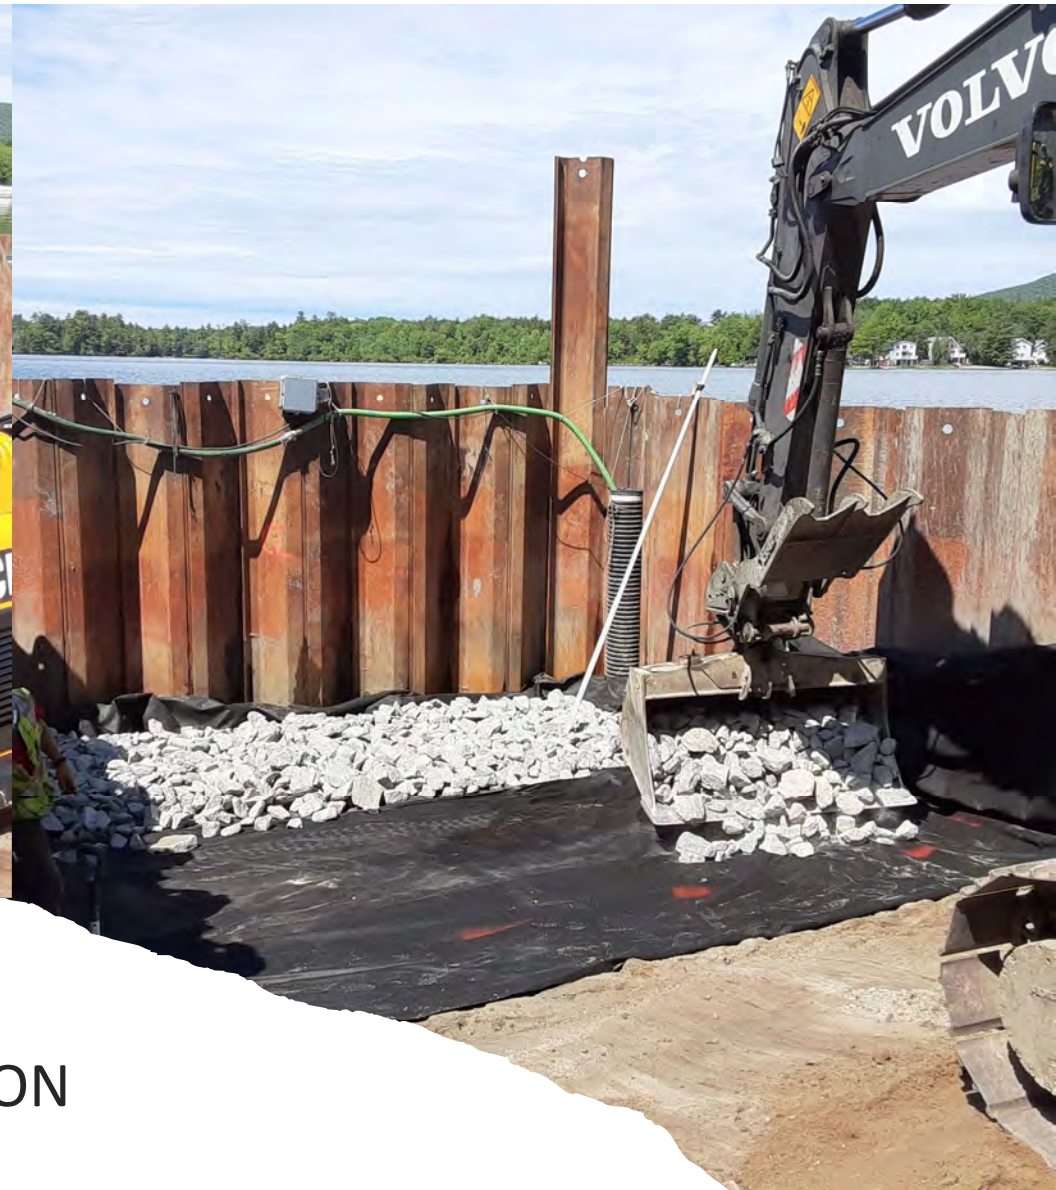
RAMP BASE MATERIAL INSTALLATION

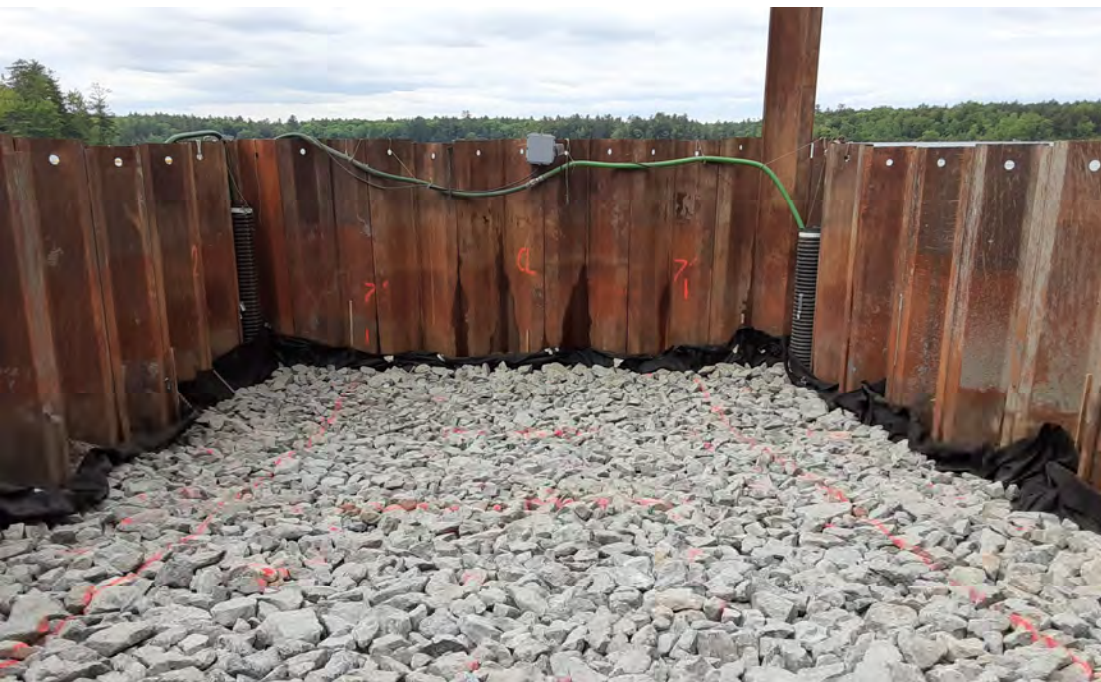
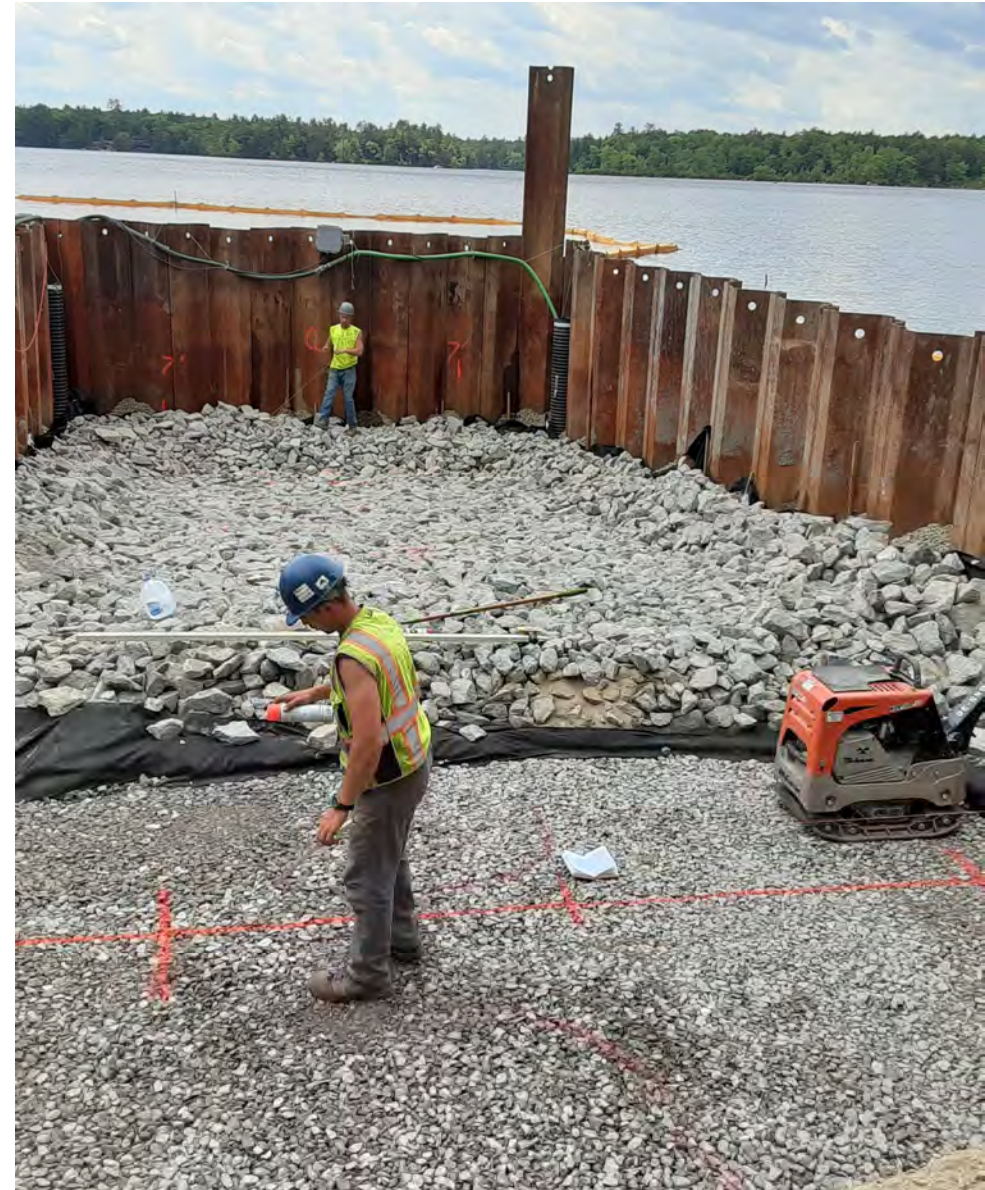
RAMP LAYOUT FOR CONCRETE PLANKS

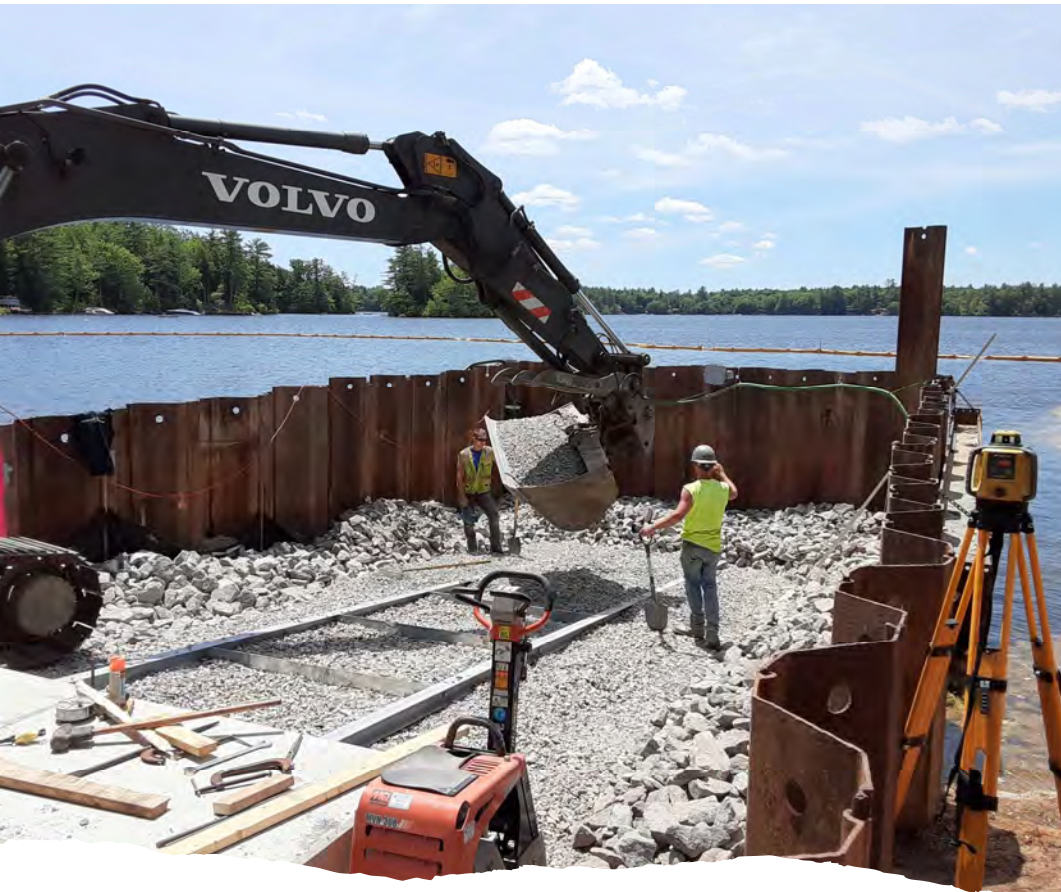
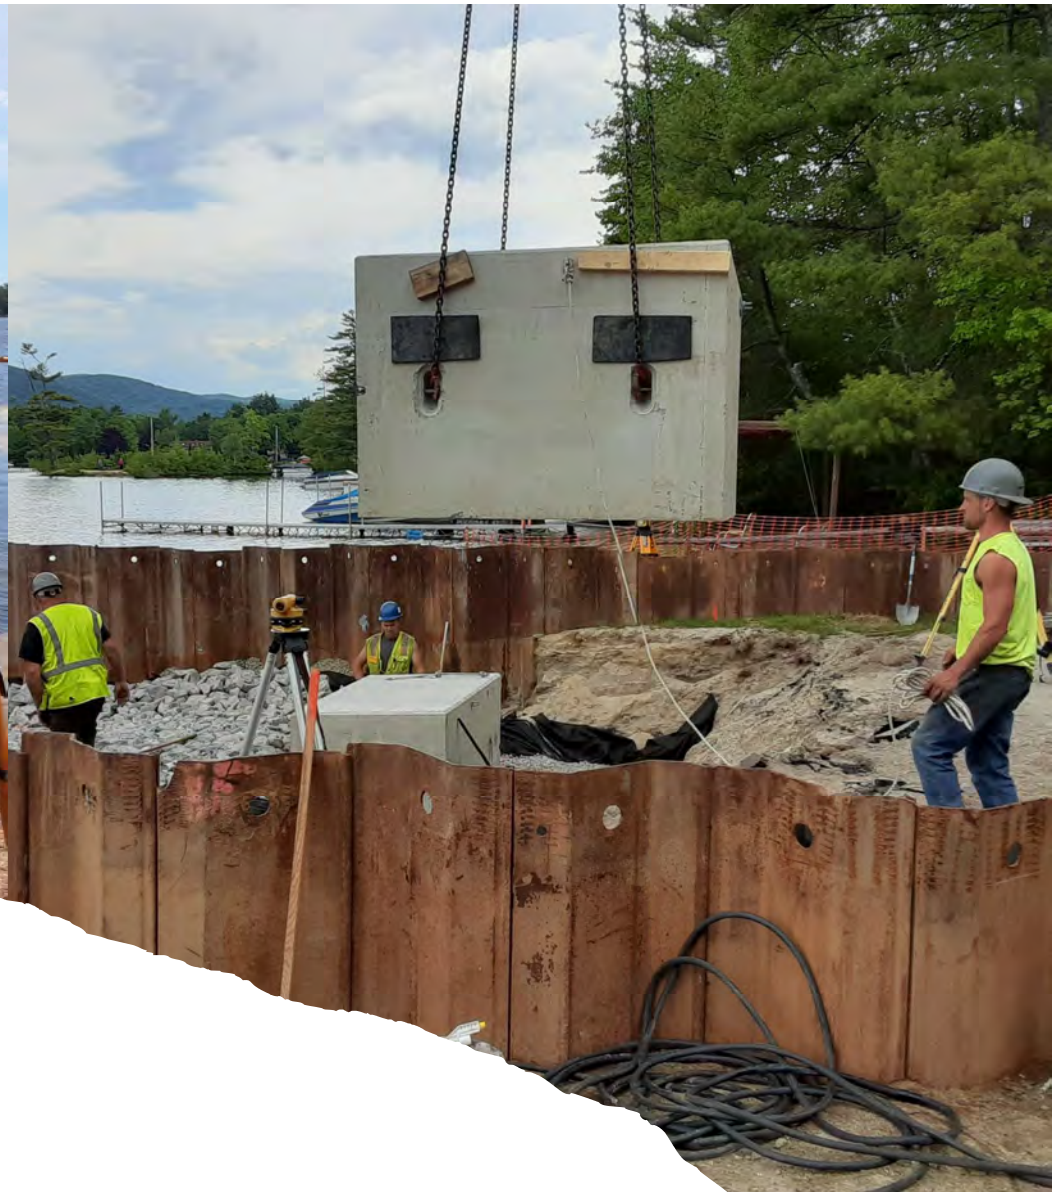
**SETTING RAMP ANCHOR
AND RAILS IN PLACE**

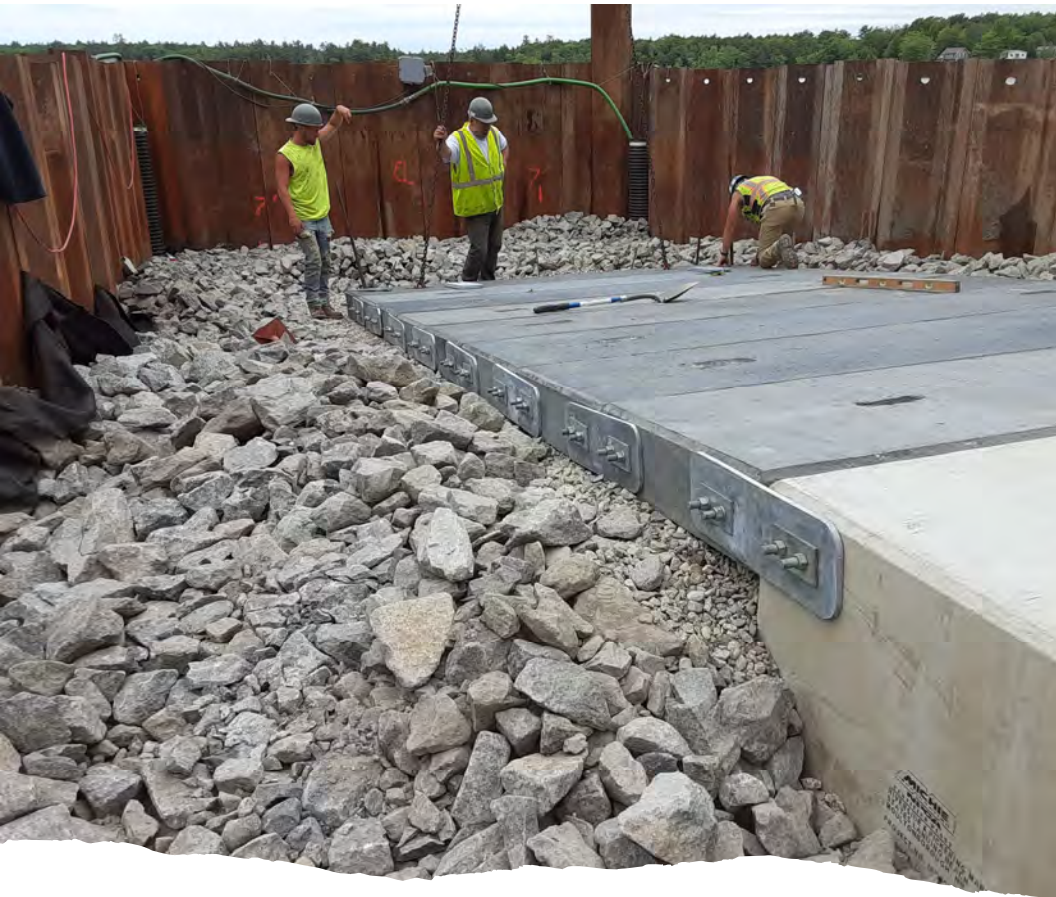
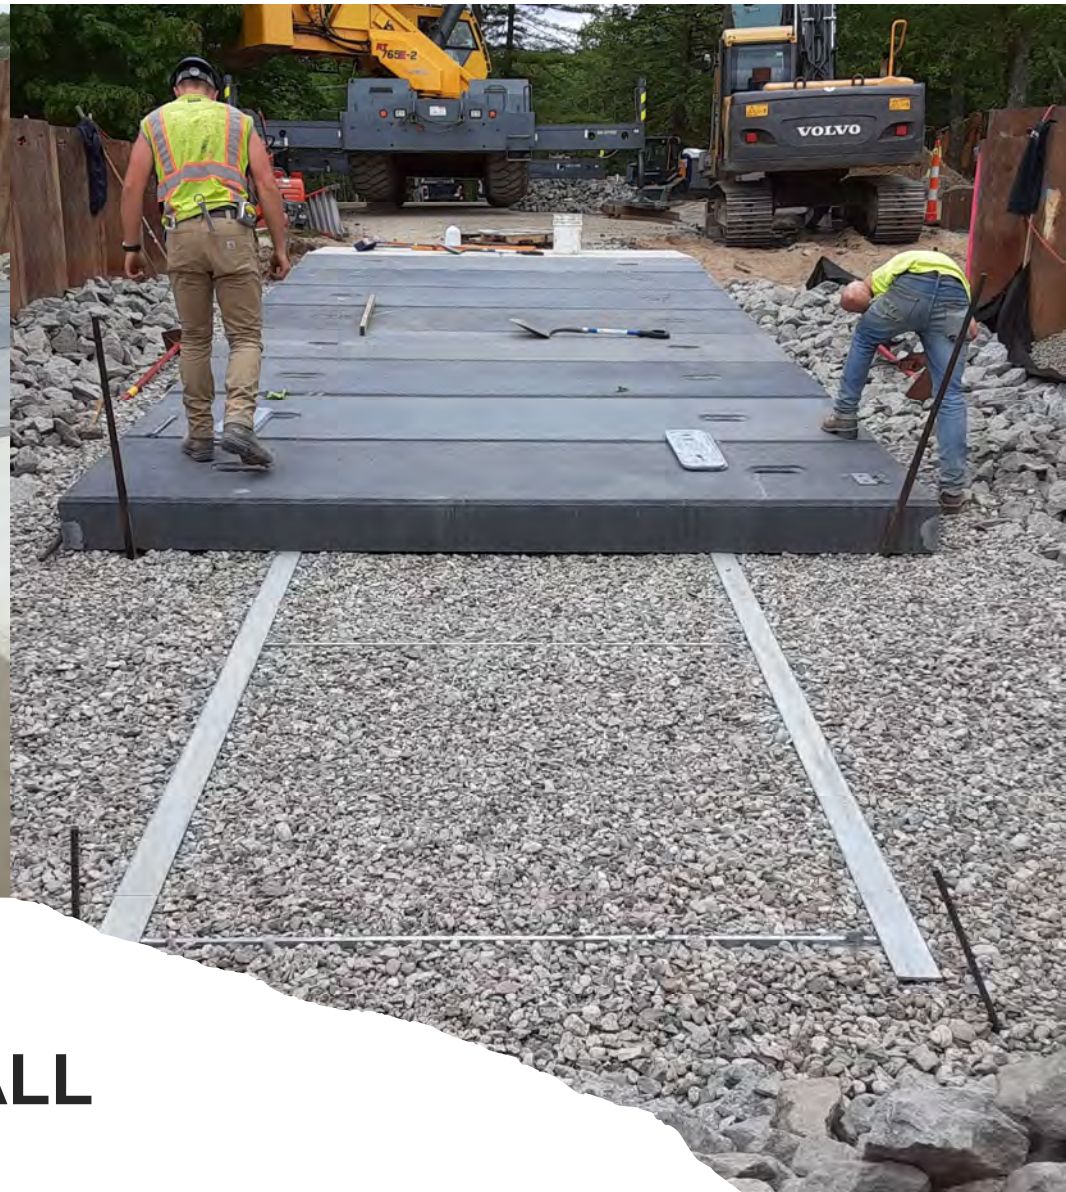
CONCRETE RAMP INSTALL

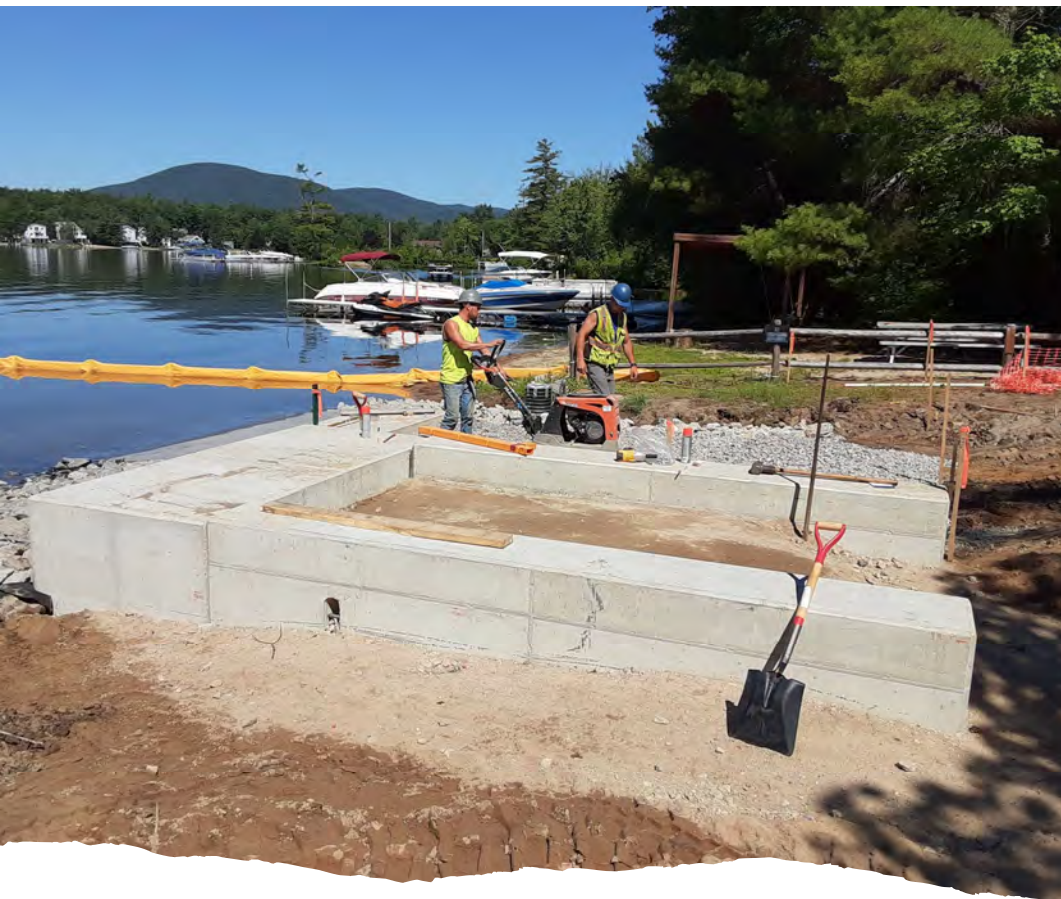
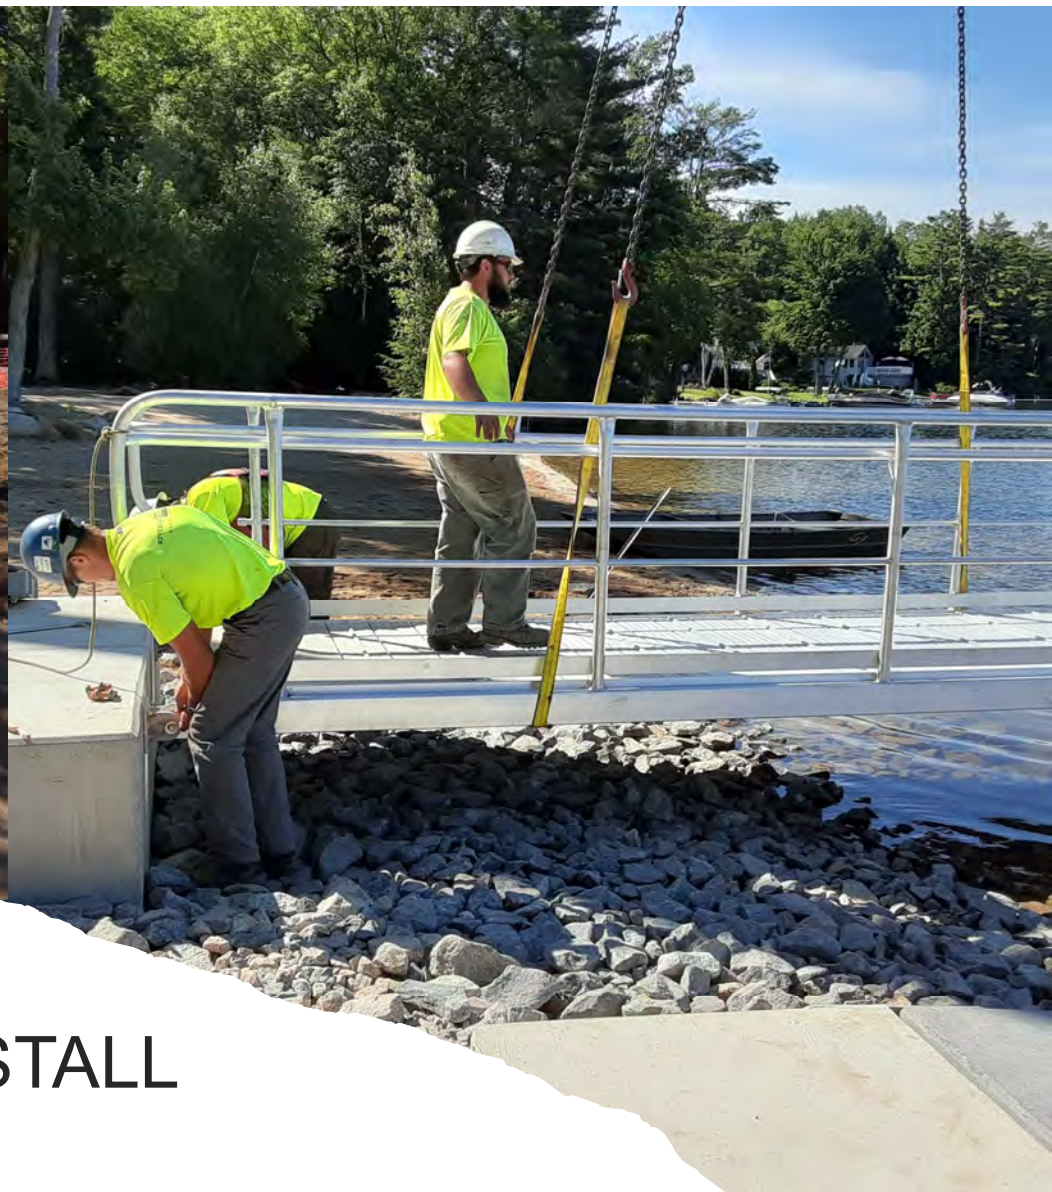
DOCK ANCHOR & DOCK INSTALL

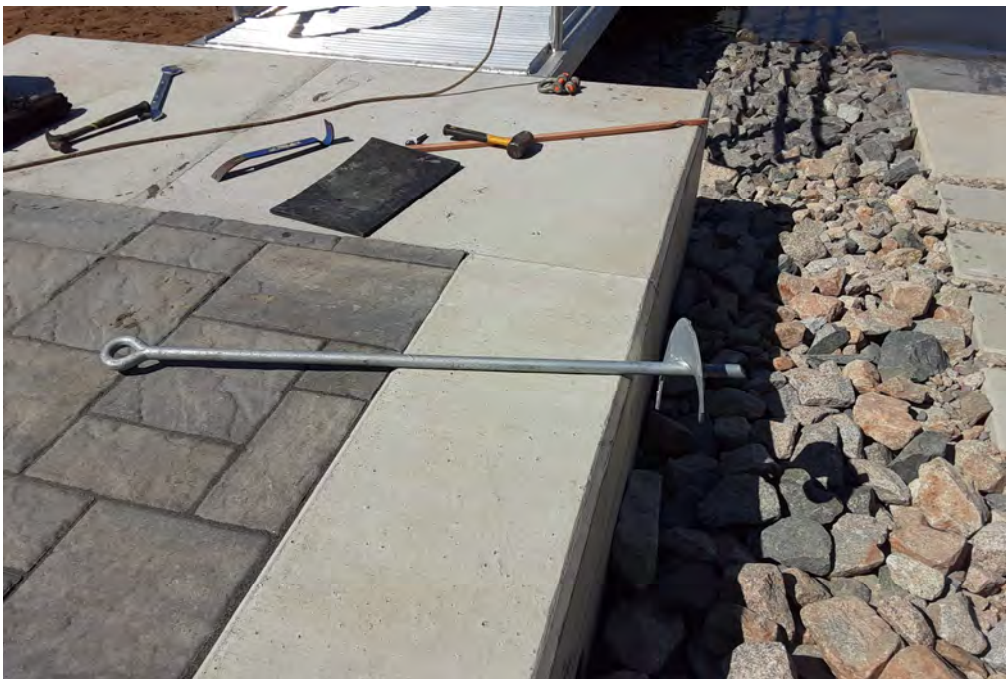
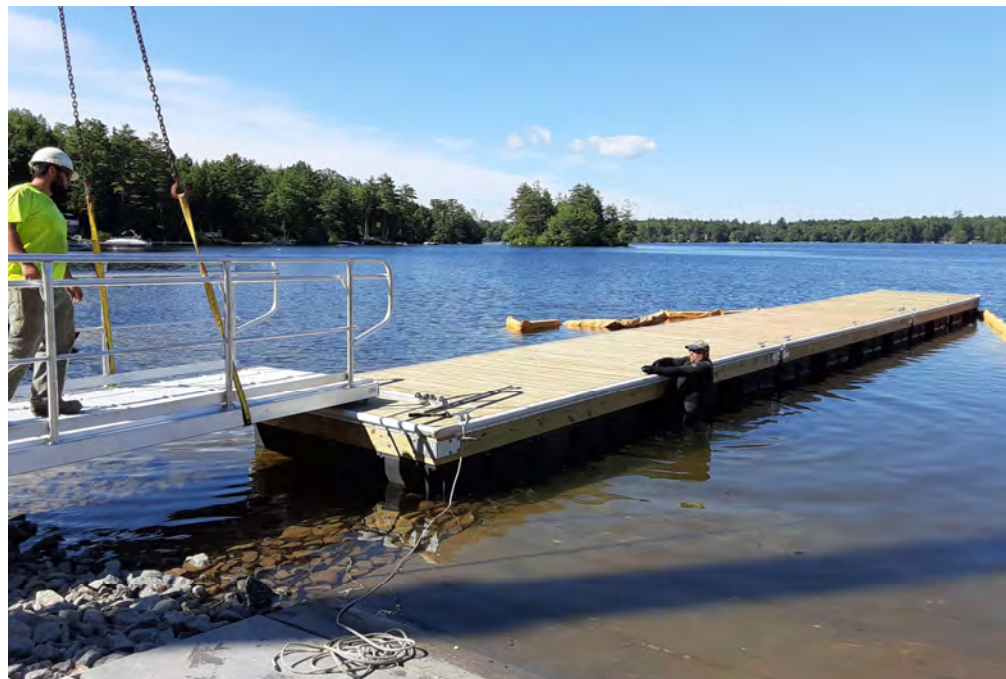
SETTING DOCK INTO FINAL POSITION

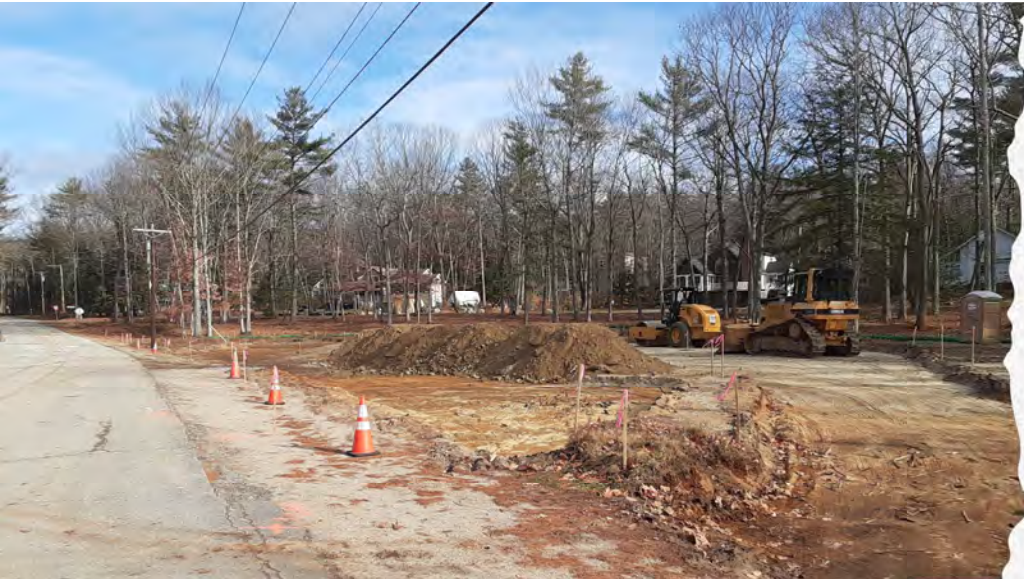
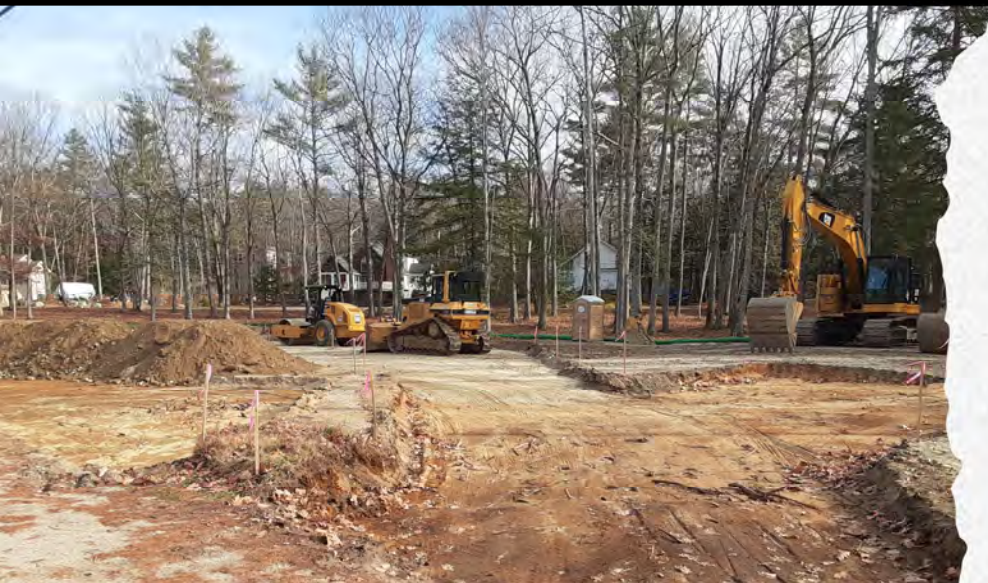
PARKING AREA CONSTRUCTION

- EXCAVATE SUBGRADE
- PLACE BANKRUN GRAVEL BASE
- PLACE CRUSHED GRAVEL SURFACE
- FINE GRADE
- PAVING

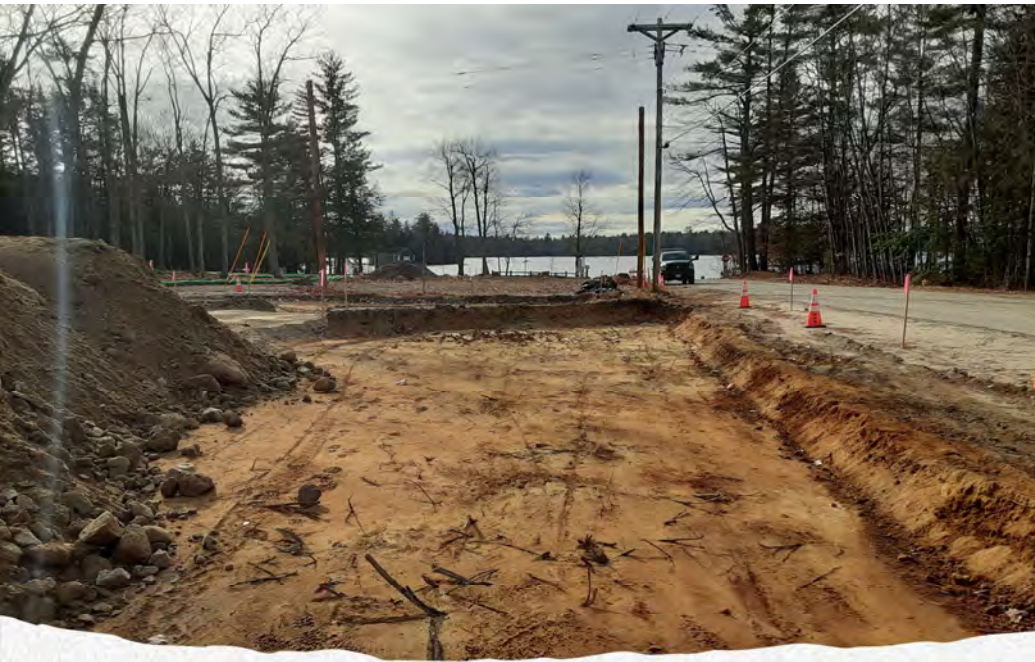
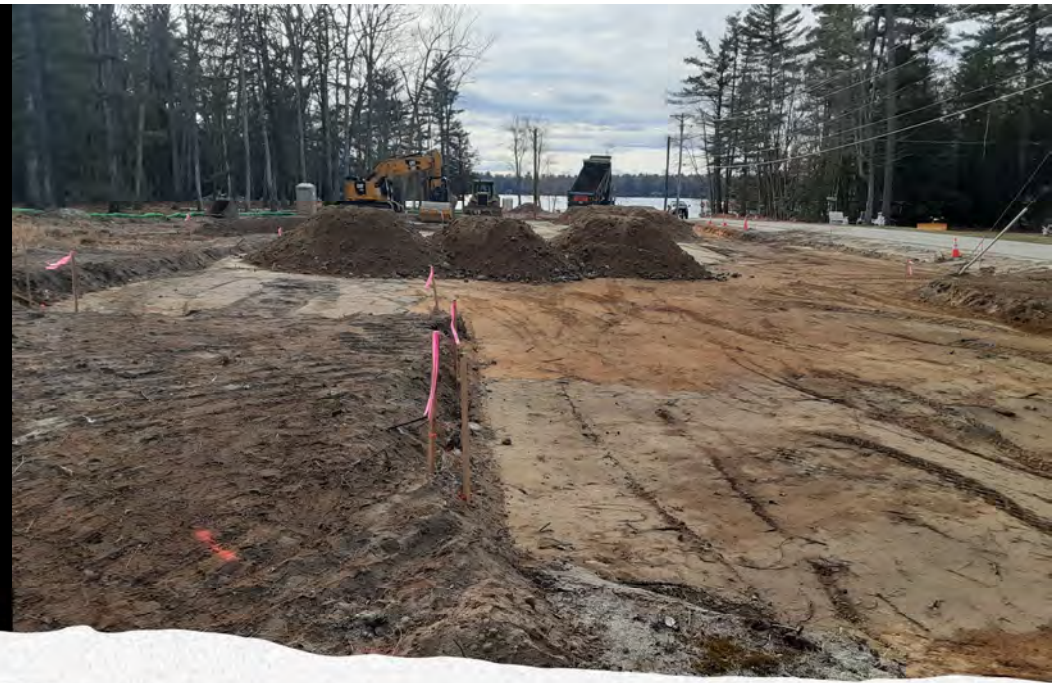
SUBGRADE AND BANK RUN GRAVEL
PLACEMENT
