States Landing Case Study: A Watershed Management Plan Success Story

Lakes Congress

LAKE WINNIPESAUKEE
ASSOCIATION

States Landing Beach

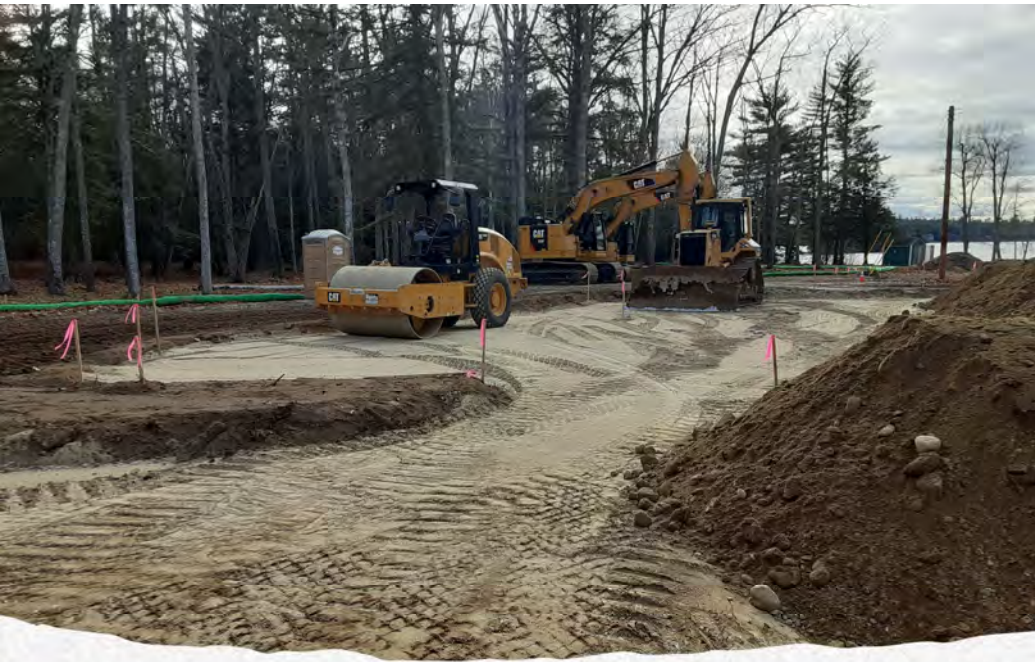
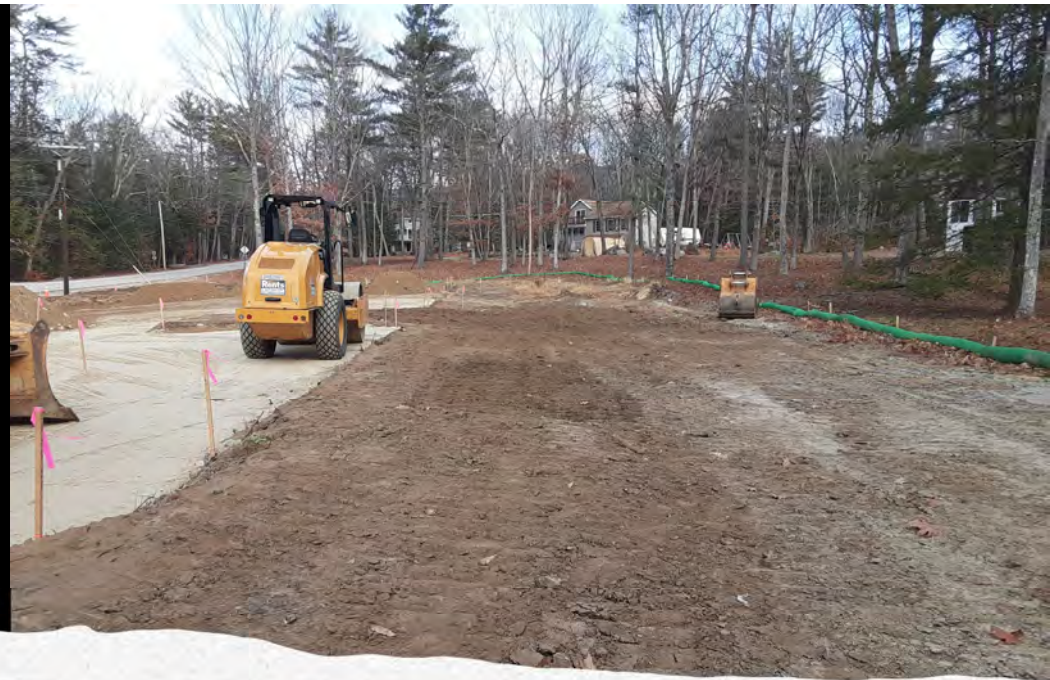
COMPACTING GRAVELS AND
PREPARING LOAM/SEED AREA
BEHIND PARKING LOT

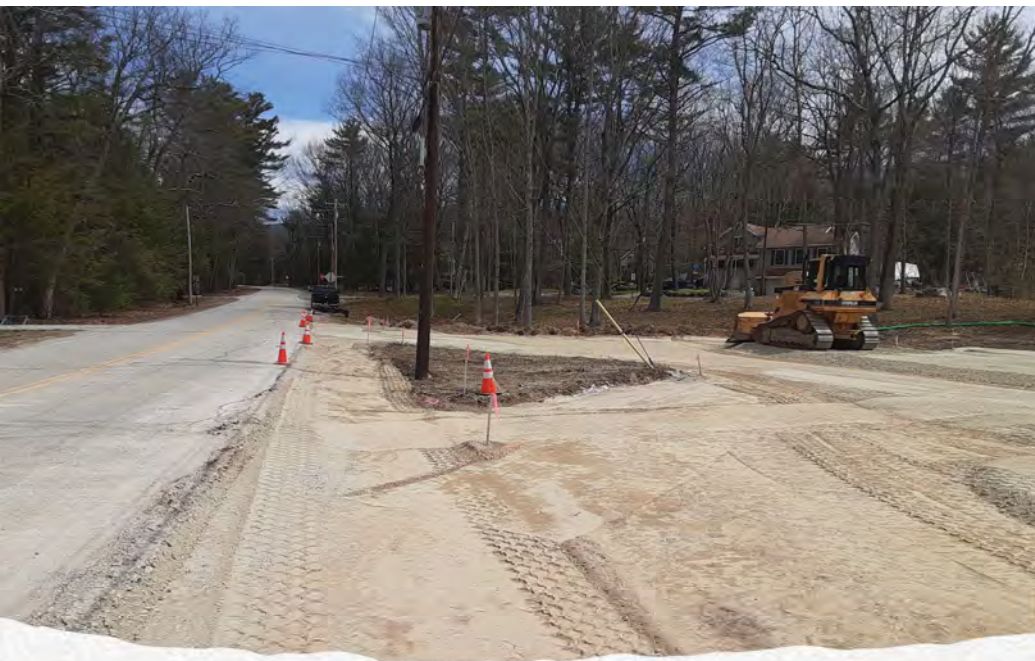
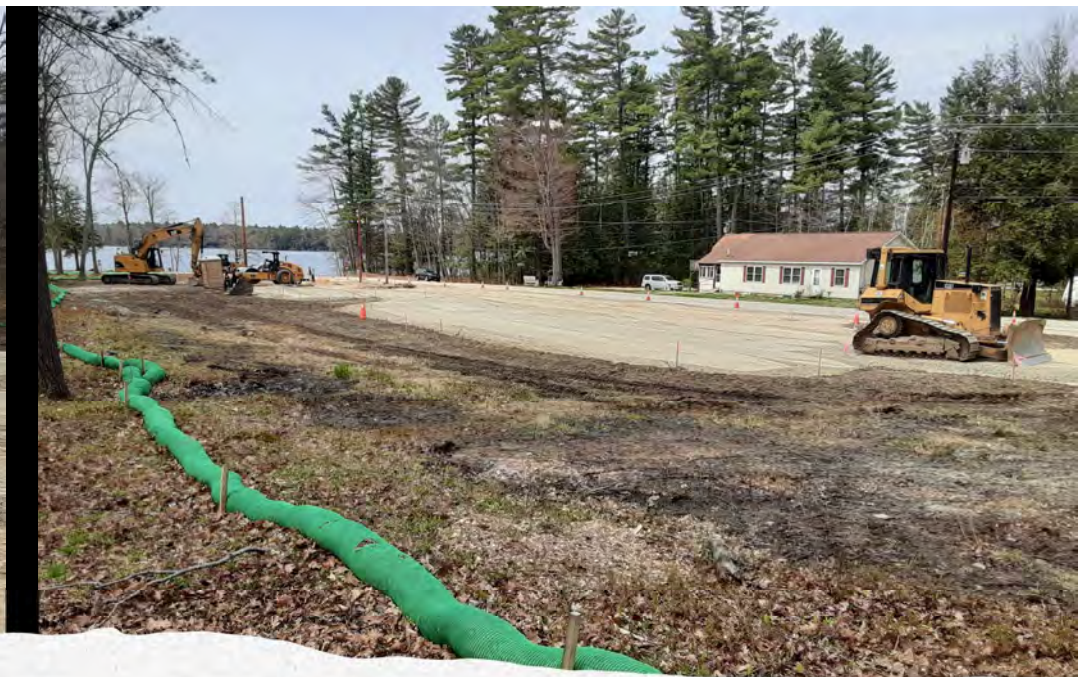
PREPARING FINISH GRADE WITH CRUSHED GRAVEL

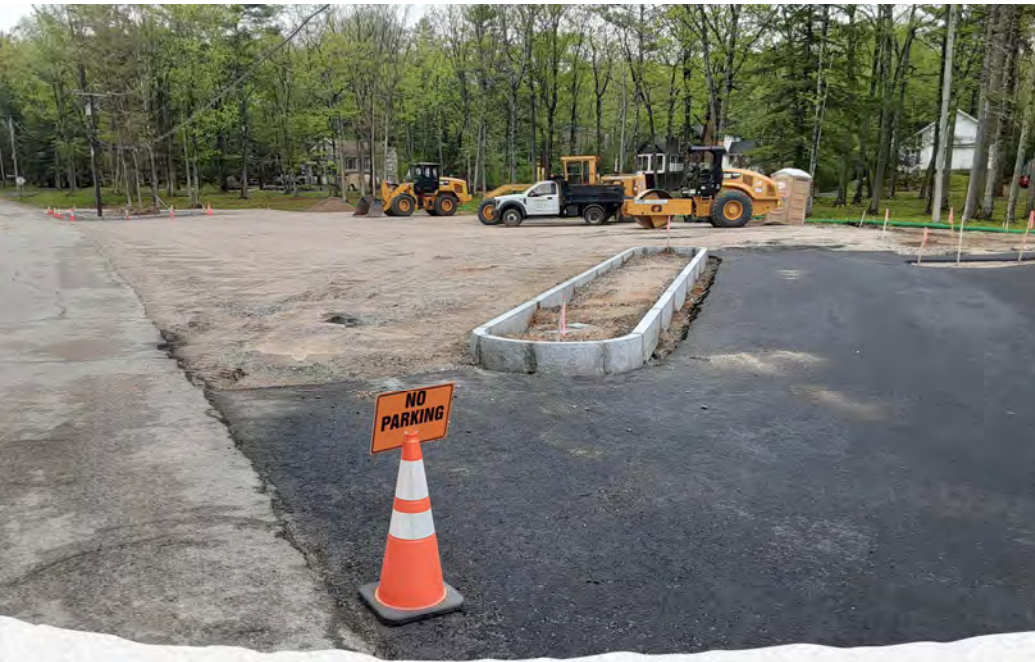
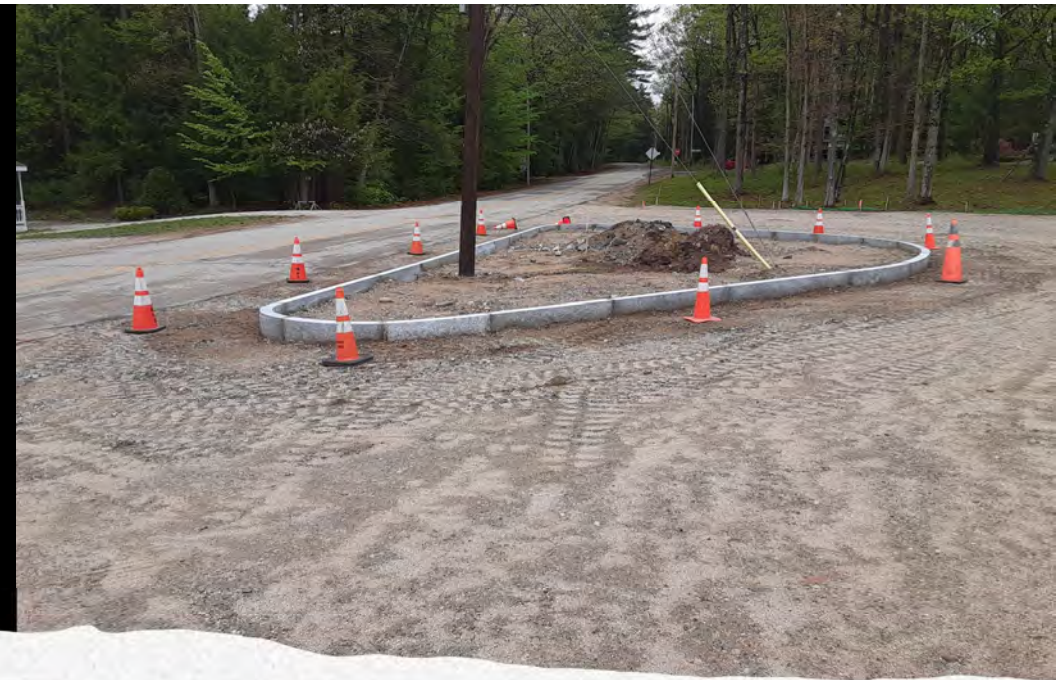
BASE PAVING AND SETTING GRANITE CURB

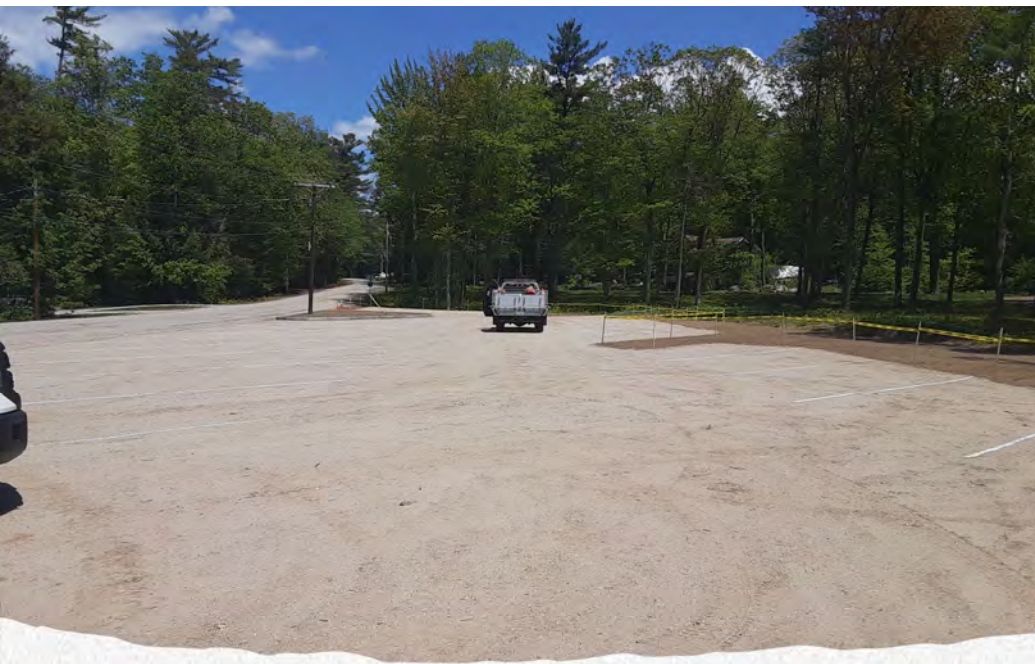
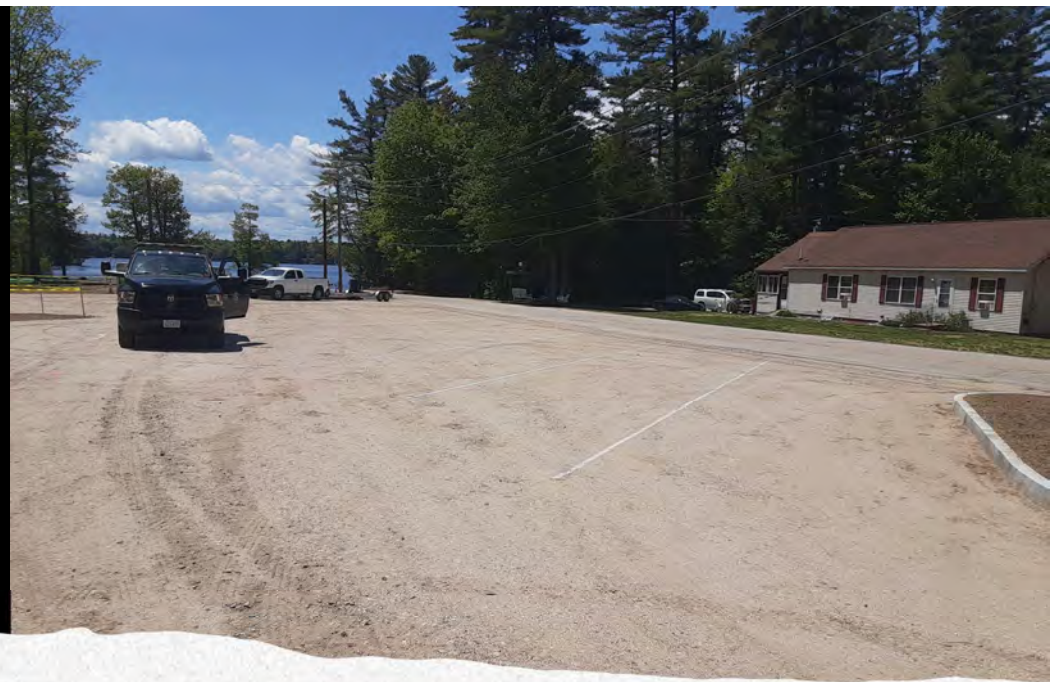
GRAVEL PARKING AREA LAYOUT

FINAL PAVED PARKING AREA

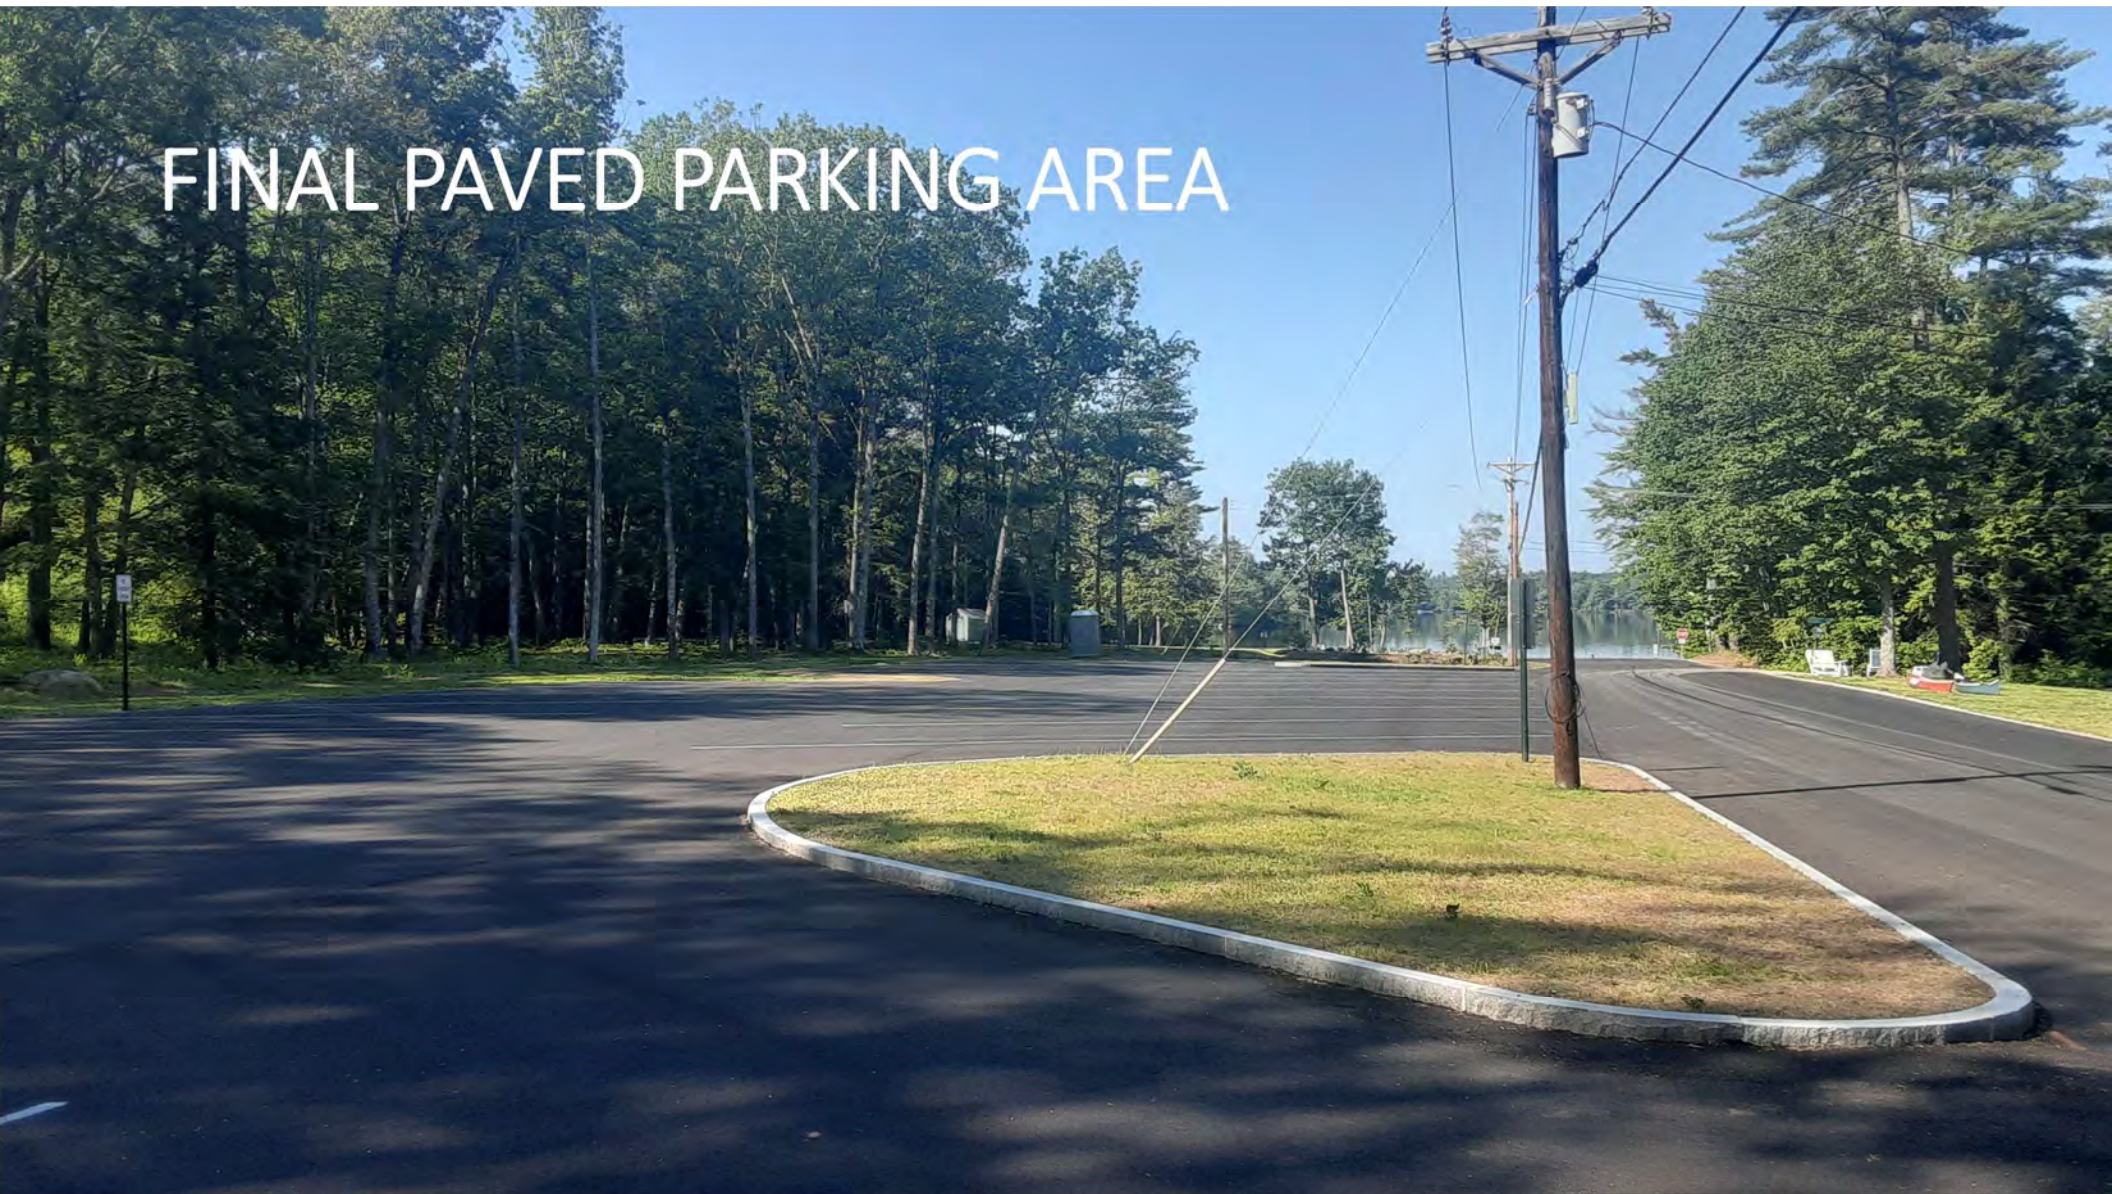
A photograph of a newly constructed rain garden. The garden is a sloped area with a stone retaining wall on the left, filled with young green shrubs and plants. In the background, there is a forest of tall trees, a small blue shed, and a paved road with a white pickup truck and orange traffic cones. The sky is overcast.

RAIN GARDENS

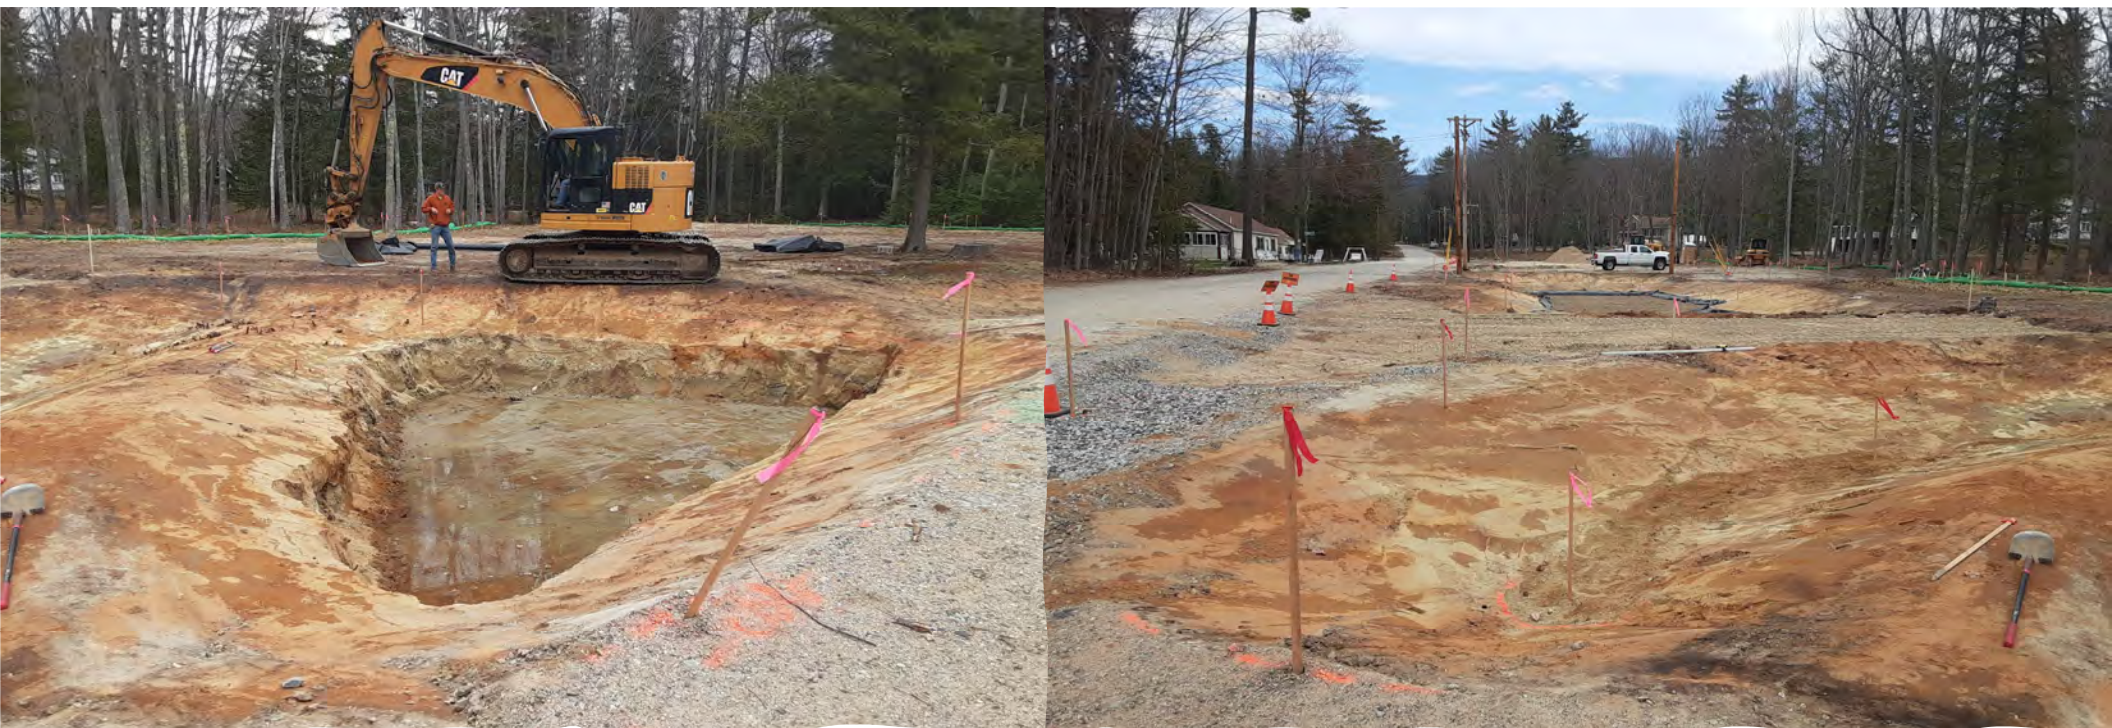
EXCAVATION TO SUBGRADE

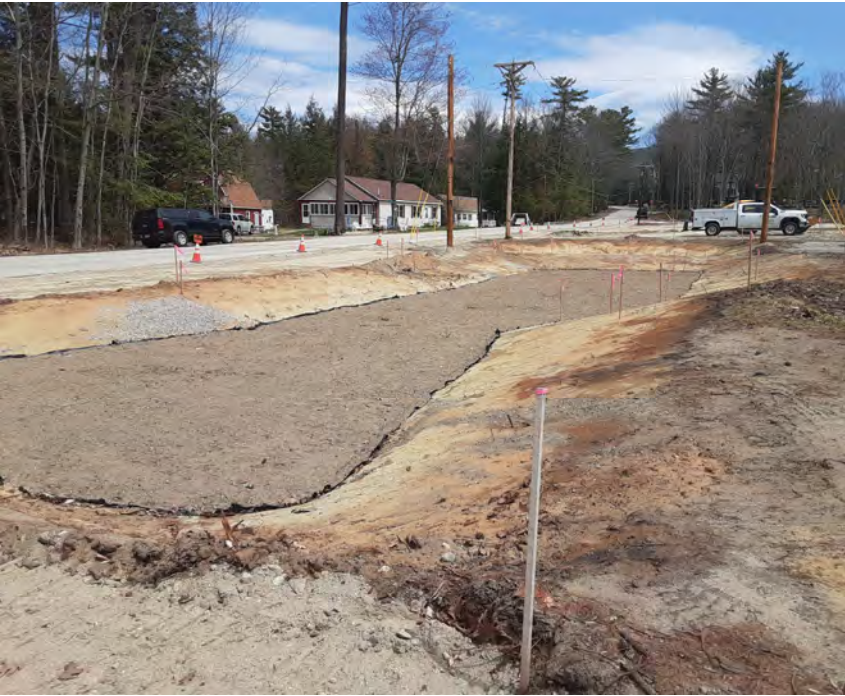
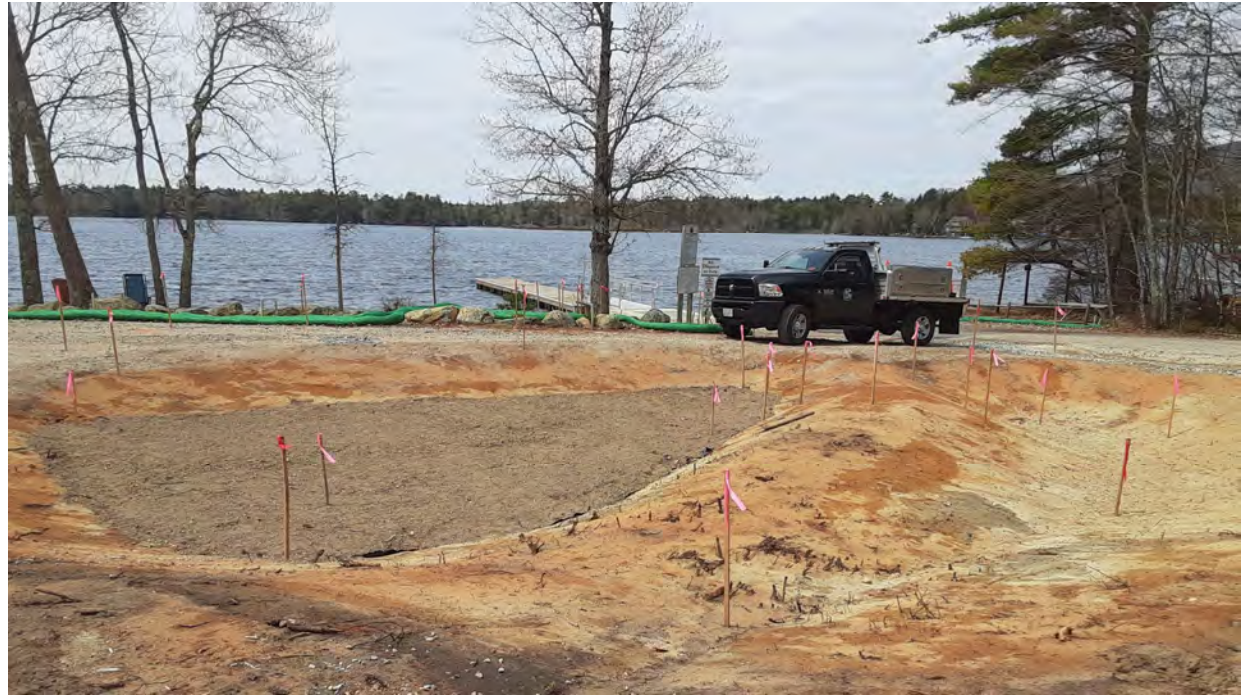
SOIL FILTER LAYER

- 18" DEEP SOIL FILTER BLEND
- 20-30% TOPSOIL
- 20-30% BARK MULCH
- 50-55% SAND

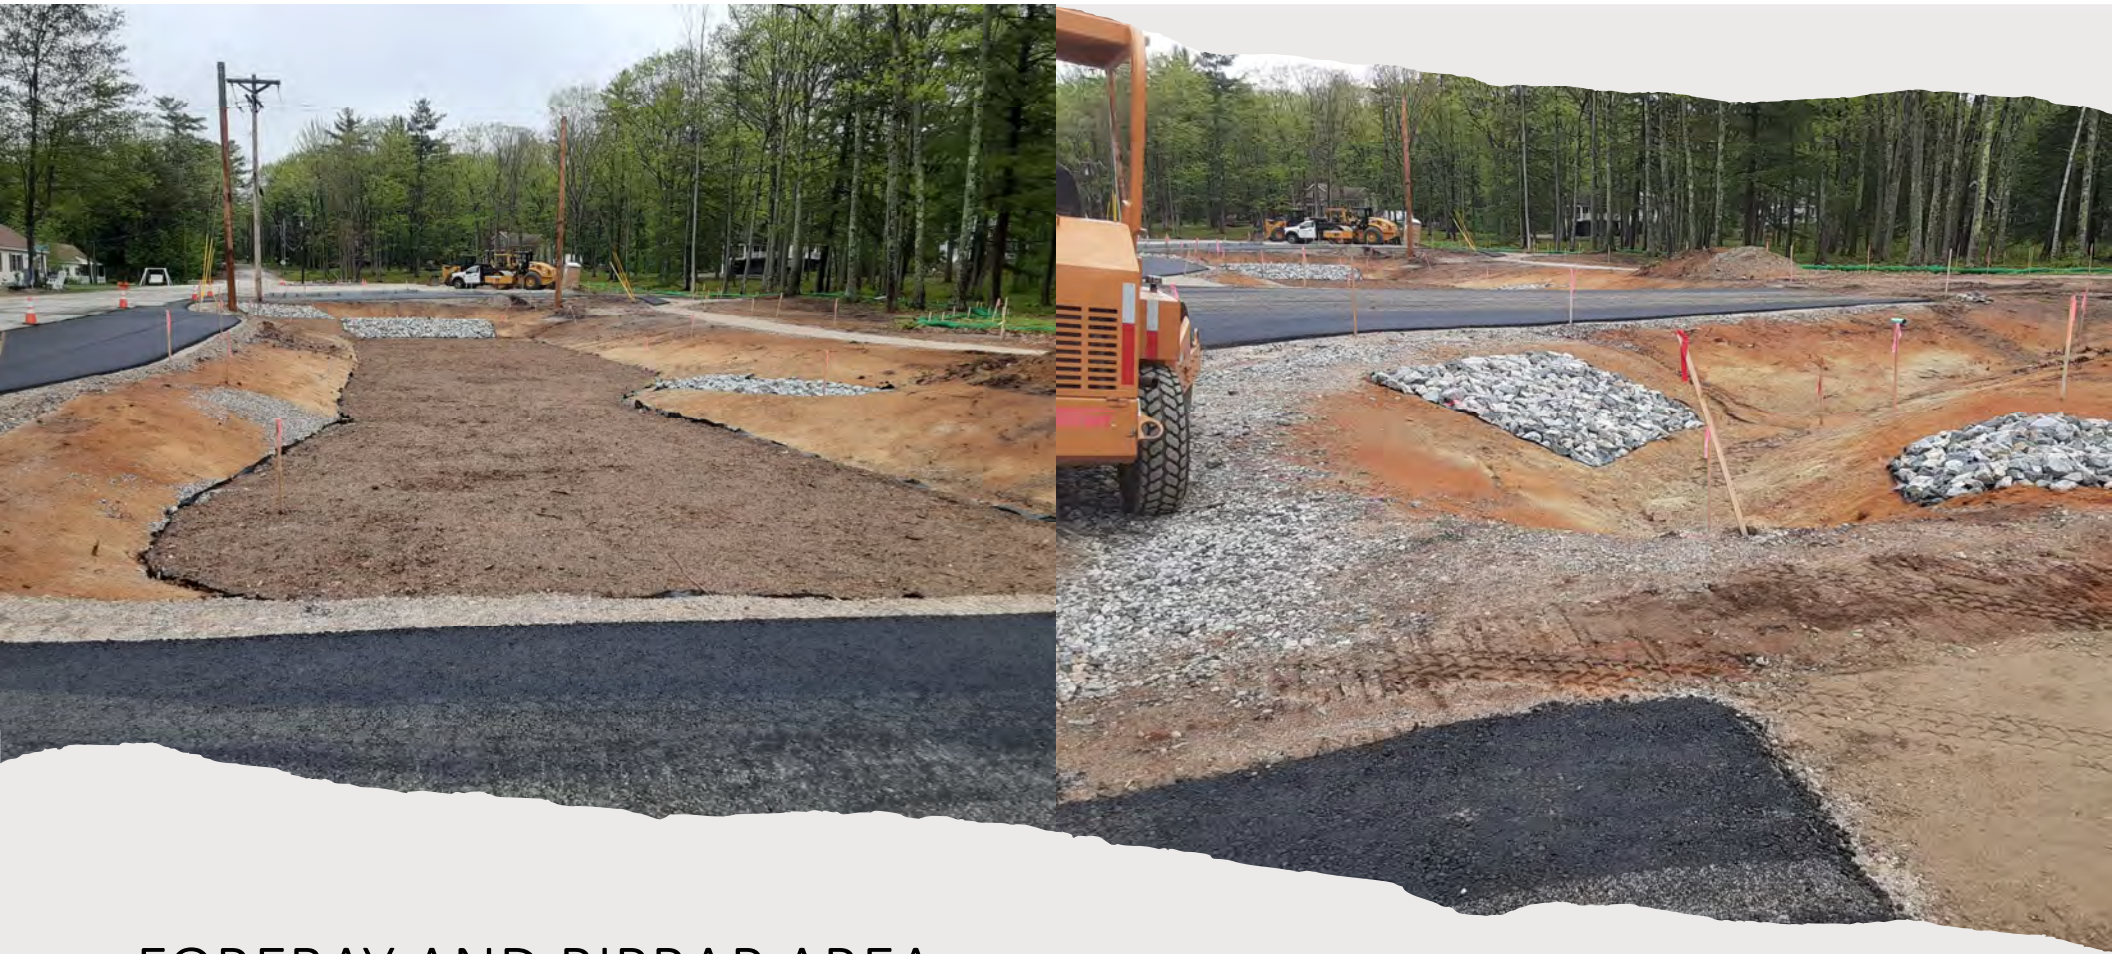
FOREBAY AND RIPRAP AREA
CONSTRUCTION

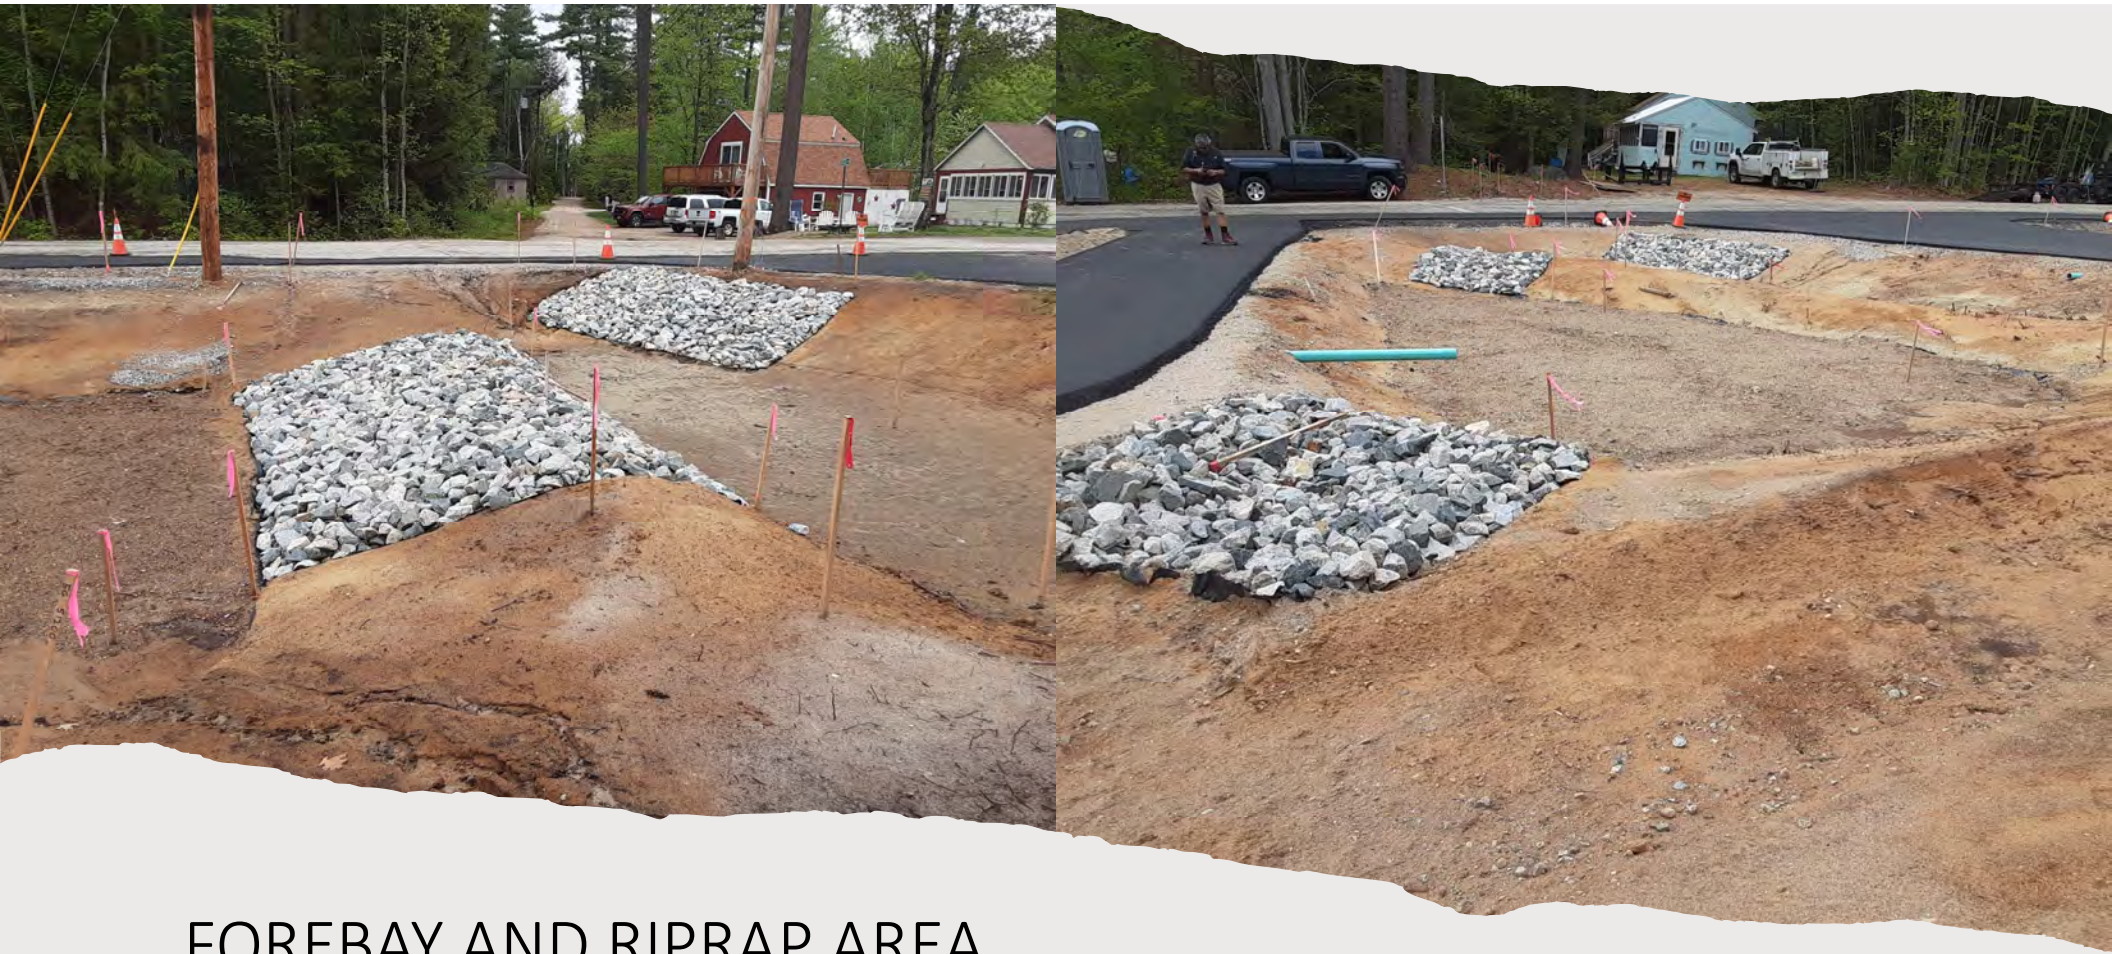
FOREBAY AND RIPRAP AREA
CONSTRUCTION

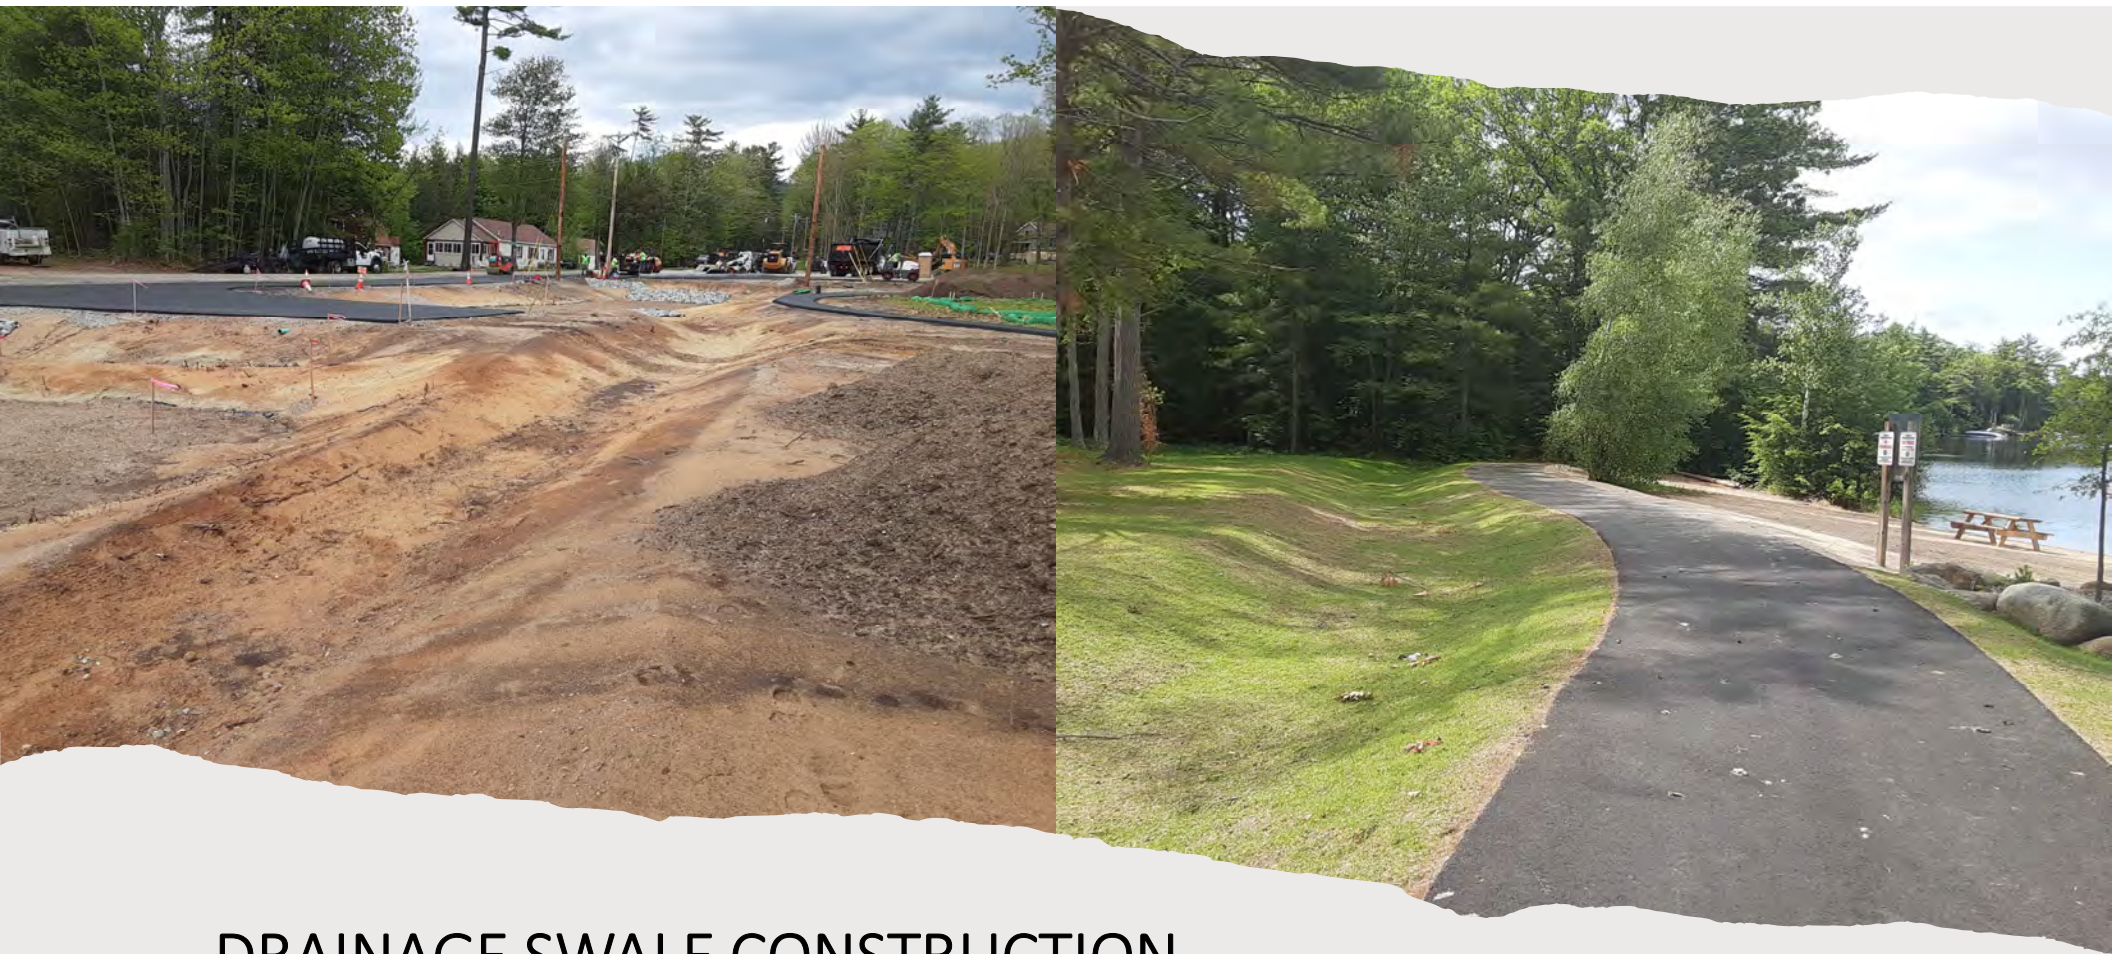
DRAINAGE SWALE CONSTRUCTION

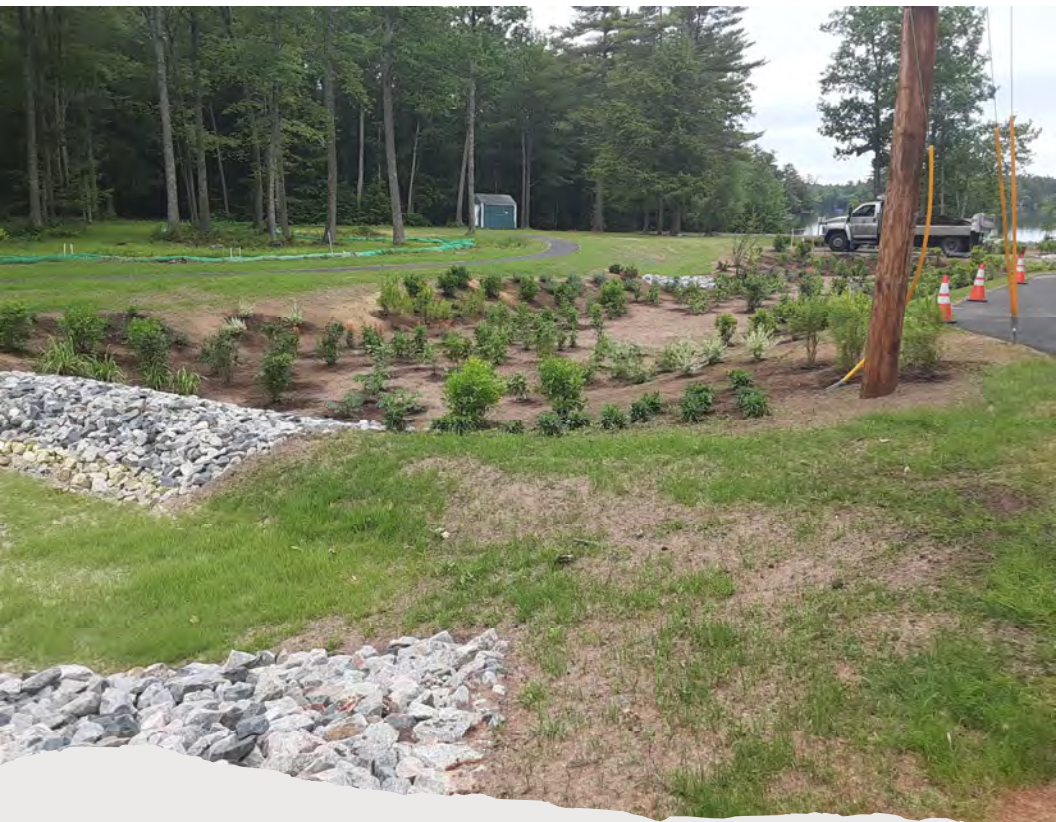
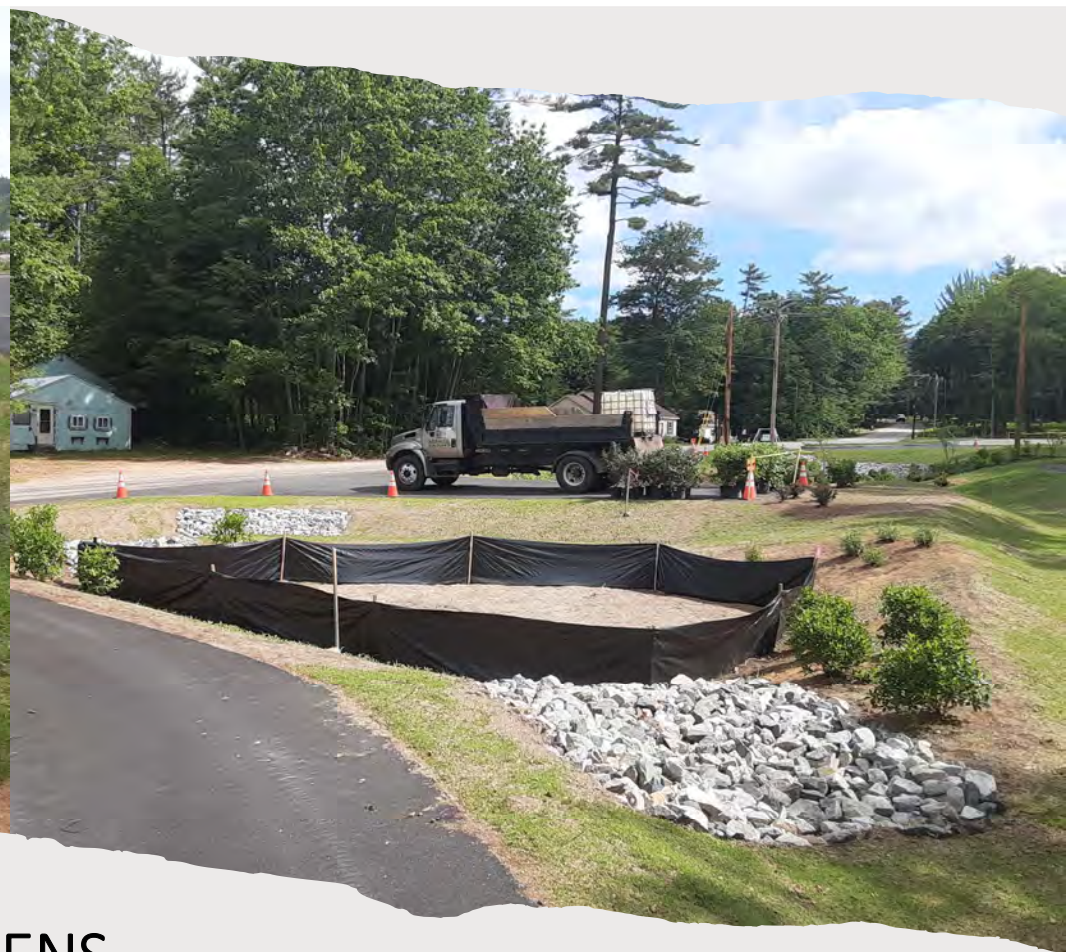
PLANTING OF THE RAIN GARDENS

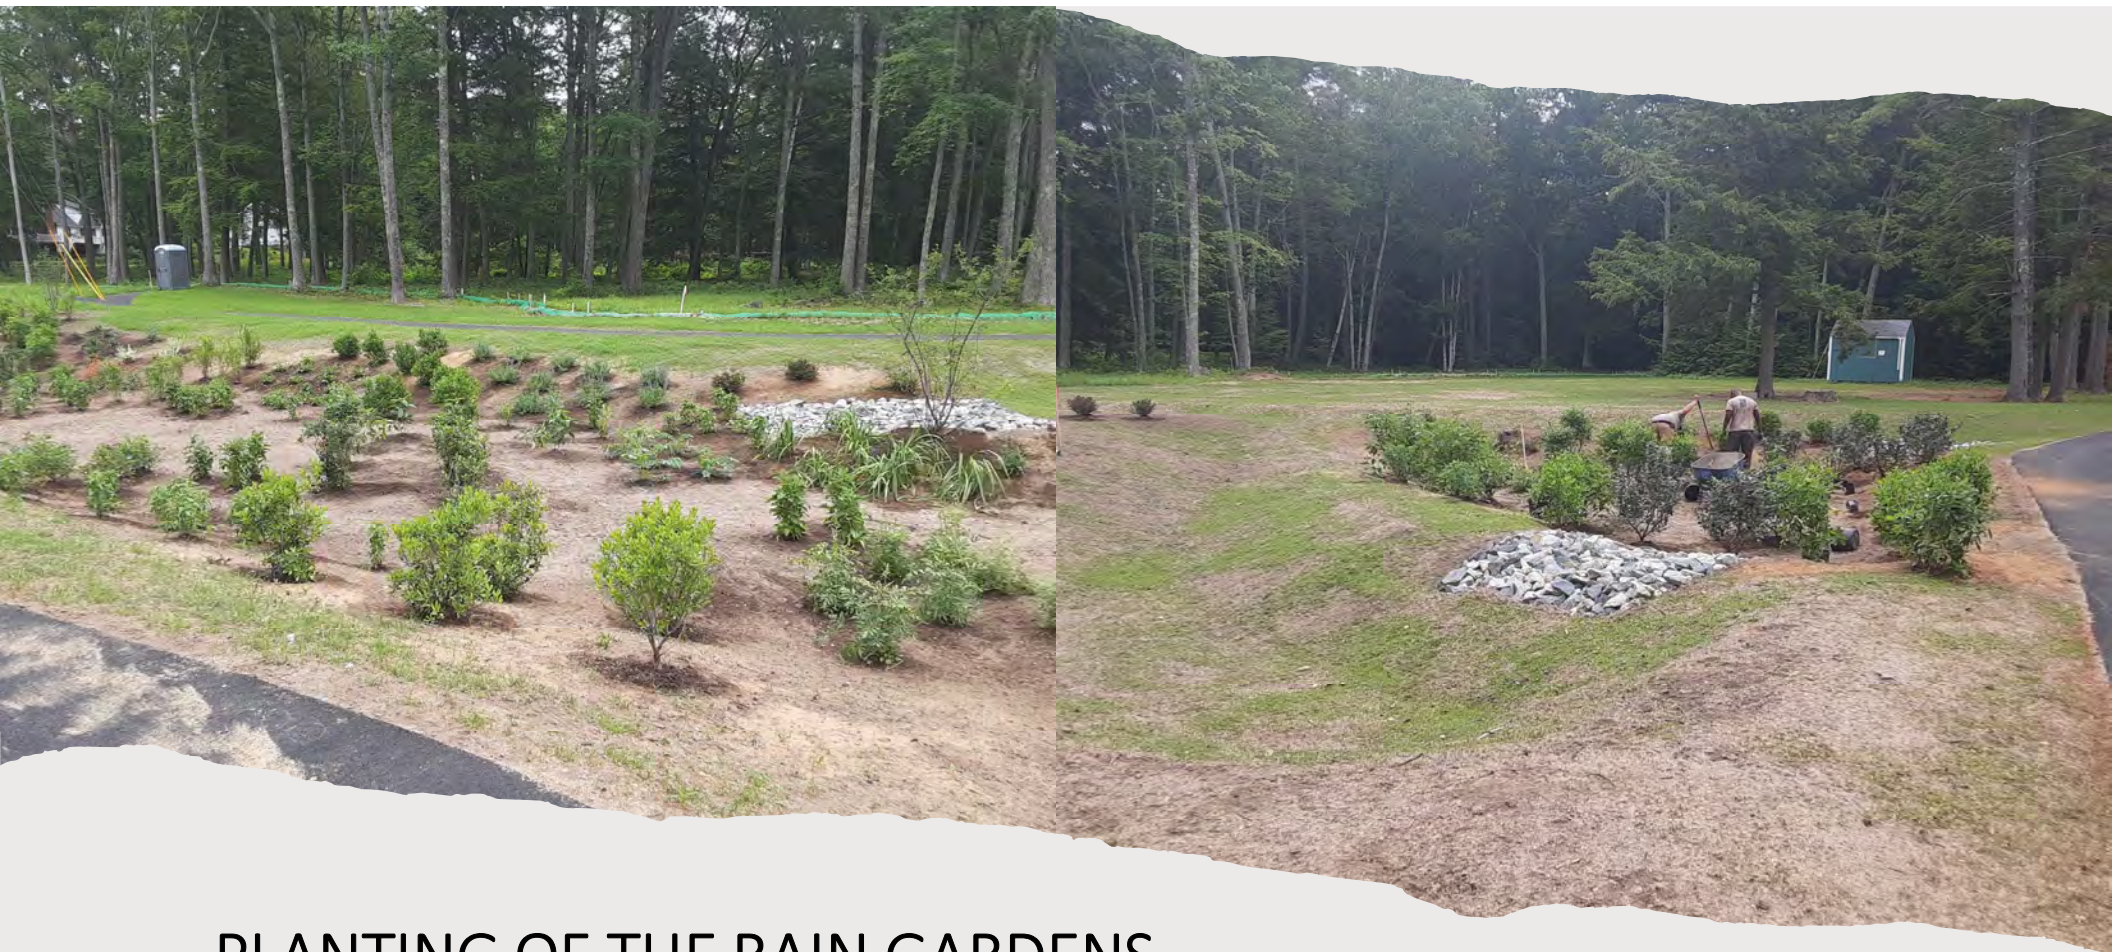
PLANTING OF THE RAIN GARDENS
