# Dam Decisions! Understanding Dam Maintenance and Repair

*NH Lakes Webinar – July 29, 2026*

Corey Clark, P.E.

Chief Engineer – Dam Bureau

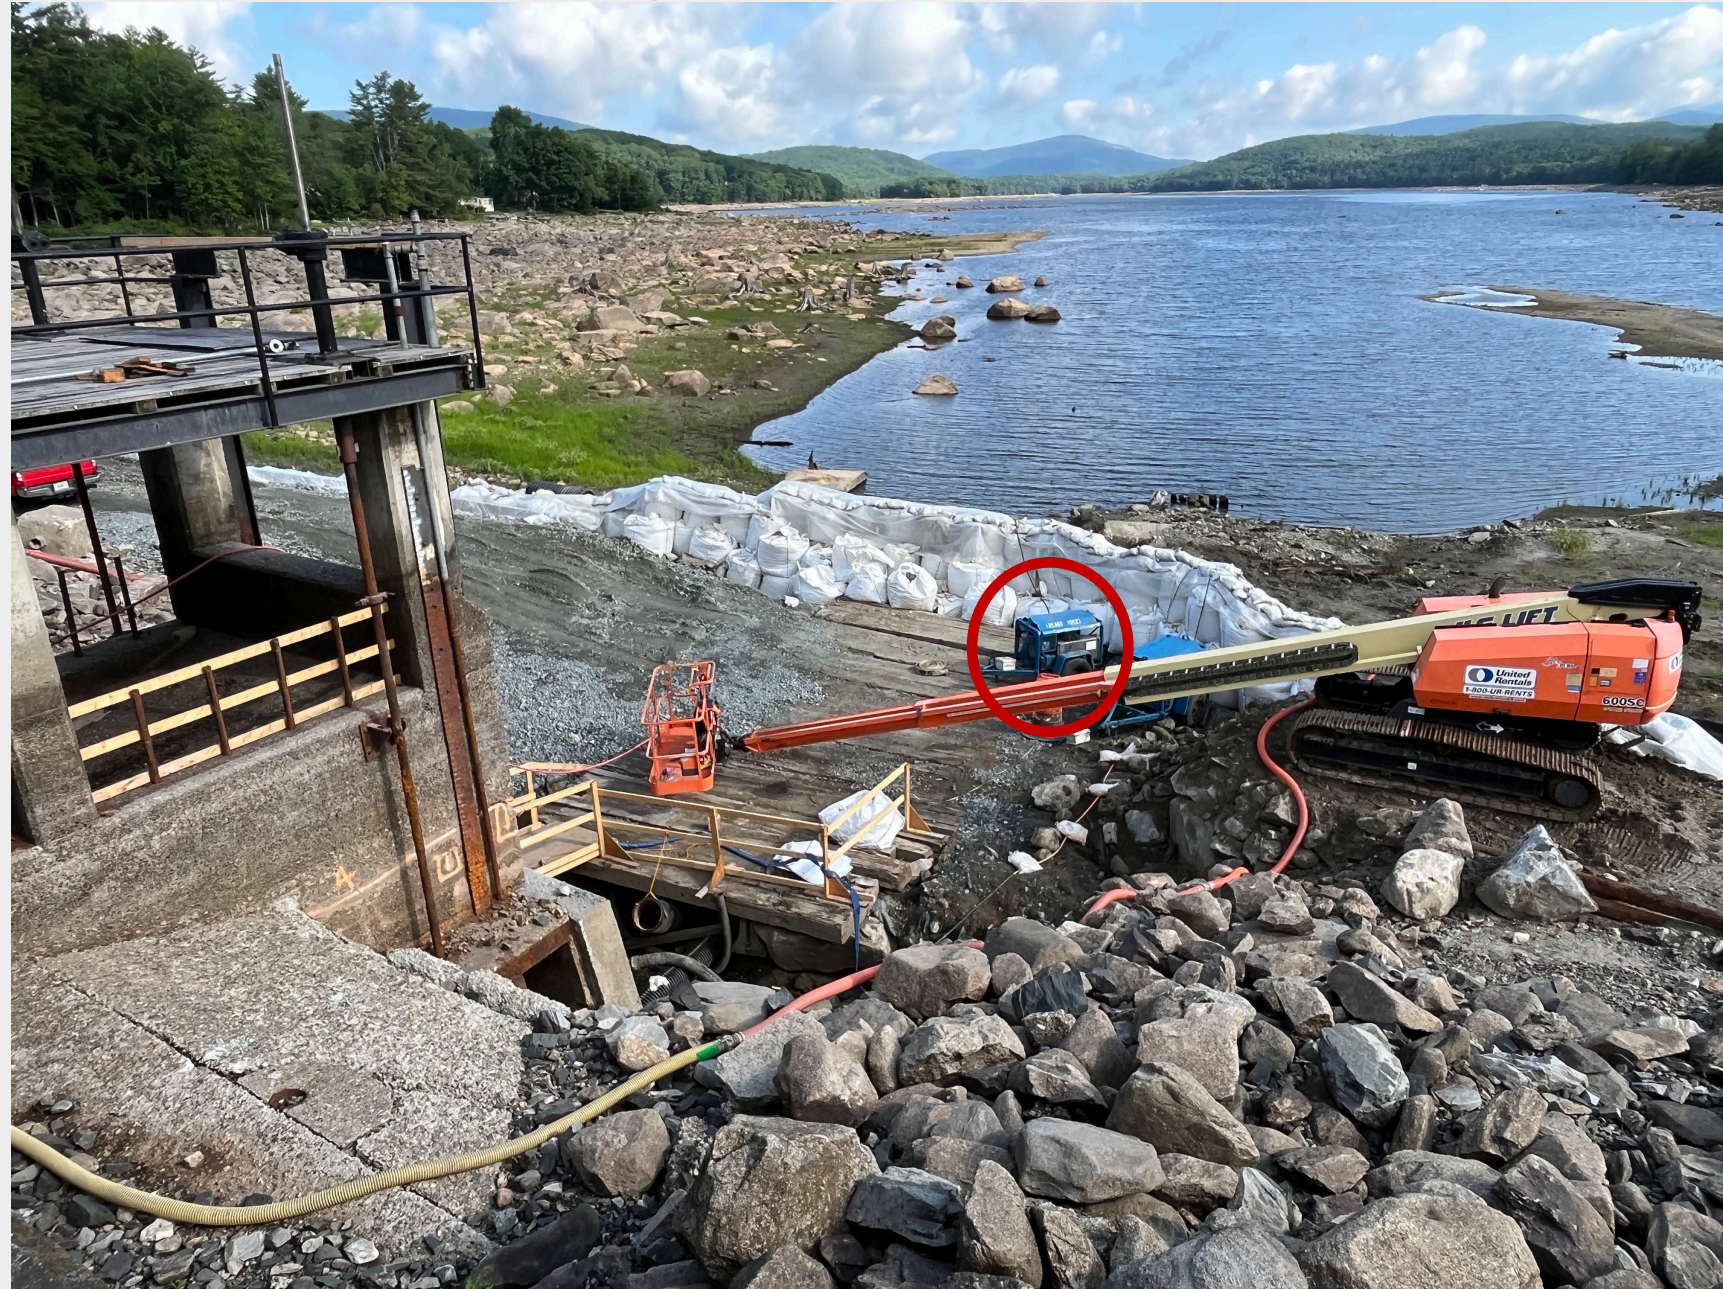
- Contractor installed 10-12 foot tall cofferdam and installed two 12-inch bypass pipes in the spring of 2024

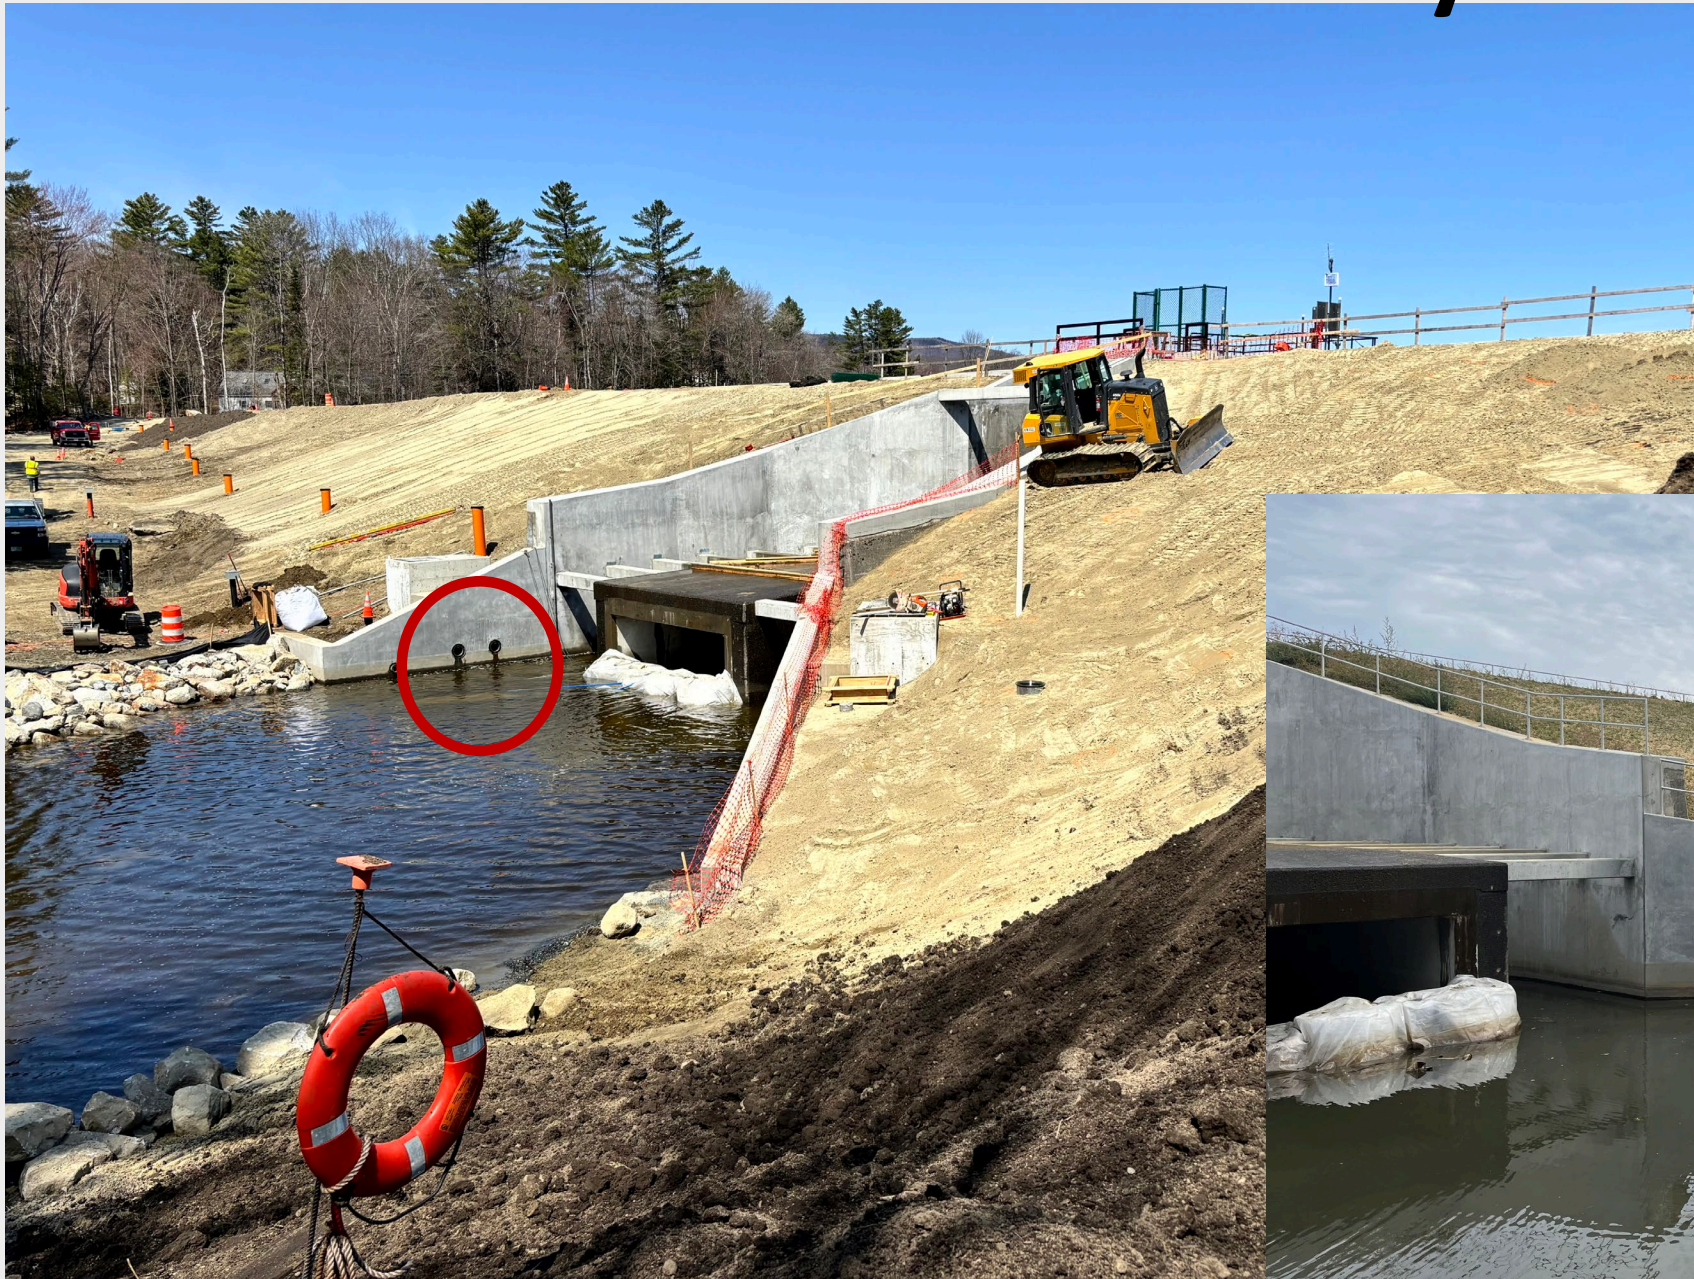
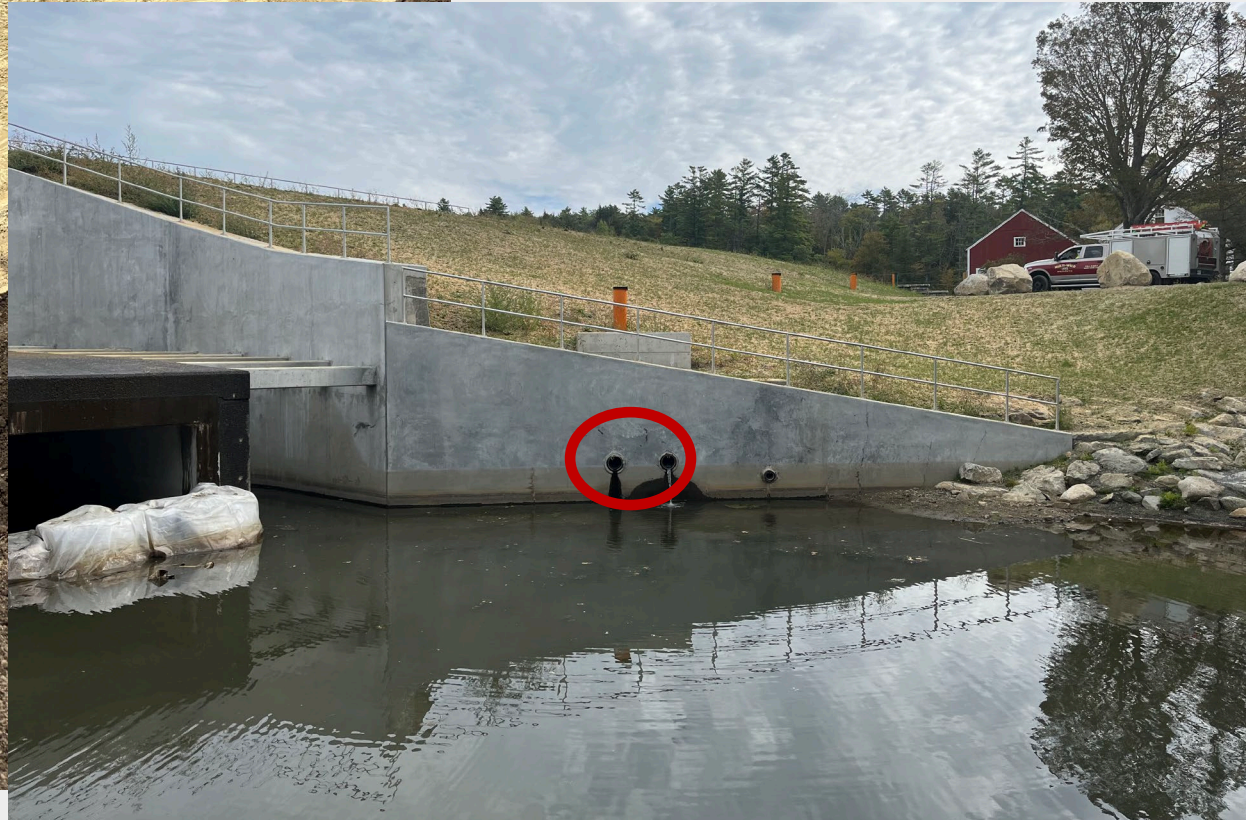
- Toe drains and relief wells have been operating as intended since the lake refilling process started in 2025

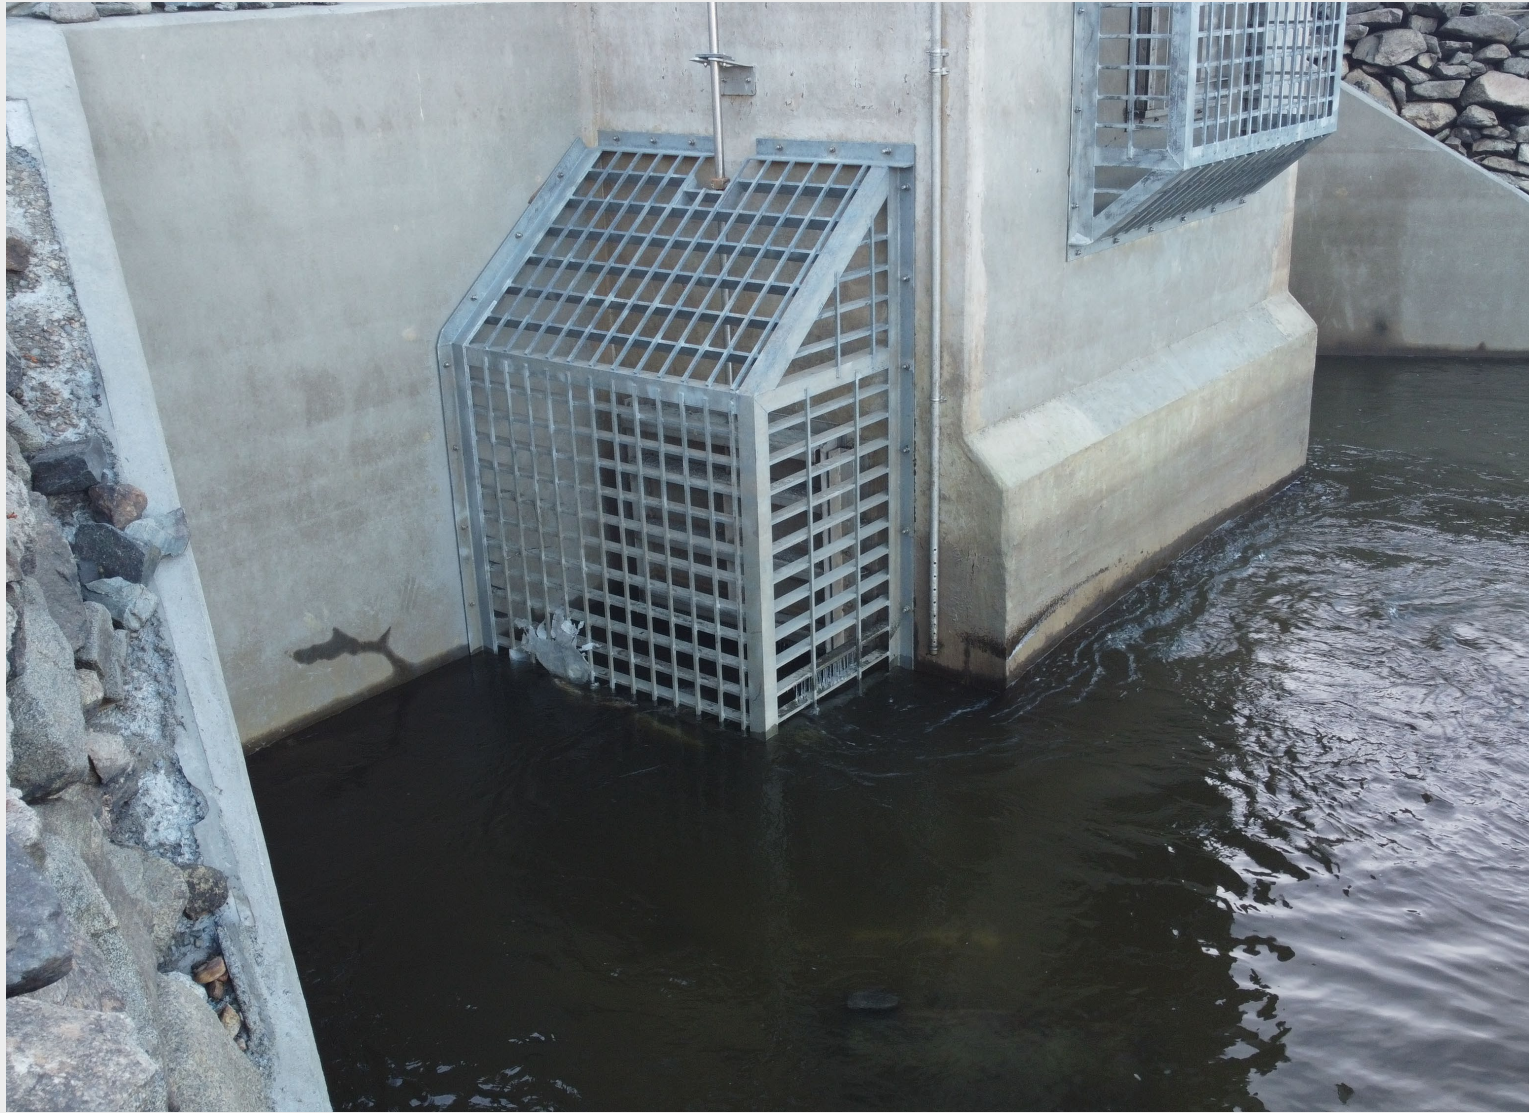
- Goose Pond was lowered in the fall of 2025 for gate adjustments after unsatisfactory gate testing
- Goose Pond was refilled in May 2026
- Final gate testing in June of 2026 indicated that gates are not properly sealing
- Contractor and gate manufacturer are seeking solutions

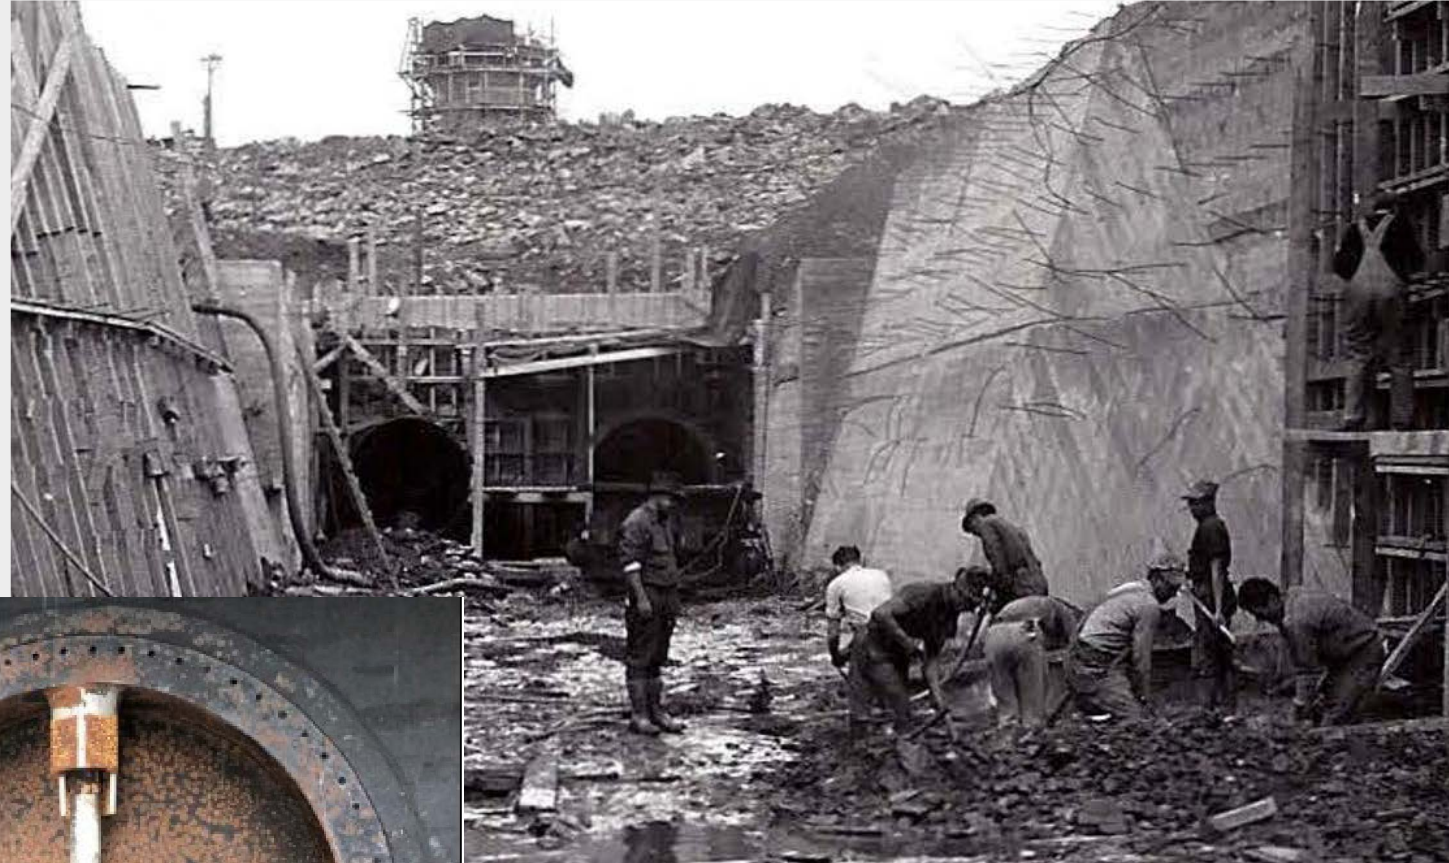
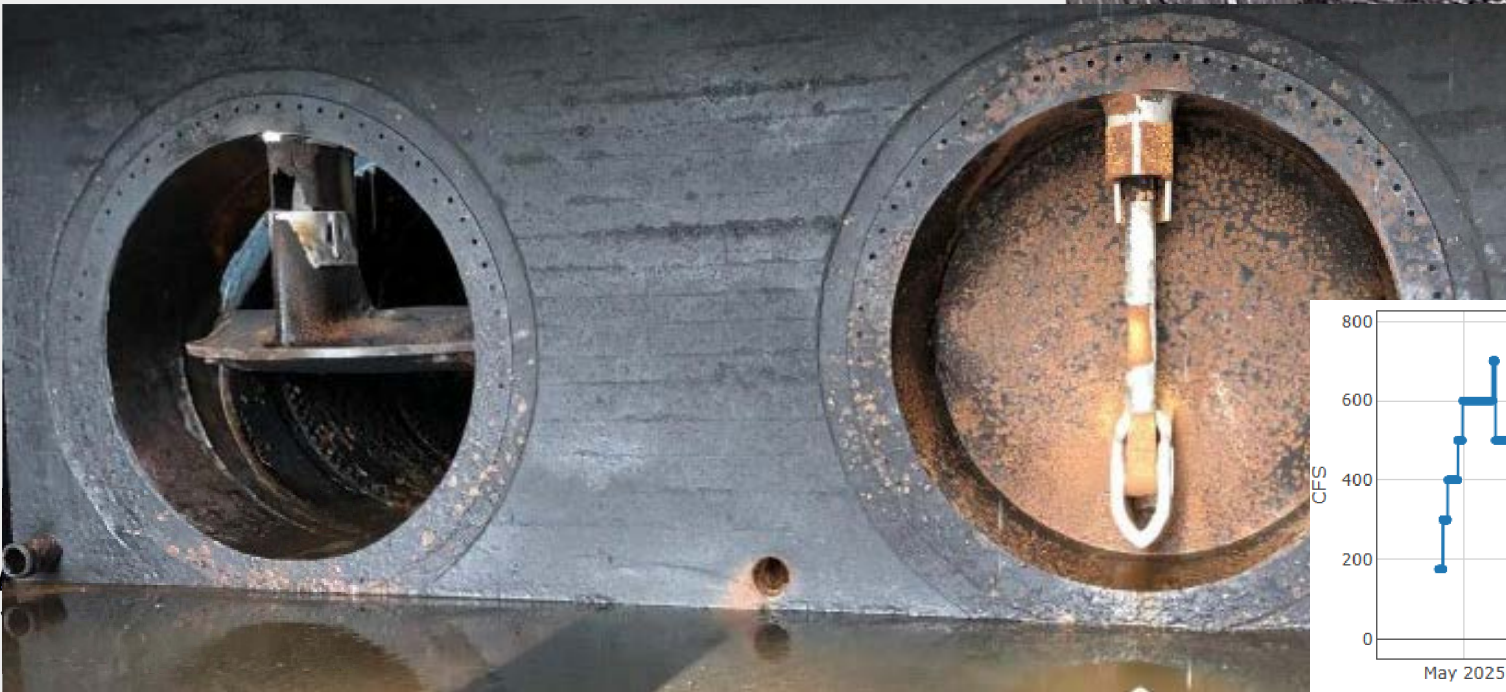
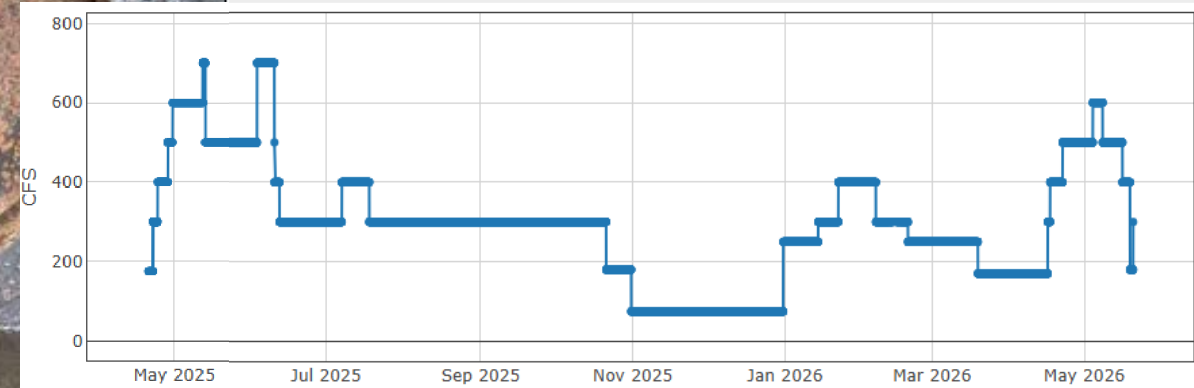
- 7-foot diameter butterfly valves
- Used to regulate Connecticut River flow
- Max discharge for both is 3,900 cfs (avg 300 cfs)

- Valves must run at very small openings they weren't designed for
- Small openings cause cavitation and steel loss
- Valves knock at flows over 400 cfs
